## Min/max tolerance sample catalogue for paintwork and corrosion damage

**Situation:** Min/max tolerance samples are available to enable improved pinpointing of paint and corrosion damage. They are a supplement to the BMW Paintwork publication announced in Service Information [41 01 08 \(452\)](#) and published in October 2008.

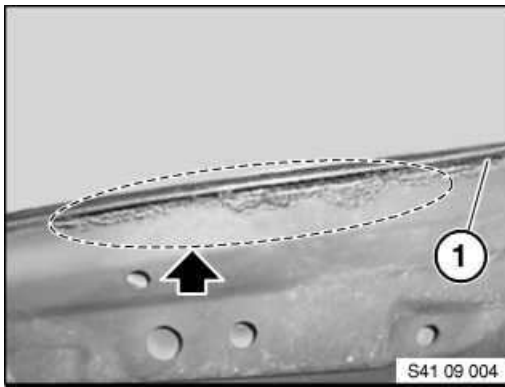
Sample A3:

Bubbling on the inside of the fold seal (1) is more extensive than the width.

| <u>Not for damage caused by customer</u> | <u>Period in years</u><br><u>First registration after</u><br><u>1.1.2004</u> | <u>Selection of the repair method</u> |
|---|---|---|
| <u>Min/max tolerance sample A</u> | 12 | Component replacement if feasible in terms of time |

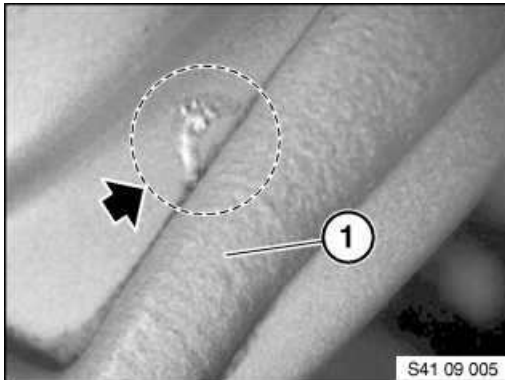
Sample B1:

General appearance: Rust is **NOT** visible without scratching the surface.

Bubbling on the inside of the fold seal (1) is less extensive than the width. Lengthwise distribution is less than the width of the fold seal (1).

| <u>Not for damage caused by customer</u> | <u>Period in years</u><br><u>First registration after</u><br><u>1.1.2004</u> | <u>Selection of the repair method</u> |
|---|---|---|
| <u>Min/max tolerance sample B</u> | 3 | Component replacement |
| <u>Min/max tolerance sample B</u> | from 3 | <u>NO part exchange permitted. The approval regulations of the local market must be observed at all times.</u> |

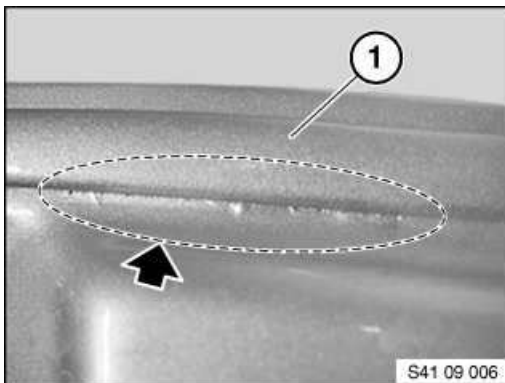
Sample B2:

Bubbling on the inside of the fold seal (1) is less extensive than the width. Lengthwise distribution is greater than the width of the fold seal (1).

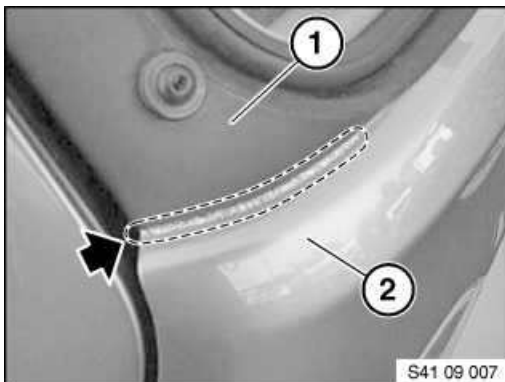
Sample C1:

Scrape marks on paint surface of the tailgate (2) by plastic trim (1) (only Touring).

| <u>Not for damage caused by customer</u> | <u>Period in years</u><br><u>First registration after</u><br><u>1.1.2004</u> | <u>Selection of the repair method</u> |
|---|---|---|
| <u>Min/max tolerance sample C</u> | 12 | Paint |

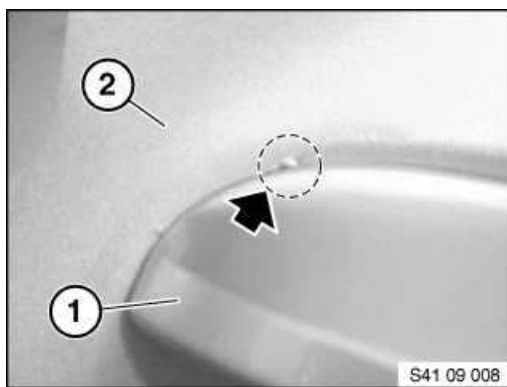
Sample C2:

Chafe marks on paint surface caused by tailgate handle strip (1) on tailgate (2).

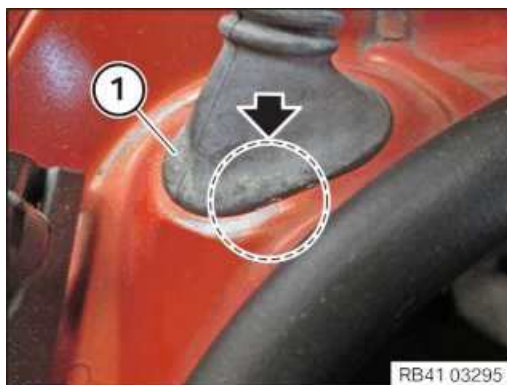
3. Tolerance sample D (rubber grommets)

Formation of blisters is not visible without lifting the rubber grommet (1).

| <u>Tolerance sample</u><br><u>D</u> | 12 | Paint |

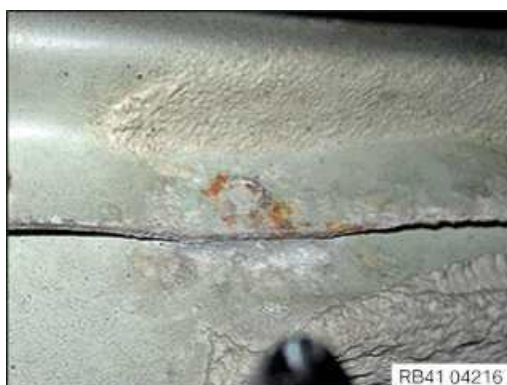
3. Min/max tolerance sample E (vehicle underbody)

Visible red rust formation originating from an edge or a spot-weld.

| <u>Min/max tolerance</u><br><u>sample E</u> | 12 | Seal and preserve. |
