## **Service Information**

**Rolls-Royce & Bentley  
motor cars**

TSD 4446

## SERVICE INFORMATION SHEETS INDEX FOR TSD 4446

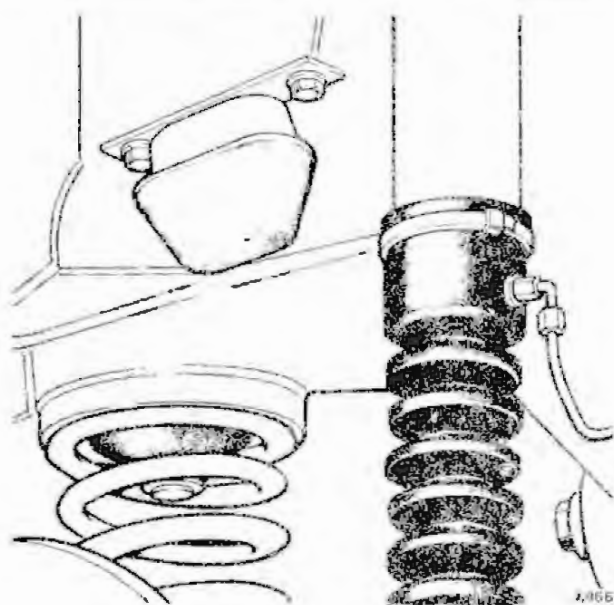
Fig. 1 Expanded polyurethane bump stop

In the event of service personnel encountering a complaint of 'knocks' from the rear suspension, the following procedure should be adopted.

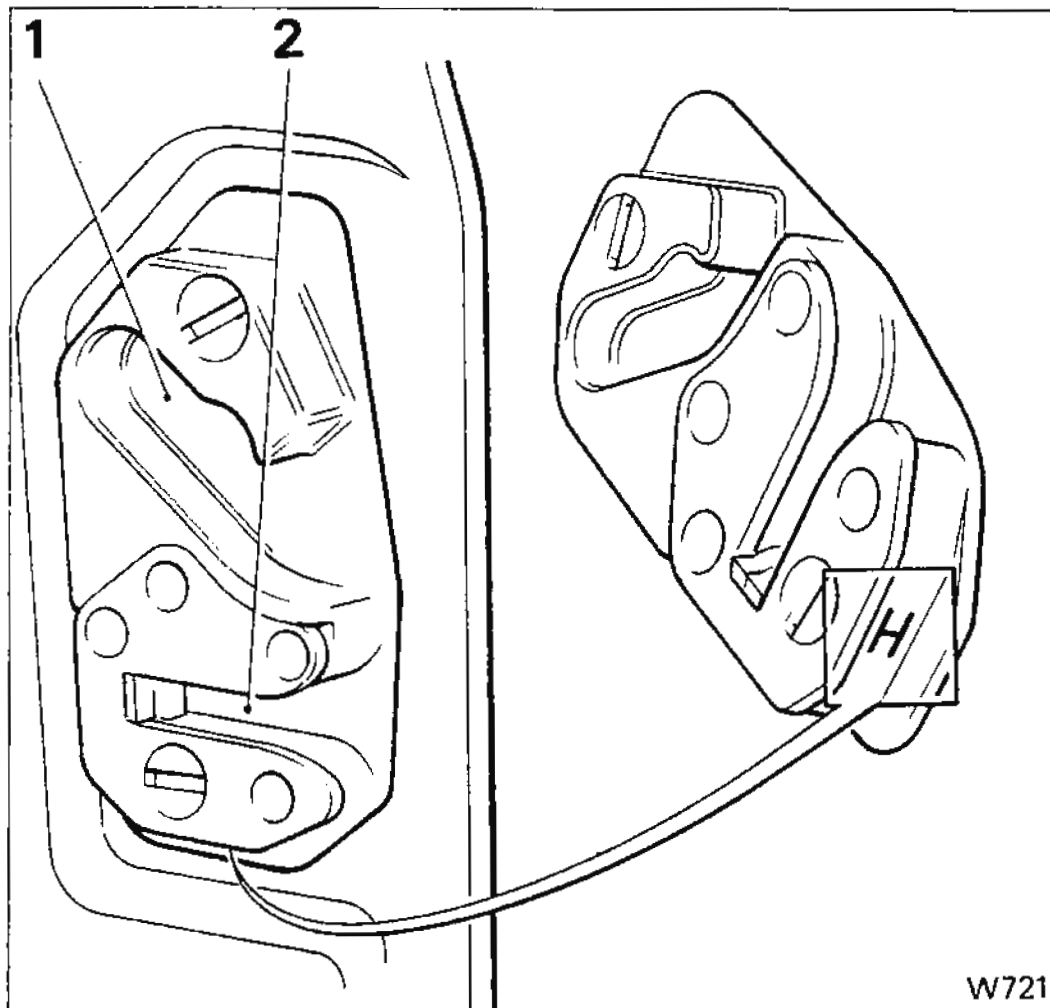
Fig. 1

A knocking noise from the door lock striker plate, and fidgeting from the window frame/door seal area when traversing broken road surfaces. It is the front doors which are more likely to be affected.

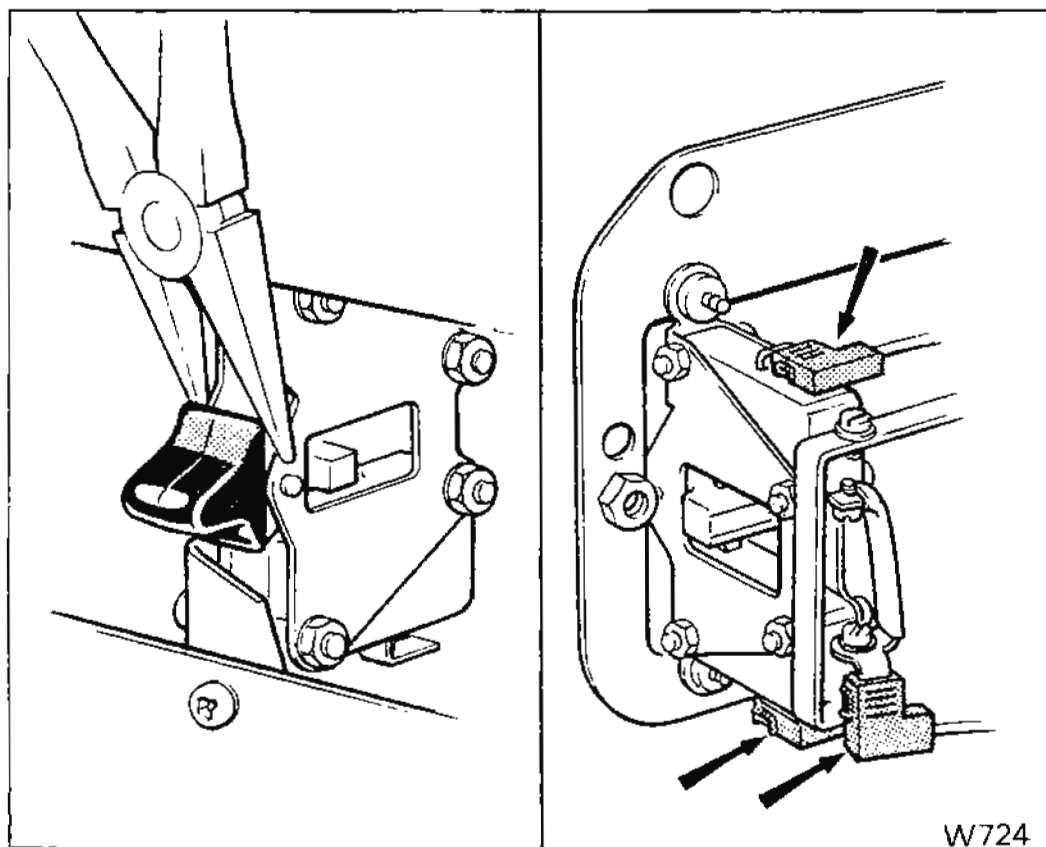
Fig. 5

The single electric window lift switch roll pin stop button can rattle. Also, the mounting bracket can vibrate on the inner door panel.

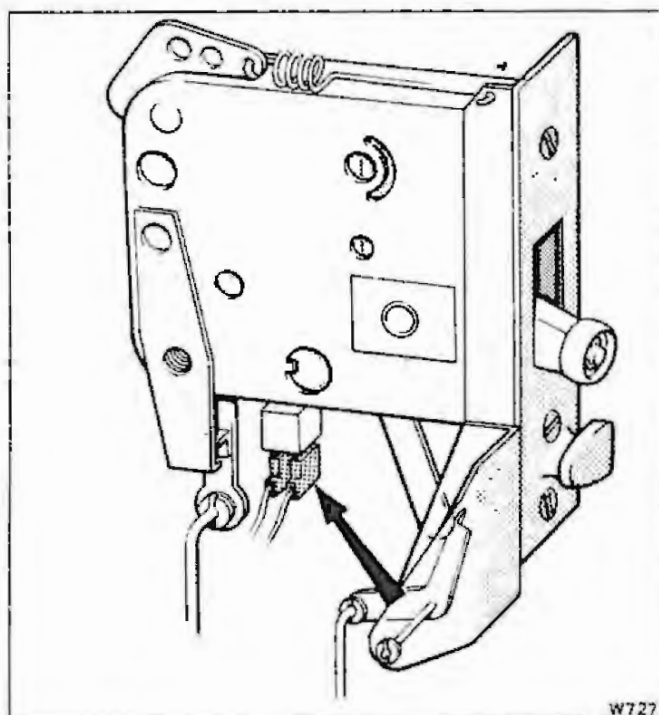
Fig. 8

The Lucar sleeves on the door lock courtesy switch connections can vibrate (see fig. 8).
