## 'Troubleshooting TPMS DTCs 32, 34, 36, or 38

## Troubleshooting Tips for DTC P1381

ASN 30817 (0509)

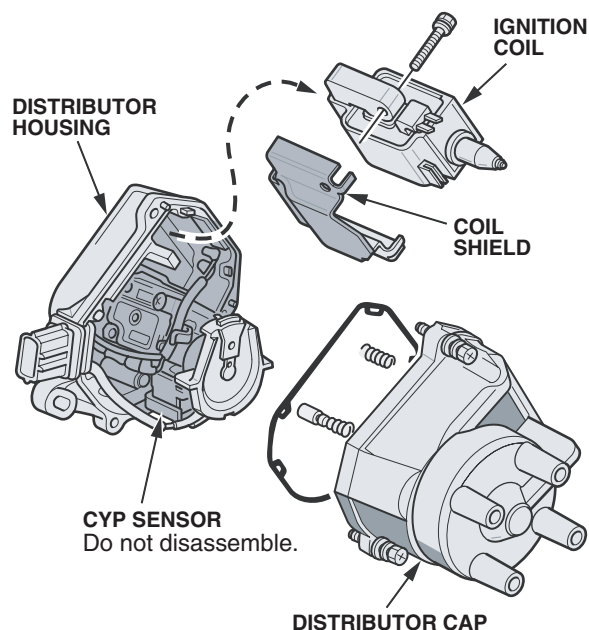
Troubleshooting a '98–02 Accord L4 or '96–00 Civic with DTC P1381 (CYP sensor intermittent interruption)? If you can't find anything wrong after following the procedure in the appropriate S/M, then try this:

1. Remove the distributor cap, and make sure the ignition coil shield is there and it's correctly installed.

- If the ignition coil shield installation is right, go to step 2.
  - If the ignition coil shield installation isn't right, properly install the coil shield.
2. Unplug the 4P connector from the alternator
  3. Test-drive the vehicle.
    - If DTC P1381 comes back with the alternator unplugged, replace the distributor housing.
    - If DTC P1381 doesn't come back, go to step 4.
  4. Plug the 4P connector into the alternator, and use the HDS to do a charging system test. Look at the alternator diode pattern on the display screen.
    - If the diode pattern doesn't look right, replace the alternator. A faulty diode can cause electrical interference that sets this DTC.
    - If the diode pattern looks OK, press on with normal troubleshooting.

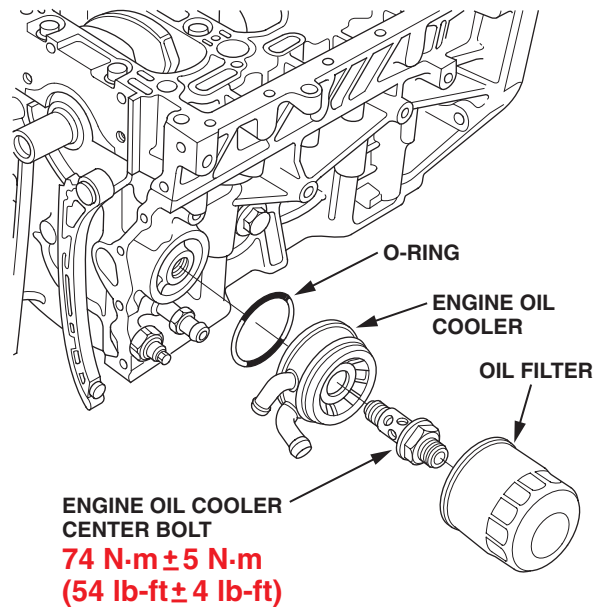
Need the torque spec for the engine oil cooler center bolt in a '00–05 S2000? Although there's a picture of this bolt in the Component Location Index in the '00–05 S2000 S/M and in ISIS, there's no mention anywhere of its torque spec. In fact, there's no mention of how to replace the engine oil cooler.

The upcoming '00–06 S2000 S/M will include an engine oil cooler replacement procedure. For now, jot down this torque spec for the center bolt in your copies of the S/M: **74 N·m ± 5 N·m (54 lb-ft ± 4 lb-ft)**.

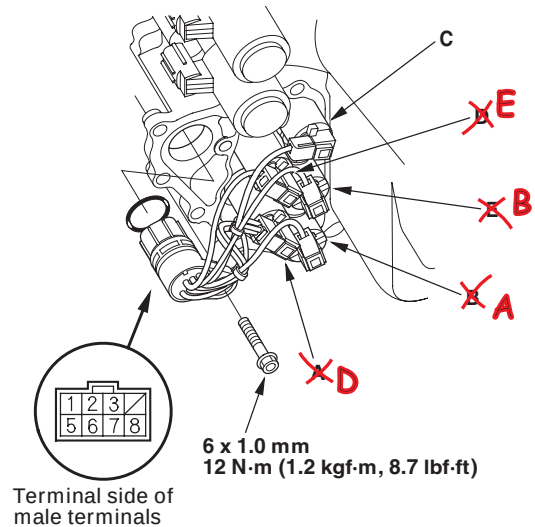
You need to tweak the illustration for step 19 on page 14-193 of the '03–06 Accord L4 S/M. The callouts are wrong. Mark up your copies of the S/M to look like this:

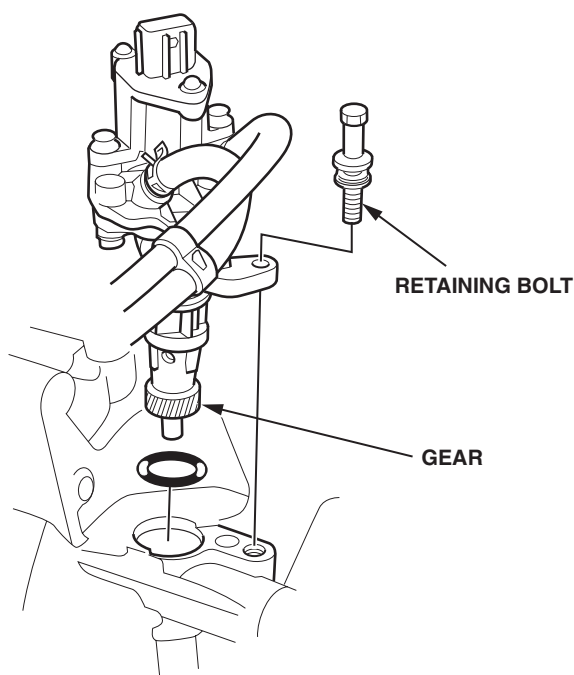
This is particularly true when it comes to installing the vehicle speed sensor (VSS). Step 6 of the instructions tells you to make sure its gear is fully engaged and the VSS is fully seated before you tighten the retaining bolt.

If you don't install the VSS properly, the speed sensor gear will get stripped and the A/T will be seriously damaged. So don't take risks with your customer's vehicle. *Always* follow these instructions to the letter. You can rest assured you're doing the job right.
