# 003 Symptoms and Field Observations

This repair group includes a list of symptoms, field observations, and suggested fixes for common problems and issues found on BMW 5 Series (E60, E61) vehicles.

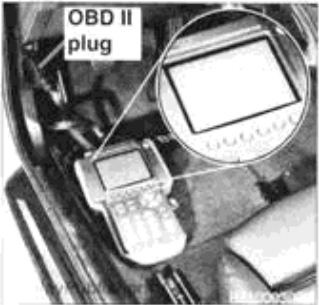
| Topic | Notes | Additional information (when available) |
|---|---|---|
| <p>No communication with BMW scan tool on DCAN.</p> | <p>When performing diagnosis on a vehicle with the BMW scan tool, the message "Connect diagnostic connector and switch ON ignition (Terminal 15)!" is displayed.</p> <ul style="list-style-type: none"> <li>• D-CAN failure in vehicle.</li> </ul> <p>Before diagnosing D-CAN in the vehicle, try communicating with another vehicle. If communication cannot be established on other vehicle, try a different scan tool. If communication resumes on the other vehicle, use the following steps to diagnose DCAN.</p> <ul style="list-style-type: none"> <li>— Disconnect vehicle power supply / charger (if connected).</li> <li>— Disconnect battery.</li> <li>— Check resistance of D-CAN circuit across OBD socket Pin 6 (D_CAN_H) and Pin 14 (D_CAN_L). A good D-CAN measures 60 ohms. The D-CAN circuit is fitted with two 120 ohm terminal resistors. One is fitted in wiring near OBD socket. The second is fitted in gateway module of vehicle (KGM or SGM).</li> <li>— If resistance reading is 0 ohms, the D-CAN wires are shorted together. Check circuit for shorts as per wiring diagram.</li> <li>— If resistance reading is Mega ohms, the D-CAN wiring has an open circuit. Check circuit for opens as per wiring diagram.</li> <li>— If resistance reading is 120 ohms, one of terminal resistors is faulty. Check resistance of both resistors for an open circuit and replace as necessary.</li> </ul> | 020, 600 |

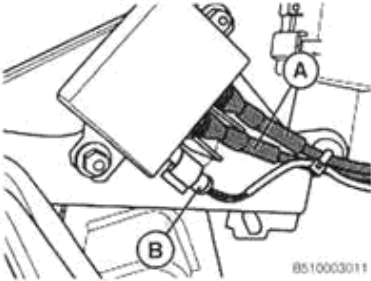
| Topic | Notes | Additional information (when available) |
|---|---|---|
| <b>Diagnosing electric cooling fan</b><br> | <p><b>From 03 / 2007 production vehicles:</b> A revised power supply relay for the electric coolant fan power supply was used on these vehicles</p> <p>Coolant fan power supply relay K9137 is located in the back of the rear fuse box. Connector (B) provides control signals for relay activation (KL30g from the rear fuse box/power distribution box and local ground KL31).</p> <p>On cars with inoperative electric coolant (with symptoms of A/C malfunction, engine overheating, or fault code 2EFE "Cooling fan activation" stored in the DME), check the power supply relay operation:</p> <p>Check that both B+ connections (A) are threaded on tight and free of corrosion.</p> <p>Check KL30g (B+) and KL31 (ground) signals (B) for correct operation.</p> | 170, ELE |

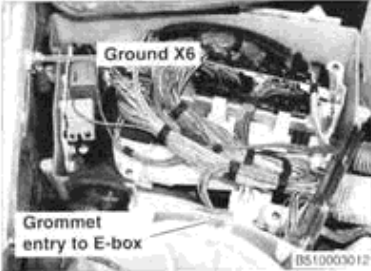
| Topic | Notes | Additional information (when available) |
|---|---|---|
| <b>E-box water ingress</b><br> | <p>Water leaks into the E-box may cause various drivability complaints, loss of power or the "Service Engine Soon" lamp to illuminate while driving.</p> <p>Water can enter through the grommet for the ground connection X6 on the front of the E-box.</p> <p>If water is present, check that all drains and water channels are clear.</p> | |

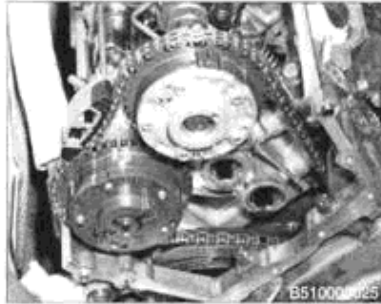
| Topic | Notes | Additional information (when available) |
|---|---|---|
| <b>Valvetrain service note</b><br> | <p>When diagnosing engine noise, do not rule out worn timing chain components. This is especially applicable to high mileage engines and engines with extended oil change intervals.</p> | 117 |

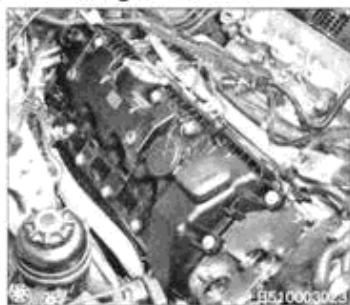
| Topic | Notes | Additional information (when available) |
|---|---|---|
| <b>Valve cover gasket leaks</b><br> | <p>When replacing valve cover gasket, take extra caution when tightening fasteners and sealing at metal joining points. For example front timing cover to cylinder head. There is a small area where silicone should be applied to seal where the gasket may not.</p> <p>Applies to all engines.</p> | 113 |

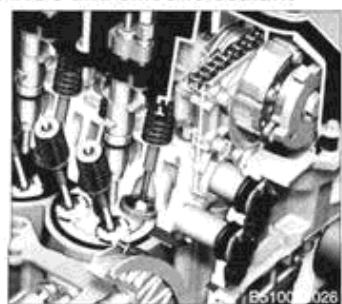
| Topic | Notes | Additional information (when available) |
|---|---|---|
| <b>VANOS and silicone sealant</b><br> | <p>When working around VANOS units keep area clean and free of silicone sealant. Even a small amount of silicone introduced into VANOS actuator or solenoid can cause a fault.</p> | 117 |

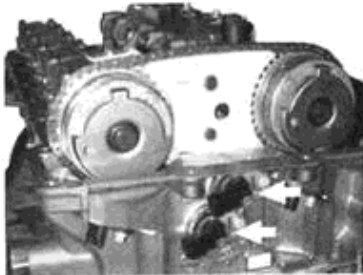
| Topic | Notes | Additional information (when available) |
|---|---|---|
| <b>Sticky VANOS solenoid sets cam position (CMP) sensor codes</b><br> | <p>A sticky / jammed VANOS solenoid can set a camshaft position (CMP) sensor fault (tooth error).</p> <p>Models with N52, N52KP, N54 and V8 engines may be difficult to start, run rough and have the Service Engine Soon lamp illuminated with one or more of the following stored faults:</p> <ul style="list-style-type: none"><li>• Cam sensor, inlet signal - signal invalid for synchronization</li><li>• Crankshaft-inlet camshaft, correlation</li><li>• VANOS intake - stiff, jammed mechanically</li><li>• Cam sensor, exhaust signal - signal invalid for synchronization</li><li>• Crankshaft - exhaust camshaft, correlation</li><li>• VANOS exhaust - stiff, jammed mechanically</li></ul> <p>Remove VANOS solenoid, intake or exhaust, depending on fault codes stored and, using shop air, gently blow out any visible particles and reinstall. If fault returns, try swapping solenoids between banks to see if fault follows solenoid. Replace solenoid if fault cannot be corrected.</p> | 117 |

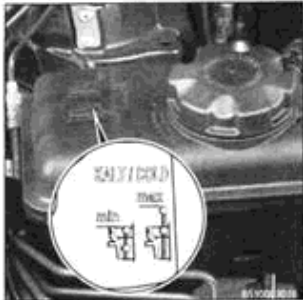
| Topic | Notes | Additional information (when available) |
|---|---|---|
| <b>Do not overfill cooling system</b><br> | <p>Be careful not to overfill cooling system during service or when topping up. V8 engine coolant caps have a tendency to not release when pressure exceeds maximum. An overfilled cooling system can amplify this problem.</p> | 170 |

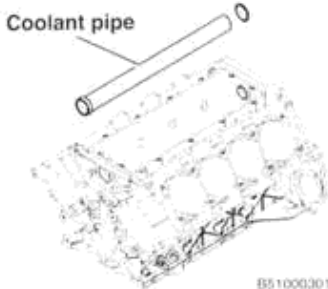
| Topic | Notes | Additional information (when available) |
|---|---|---|
| <b>Coolant pipe leak</b><br><br>BS10003013 | <p>The coolant pipe located in valley of V8 engine can develop leaks at the end O-ring seals. To replace the pipe with the OEM pipe, the front of the engine must be fully disassembled, requiring engine removal under most circumstances.</p> <p>Aftermarket options are available (threaded expanding pipe, is one example) that significantly reduce the time and cost required to do the job.</p> | |

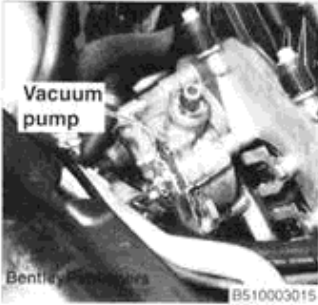
| | Topic | Notes | Additional information (when available) |
|---|---|---|---|
| V8 engine | <b>Vacuum pump diaphragm fails causing oil leak and brake booster failure</b><br> | <p>A ruptured vacuum pump diaphragm results in oil being sucked into the brake booster. Remove brake booster vacuum hose to inspect. If oil is present in hose, replace vacuum pump. If large amounts of oil are found inspect brake booster, replacement may be needed.</p> | 133 |

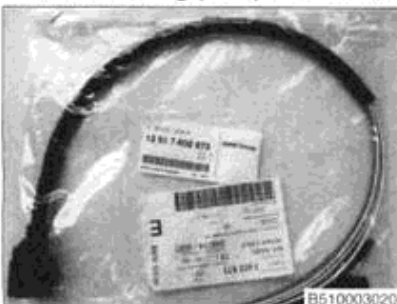
| | Topic | Notes | Additional information (when available) |
|---|---|---|---|
| V8 engine | <b>Throttle housing (EDK) fault codes</b><br> | <p>Fault codes:</p> <ul style="list-style-type: none"> <li>• 2CF8 – Throttle valve potentiometer, signal</li> <li>• 2CF9 – Throttle valve potentiometer 1, signal</li> <li>• 2CFA – Throttle valve potentiometer 2, signal</li> </ul> <p>In most cases, DSC fault 5F77 (DME invalid data) will also be stored. These faults are sporadic and usually not reproducible.</p> <p>The cause is an intermittent interruption of the EDK signal to the DME due to a resistance fluctuation in the EDK harness connector. Replace EDK harness with updated part #12 51 7 602 973.</p> | 133 |

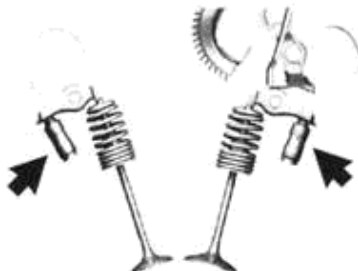
| | Topic | Notes | Additional information (when available) |
|---|---|---|---|
| N52 engine | <b>Intermittent lifter noise</b><br> | <p>An occasional ticking or rattling noise from hydraulic valve adjusters (HVA) elements may occur during cold engine starts or frequent short-distance driving. This condition will not cause any damage to the engine, and usually remedies itself with a longer driving distance or operating times at full operating temperature.</p> <p>In this situation, the lifters can bleed down or have trapped air causing ticking/rattling noise and may require bleeding, as described below. The bleed time may take anywhere from two minutes to a maximum of 30 minutes.</p> <p>Procedure preconditions:</p> <ul style="list-style-type: none"> <li>• Engine running at operating temperature</li> <li>• Vehicle stationary on a level surface in a properly ventilated area</li> <li>• Engine oil level correct – not underfilled or overfilled</li> </ul> <ol style="list-style-type: none"> <li>1. Bring engine up to an operating speed (no load) of 2000-3000 rpm and maintain this speed for three minutes.</li> <li>2. Let engine idle for 15-30 seconds. Listen for whether the noise is still present: <ul style="list-style-type: none"> <li>- If engine is quiet, procedure is finished.</li> <li>- If engine noise still present, repeat procedure; perform steps 1 and 2 up to a maximum of 5 times.</li> </ul> </li> </ol> <p>If the noise remains after performing the bleeding procedure 5 times: proceed by performing the procedure for a final time, also at an engine operating speed of 2000-3000 rpm, but for a total time duration of 15 minutes. If noise returns after multiple bleedings, the cylinder head may be faulty and require replacement.</p> | 113 |

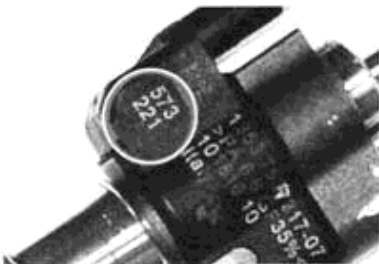
| Topic | Notes | Additional information (when available) |
|---|---|---|
| N54 engine | <p>Cylinder-assigned high pressure injectors</p> <p>On N54 engines, mark the cylinder locations on the fuel injectors when removing them.</p> <p>As part of injector manufacturing, tolerance ranges for injection quantity are determined and specified in a six-digit number combination. These values are used by the DME to compensate for variations in the individual injectors.</p> <p><b>NOTE —</b></p> <ul style="list-style-type: none"> <li>When replacing an injector, it is essential to carry out an injector adjustment using the BMW scan tool.</li> </ul> | 130 |

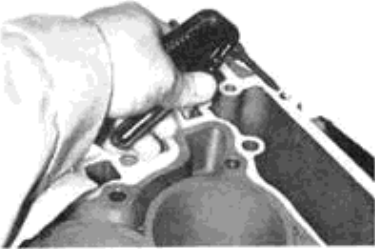
| | Topic | Notes | Additional information (when available) |
|---|---|---|---|
| N52, N54 engines | <b>Coolant contact with magnesium components</b><br> | <p>During service procedures which involve coolant, such as cylinder head replacement, the bolt holes must be blown dry immediately. To prevent corrosion, do not allow any traces of coolant to remain in holes.</p> | 113 |

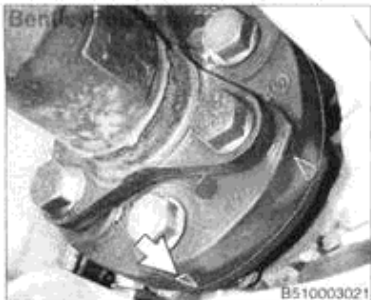
| Topic | Notes | Additional information (when available) |
|---|---|---|
| <b>Vibration or noise in drive train</b><br><br>B510003021 | <p>One or more of the following may be heard while driving slowly, coming to a stop or at highway speeds:</p> <ul style="list-style-type: none"> <li>• A clunk can be heard while rolling slowly and downshifting from 2nd to 1st gear coming to a stop.</li> <li>• Load reversal causes a slight clunk noise.</li> <li>• A clunk noise can be heard while shifting into forward or reverse gear from park or neutral.</li> </ul> <p>Check for a deterioration or separation of the rubber in the universal joint located between the transmission and drive shaft assembly.</p> <p>To check if the noise is caused by a defective universal joint the driveshaft must first be removed. Once removed, check if any of the metal collars are loose and/or rubber cracking is found. Replace the universal joint if any fault are found.</p> | 240 |

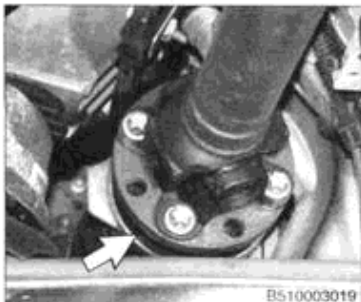
| Topic | Notes | Additional information (when available) |
|---|---|---|
| <b>xDrive front pinion seal leak</b><br> | <p>Front pinion seal leaks (<b>arrow</b>) should be addressed promptly. The front differential has a low fluid capacity and any size leak can pose an immediate problem.</p> | 311 |

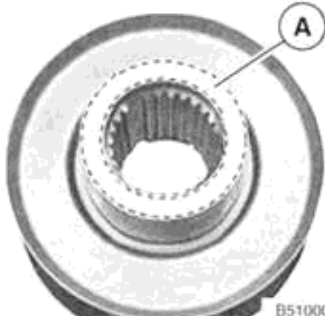
| Topic | Notes | Additional information (when available) |
|---|---|---|
| <p>Clicking or cracking noise from rear differential</p> <p>BS10003010</p> | <p>The differential input flange mating surface with the input drive pinion is insufficiently greased.</p> <p>This is not a failure of the differential assembly. Do not replace the complete differential.</p> <p>Remove the differential drive flange.</p> <p>Apply lubricant P/N 83 23 0 443 864 on the input flange mating surface (A), as described in the illustration.</p> <p>Before complete reassembly, replace the input flange seal and collar nut retaining plate</p> | |

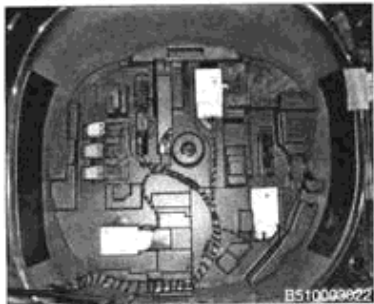
| Topic | Notes | Additional information (when available) |
|---|---|---|
| <p>Multiple electrical faults caused by water leak into trunk</p> | <p>Electrical components mounted in spare tire well may become damaged by water leaking into trunk. Inspect trunk rubber seal and in particular, the large rubber washers at the bumper fasteners (as viewed from inside trunk).</p> | |

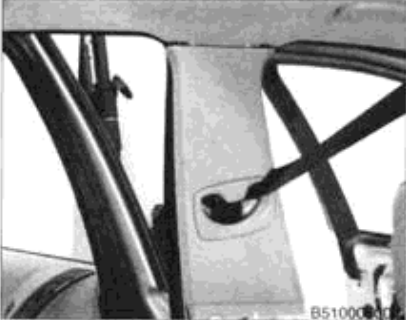
| Topic | Notes | Additional information (when available) |
|---|---|---|
| <p>Squeaking noise from B-pillar</p> | <p>A squeaking or grating noise may be heard from the top of the B-pillar when driving over rough roads at very cold ambient temperatures. This noise typically occurs only below approximately 20°F. (For noises from this area at high temperatures, refer to BMW Service Bulletin SI B51 02 05).</p> <p>This is caused by a bad bond between the B-pillar trim and the rear door seal.</p> <p>Replace the door seal with an updated part, which uses a softer rubber compound.</p> | |

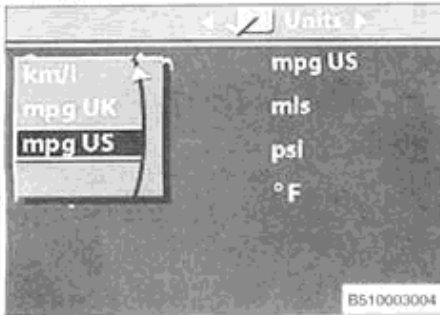
| Topic | Notes | Additional Information (when available) |
|---|---|---|
| <b>Consumption is Set to mpg UK instead of mpg US</b><br><br> | <p>Using iDrive menu change setting under Display Settings.</p> | |

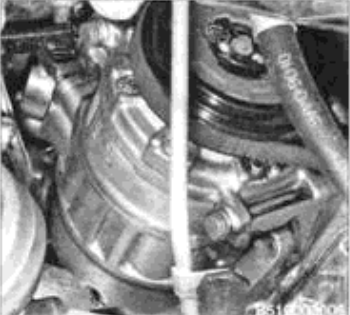
| Topic | Notes | Additional information (when available) |
|---|---|---|
| A/C compressor does not switch ON<br> | <p>IHKA (Integrated Heating and Air Conditioning) fault 9C6A – Compressor Coupling is stored.</p> <p>Check for a loose ground connection at compressor. If the ground connection is not loose, continue troubleshooting fault using BMW scan tool test plan</p> | |

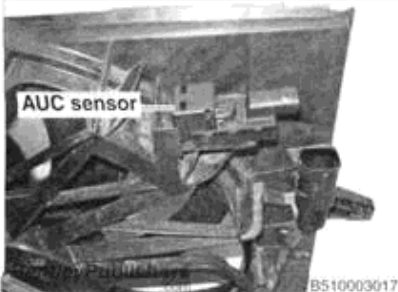
| Topic | Notes | Additional information (when available) |
|---|---|---|
| Testing automatic recirculation (AUC) sensor.<br> | <p>Use the following steps to diagnose AUC-related fault codes.</p> <ul style="list-style-type: none"> <li>— Remove AUC sensor from mounting point. Electrical connector remains connected.</li> <li>— Turn ignition key on, make sure IHKA system is on.</li> <li>— Blow into AUC sensor air intake. Fresh air flap should slam shut.</li> <li>— If flap does not close, check voltage supply to sensor. If voltage supply is good, replace AUC sensor.</li> </ul> | 640 |

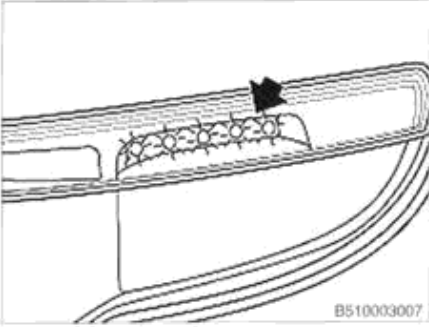
| Topic | Notes | Additional information (when available) |
|---|---|---|
| <b>Eyebrow lights inoperative after programming</b><br> <p>B510003007</p> | <p>If eyebrow lights (<b>arrow</b>) fail to work after vehicle programming, reprogram complete vehicle using BMW scan tool with latest software.</p> | |

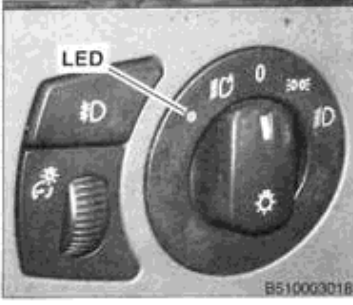
| Topic | Notes | Additional information (when available) |
|---|---|---|
| <b>LED flashing on headlight switch, no faults stored</b><br> <p>B510003018</p> | <p>With the light switch switched to the automatic position, the LED on the headlamp switch is flashing and AHL (Active Headlights) is deactivated.</p> <p>Using the BMW scan tool, carry out a short test to identify any faults related to AHL system. If no faults are stored and LED is still flashing, problem may be caused by stuck stepper motor in the headlamp.</p> <p>AHL is integrated into BUS network and relies on communication with other modules to function. Select: "Control Unit Functions/AHL/Component Activation."</p> <p>Activate each of the AHL functions in turn until the problem is identified and replace faulty components.</p> | |

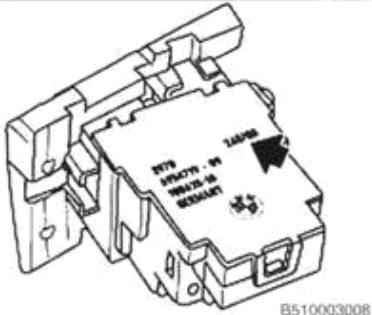
| Topic | Notes | Additional information (when available) |
|---|---|---|
| <b>Key falls out of, or gets stuck in key holder</b><br> <p>B510003008</p> | <p>Remote key is not adequately retained in the key slot and sometimes falls out. There are also situations where the remote key gets stuck in the key slot and cannot easily be removed.</p> <p>Under these situations, the key slot should be replaced with an updated part (improved mechanism for gripping the remote key). Updated part were introduced in 9 / 2005.</p> <p>The date code on the part is in day/year format. Improved parts have date code 248/05 or later. Illustration shows E90 key holder, E60 is similar.</p> | |

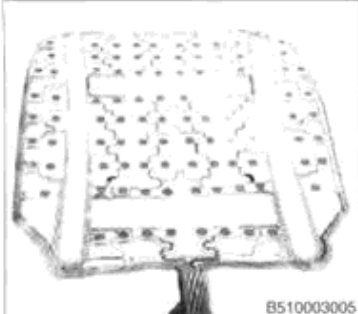
| Topic | Notes | Additional information (when available) |
|---|---|---|
| <b>OC3 (occupancy) mat installation tips.</b><br> <p>B510003005</p> | <p>When a new OC3 seat mat has been installed use the following tips to avoid activation problems:</p> <ul style="list-style-type: none"> <li>• With the new seat mat installed in the vehicle, eliminate any tension in the seat mat caused by the installation process by having an adult sit in the seat.</li> <li>• Remove all weight from the seat.</li> <li>• Using BMW scan tool, enable the seat mat.</li> </ul> <p><b>NOTE —</b></p> <ul style="list-style-type: none"> <li>• OC3 mat warranty has been extended to 10 years / unlimited mileage on vehicles produced to 11 / 2005.</li> </ul> | |

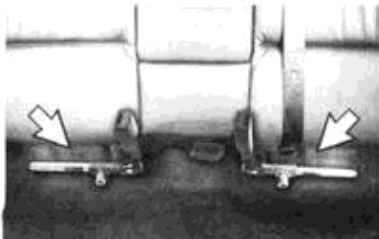
| Topic | Notes | Additional information (when available) |
|---|---|---|
| <b>Both rear belt tensioners deploy in accident</b><br> | <p>In the case of an accident that would trigger the rear belt tensioners, both tensioners will deploy, regardless of whether the rear seats are occupied, or not. This is a normal condition as the rear belt buckles have no switch.</p> <p><b>WARNING —</b></p> <ul style="list-style-type: none"> <li>• Always replace deployed airbag components and confirm MRS operational status using BMW scan tool.</li> </ul> | 721 |
