61 12 ...

## Removing and installing / replacing positive battery cable at partition seal (engine compartment)

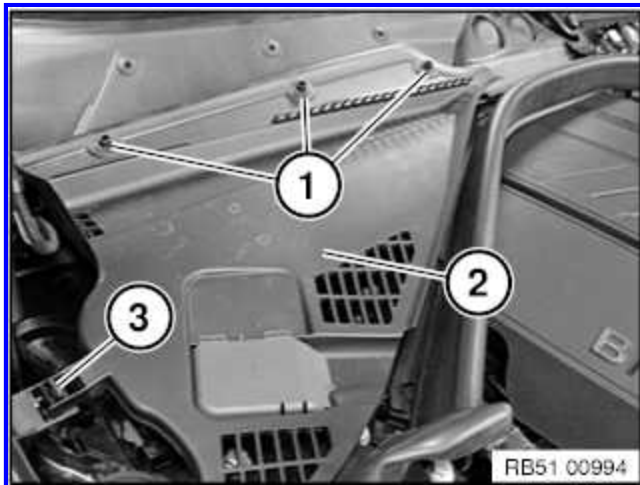
Turn locks (1) 90° counterclockwise.

Unlock catch (3).

Remove cover (2).

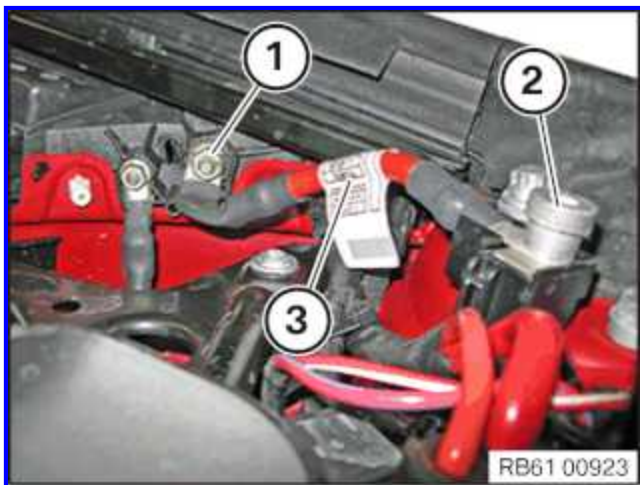
Slacken nut (1).

Tightening torque [61 21 4AZ](#).

Slacken nut (2).

Remove positive battery cable (3).

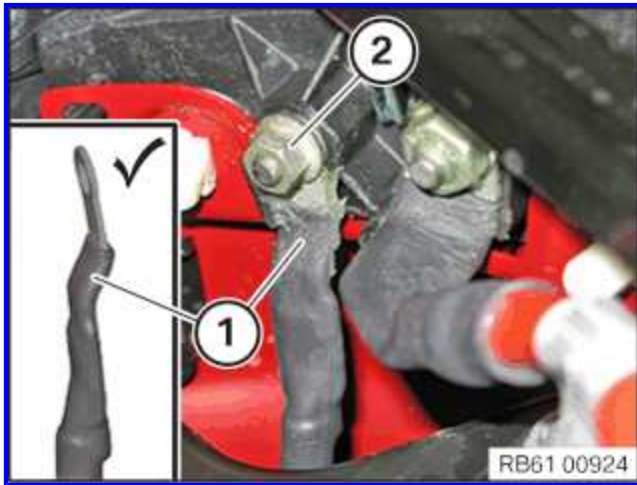
Check that the positive battery cable subsurface (1) is correctly positioned.

Positive battery cable subsurface (1) must face away from partition seal as shown.

In case of incorrect installation position:

Release nut (2) and correct installation position of positive battery cable subsurface (1).

Tightening torque [61 21 7AZ](#).

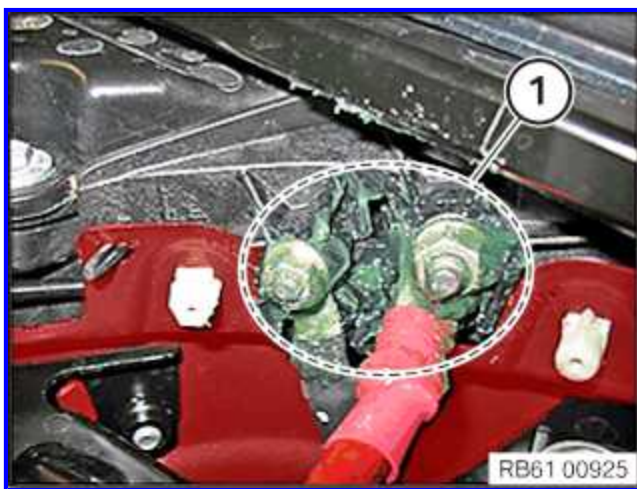
*Installation note:*

**Coat positive battery cables (1) at partition seal with contact protection grease.**

(Contact protection grease BMW part number 83 19 2 295 229.)

Use a standard flat brush with a width of approx. 2.5 cm to apply the grease.

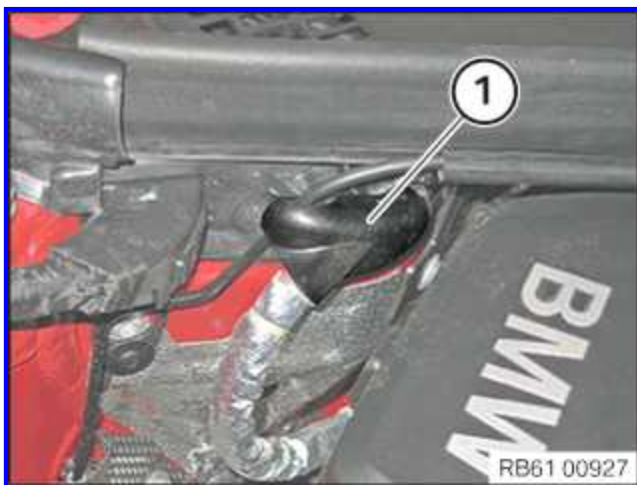
Unclip cover (1).

*Installation note:*

Guide and retaining lugs on cover (1) must not be damaged or missing.

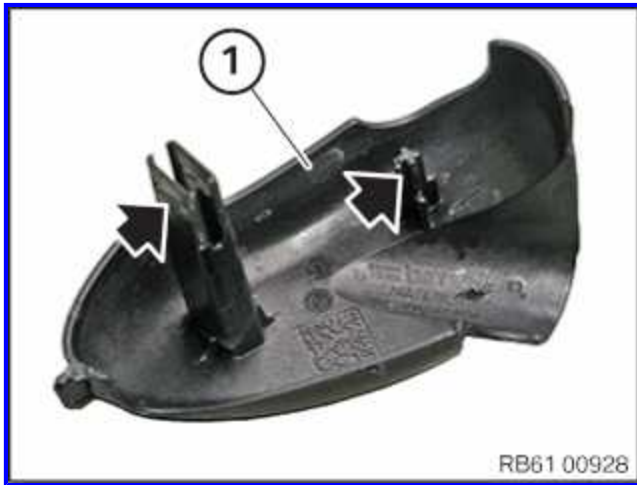
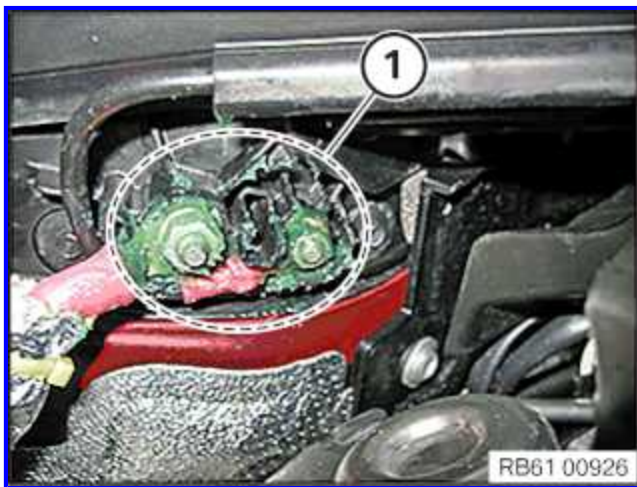
*Installation note:*

**Coat positive battery cables (1) at partition seal with contact protection grease.**

(Contact protection grease BMW part number 83 19 2 295 229.)

Use a standard flat brush with a width of approx. 2.5 cm to apply the grease.
