64 11 850

## Replacing actuator drive for rear compartment flap

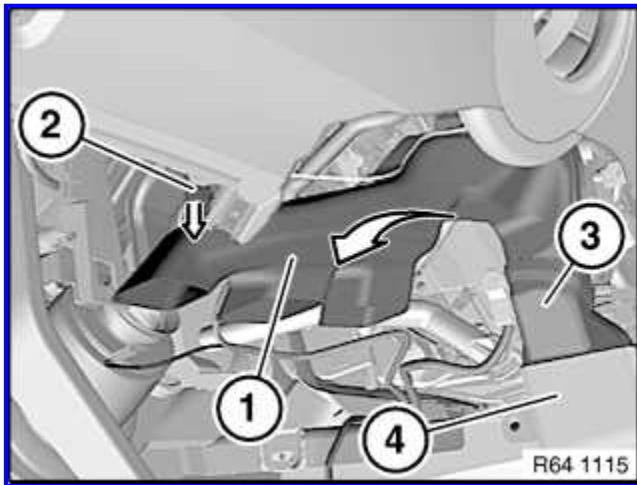
Detach left footwell heating duct (1) in area (2) in direction of arrow.

Detach left footwell heating duct (1) with adapter (3) from heating and air conditioning and remove in direction of arrow from left rear compartment heating duct (4).

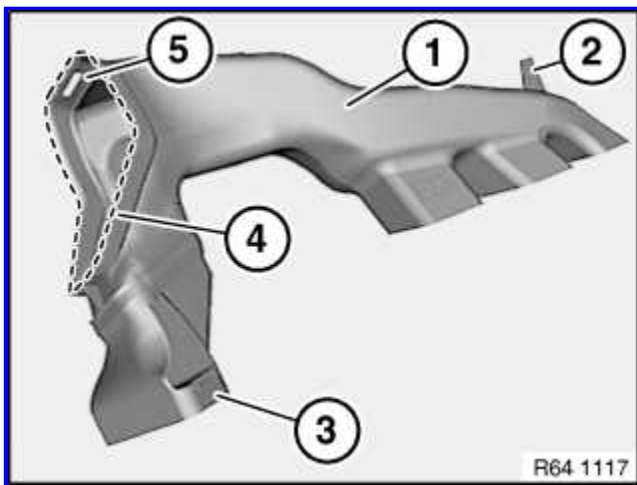
Make sure clamp (2) is correctly seated on left footwell heating duct (1).

Insert footwell heating duct (1) with adapter (3) in rear compartment heating duct (4).

Attach footwell heating duct (1) in area (4) to heating and air-conditioning unit. Make sure assembly is locked exactly at point (5).

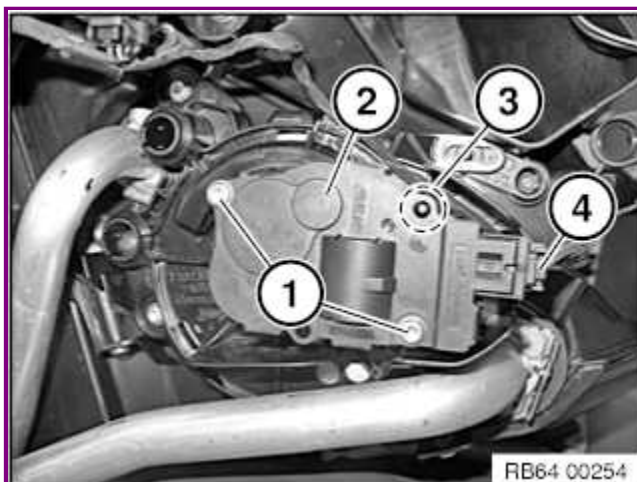
For purposes of clarity, illustration shows removed heating and air-conditioning unit.

Release screws (1).

Unlock plug connection (4) and disconnect.

Remove actuator drive (2).

Make sure actuator drive (2) is correctly seated in guide (3).

Servomotors must be readdressed in the event of replacement!
