**41 12 700****Stripping operations - Replace the left side member and luggage compartment floor (removed left side wall and tail panel)**

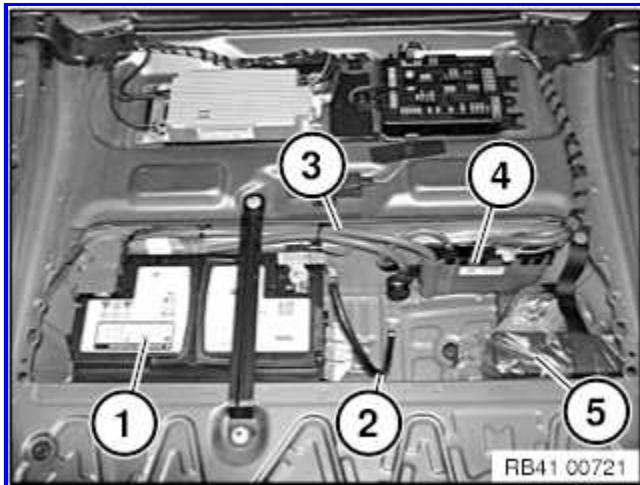
Remove [battery](#) (1).

Remove [negative terminal battery cable](#) (2).

Remove [positive terminal battery cable](#) (3).

Remove [power distribution box](#) (4)

Remove the tray for the flat tyre system (5).

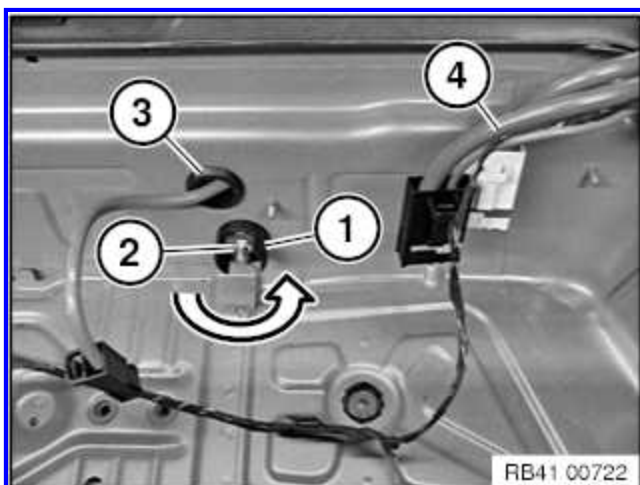
Turn the lock (1) counterclockwise and remove.

Push the positive battery wire connector (2) through the luggage compartment floor to the outside.

Push the grommet (3) with the positive battery cable out.

Set the positive battery cables (4) aside.

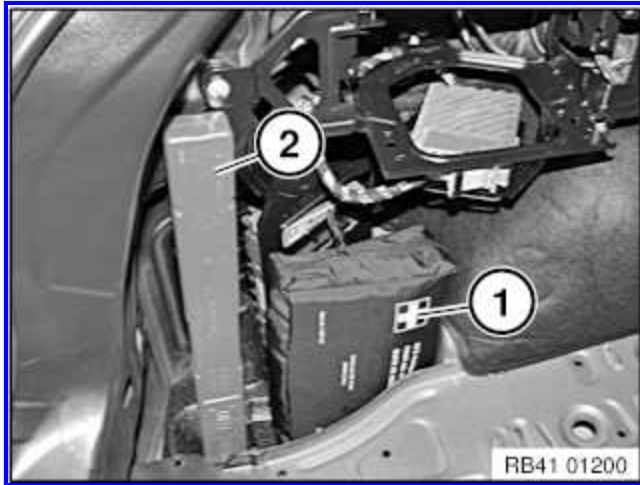
Remove the first aid set bag (1) and warning triangle (2).

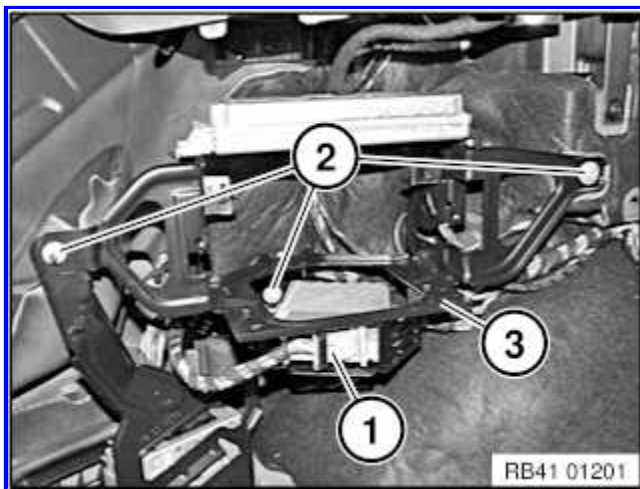
Unfasten plug connection (1) and disconnect.

Release the screw connections (2) and slowly remove the holder (3).

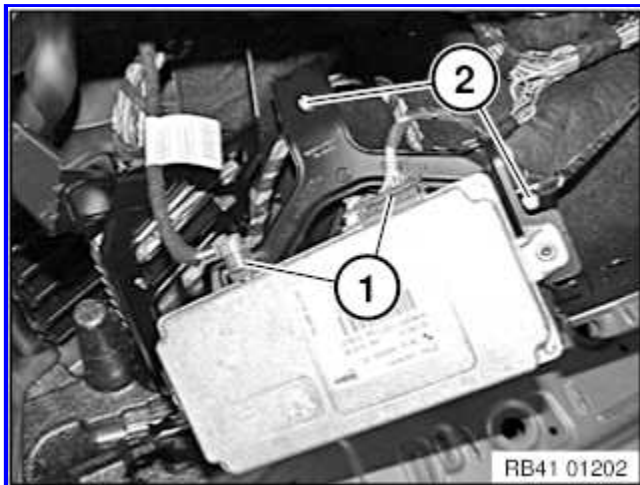
Unlock plug connections (1) and disconnect.

Release the wiring harness (2) at the attachment points and remove the holder.

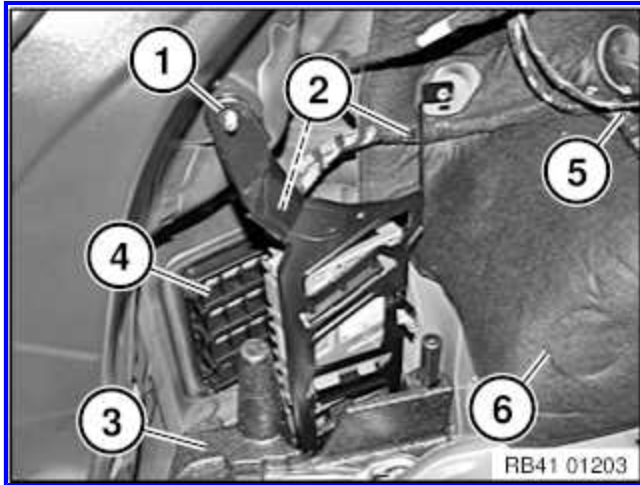
Lift up the holder (1).

Disengage the plug connection and wiring harness (2) and remove the holder.

Remove the insert (3) for the toolkit.

Release latch mechanisms and remove rear ventilation (4).

Release the wiring harness from the attachment point (5).

Partially release the insulating mat (6) and set aside.

The rear ventilation must not be damaged! (watertightness).

All latch mechanisms must engage audibly.

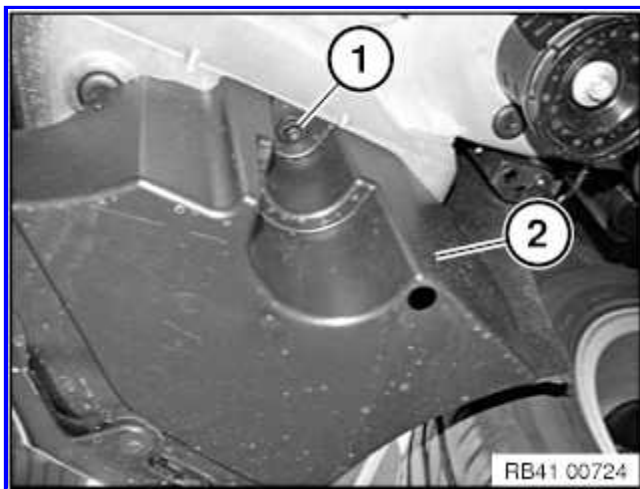
View of the left vehicle underside.

Slacken nut (1) and remove trim panel (2).
