## 65 13 ... Overview of audio components

## 65 12 210 Removing and installing/replacing CHAMP radio receiver (BMW Professional radio)

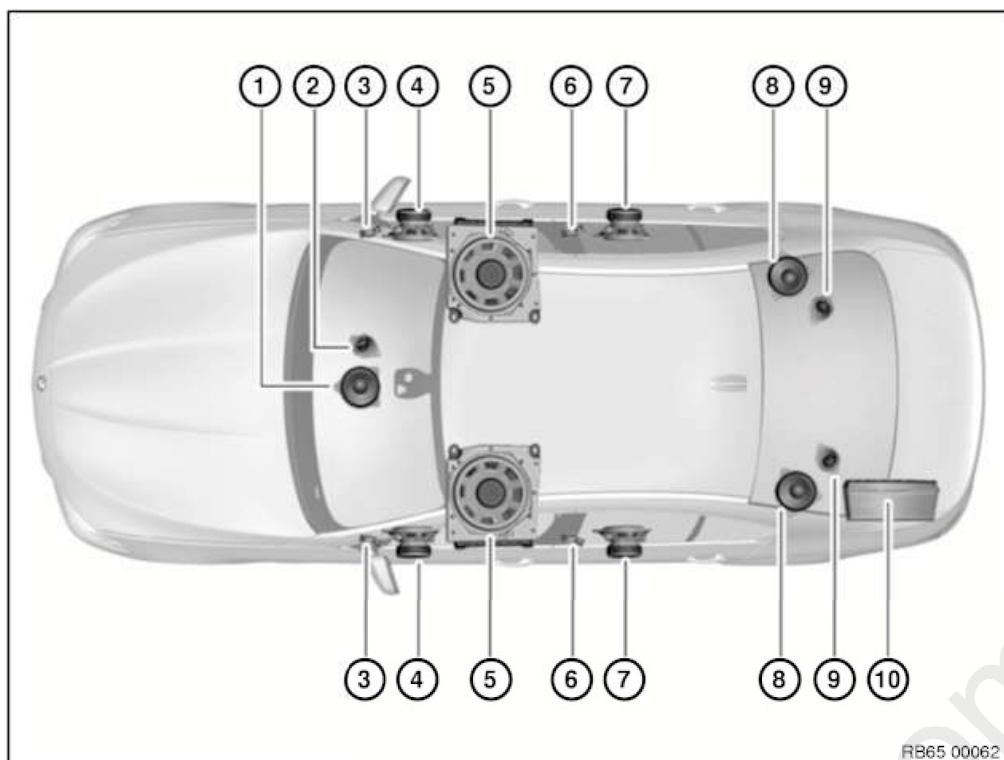
| 1 <a href="#">Mid-range speaker, front (centre)</a> | 6 <a href="#">Tweeter in rear side trim panel</a> |
| 2 <a href="#">Tweeter, front (centre)</a> | 7 <a href="#">Mid-range speaker in rear side trim panel</a> |
| 3 <a href="#">Tweeter mirror triangle</a> | 8 <a href="#">Mid-range speaker storage shelf</a> |
| 4 <a href="#">Mid-range speaker, door, front</a> | 9 <a href="#">Tweeter storage shelf</a> |
| 5 <a href="#">Bass speaker under front seat</a> | 10 <a href="#">Amplifier</a> |

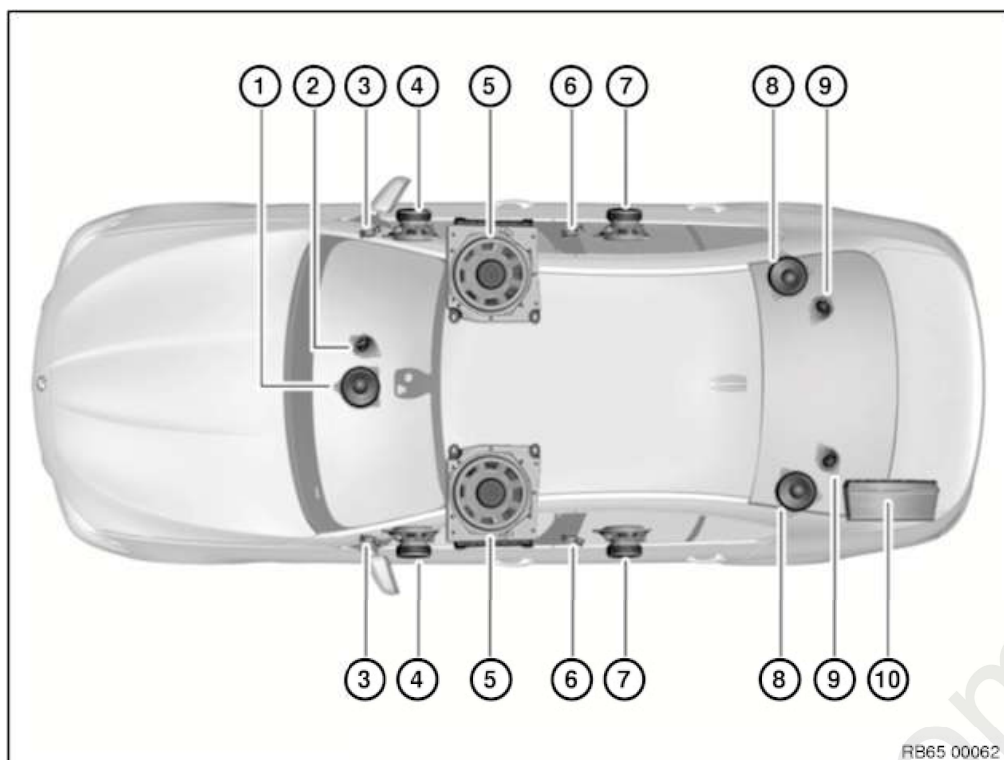
## 65 13 ... Overview of audio components

| 1 <a href="#">Mid-range speaker, front (centre)</a> | 6 <a href="#">Tweeter in rear side trim panel</a> |
| 2 <a href="#">Tweeter, front (centre)</a> | 7 <a href="#">Mid-range speaker in rear side trim panel</a> |
| 3 <a href="#">Tweeter mirror triangle</a> | 8 <a href="#">Mid-range speaker storage shelf</a> |
| 4 <a href="#">Mid-range speaker, door, front</a> | 9 <a href="#">Tweeter storage shelf</a> |
| 5 <a href="#">Bass speaker under front seat</a> | 10 <a href="#">Amplifier</a> |

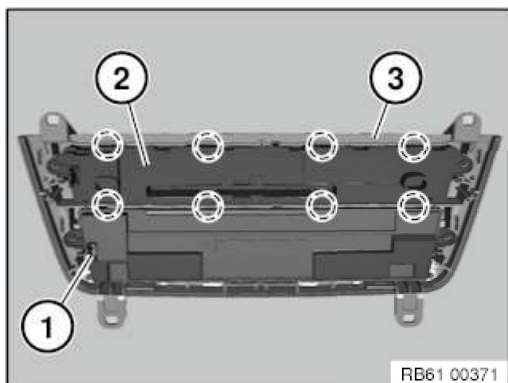
Disconnect plug connection (1).

Unclip audio operating unit (2) at the marked points using a suitable tool (such as a screwdriver - 3 mm blade).

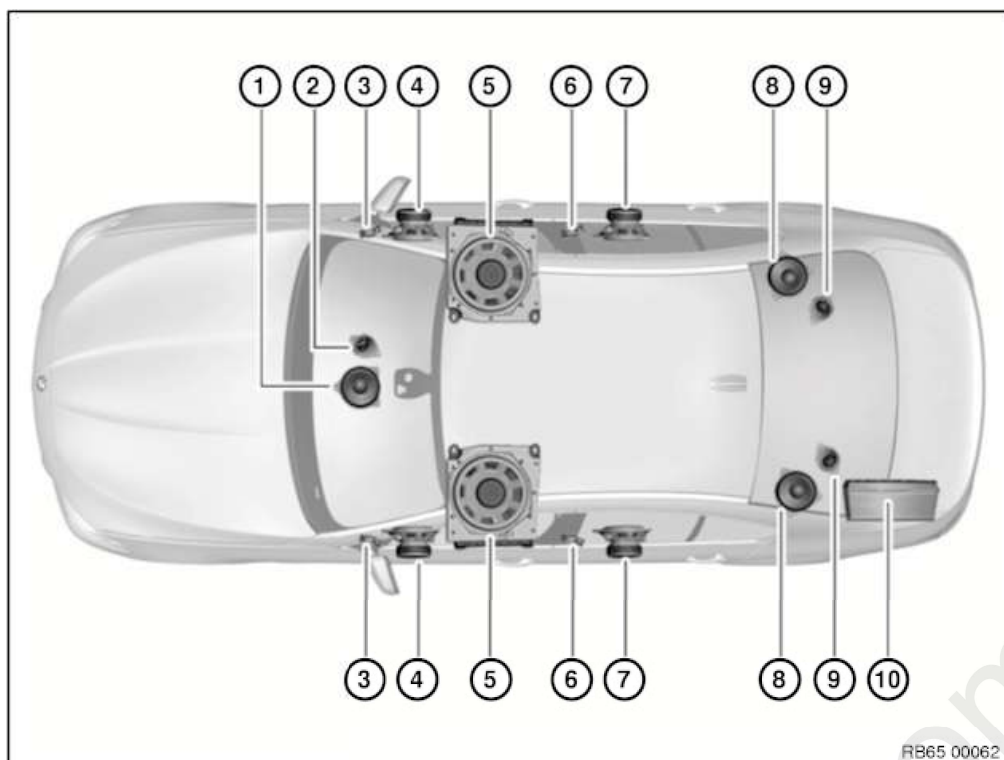
## 65 13 ... Overview of audio components

| 1 <a href="#">Mid-range speaker, front (centre)</a> | 6 <a href="#">Tweeter in rear side trim panel</a> |

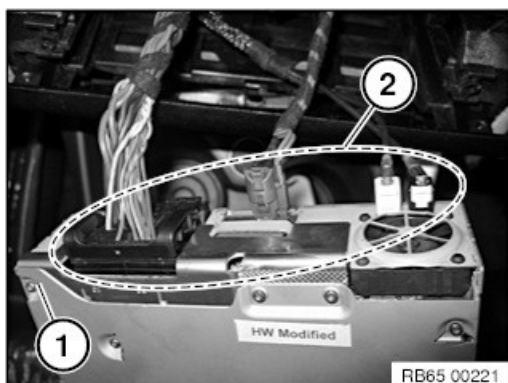
Unlock and disconnect all plug connections (2) in the marked area.

Remove headunit (1).

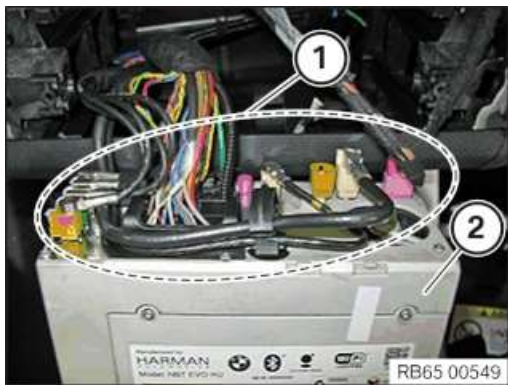
Unlock and disconnect all connectors (1) in marked area.  
Remove HU-H (2).

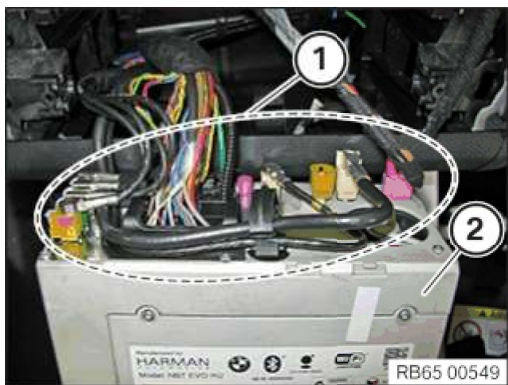
Position HU-H (2).  
Connect and lock all the connectors (1) in the marked area.

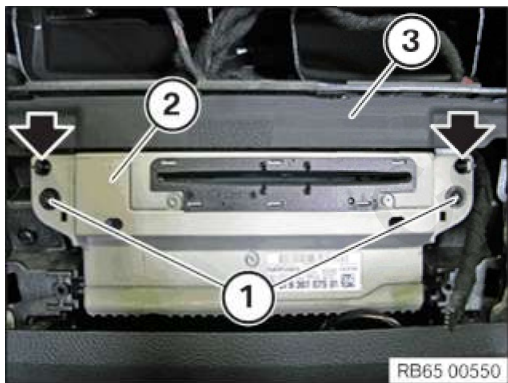
Slide the HU-H (2) toward the back into the instrument panel (3).  
Tighten down screws (1).

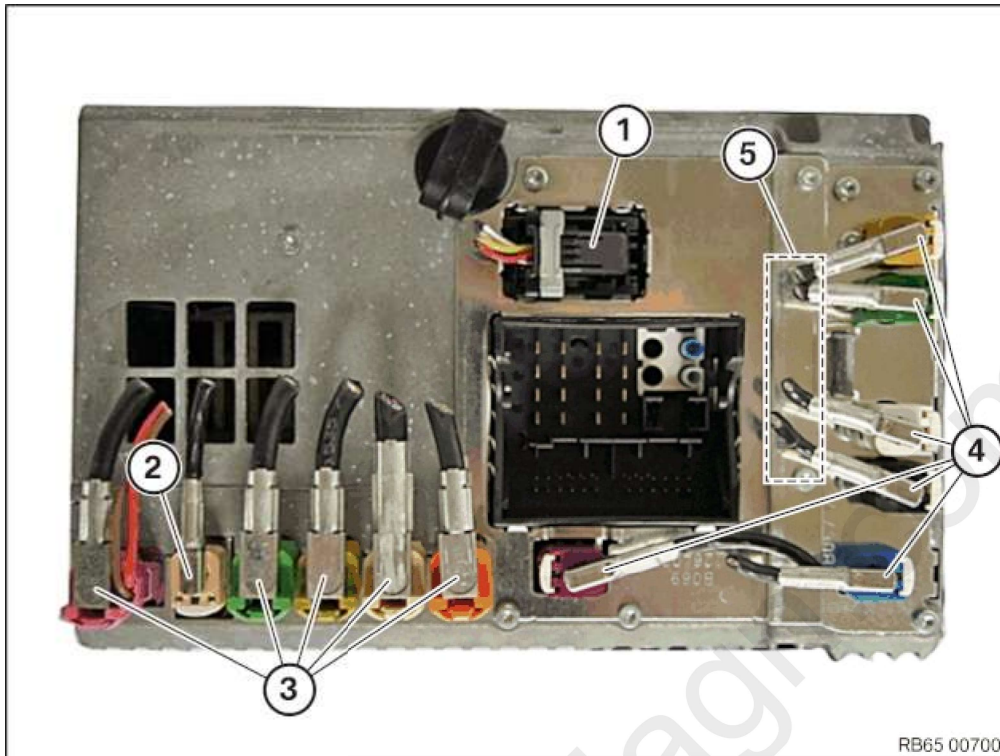
The figure shows a stolen head unit with connectors and disconnected line parts. Disconnected lines without a connector remain in the vehicle.

If **lines are disconnected** in the vehicle interior during a theft of electronic components, the disconnected lines **are to be individually repaired or replaced**.

Replacement **of the complete audio wiring harness is not permitted**.

All parts necessary for repair are available in the Electronics Parts Catalogue.

1. Repair connector with lines with the "TV module" repair kit.
- 2./4. If the (5) coaxial lines (aerial lines) are cut close to the connector, attach a new connector. Otherwise, completely replace coaxial lines (aerial lines) (line extension not possible).  
**Exception:** The connector cannot be repaired on **RG174** lines.
3. Completely replace HSD lines (repair not possible).

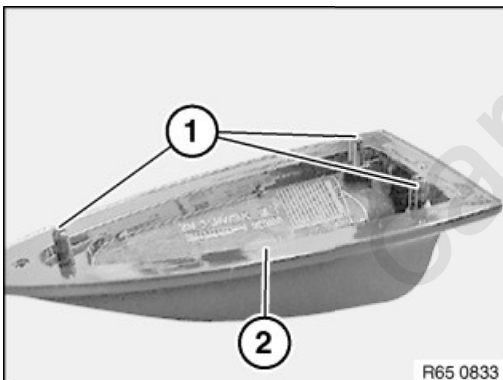
Replace empty housing for roof-mounted aerial if centering pins (1) on empty housing are damaged.

Bonding surface (2) must be clean and free from grease.

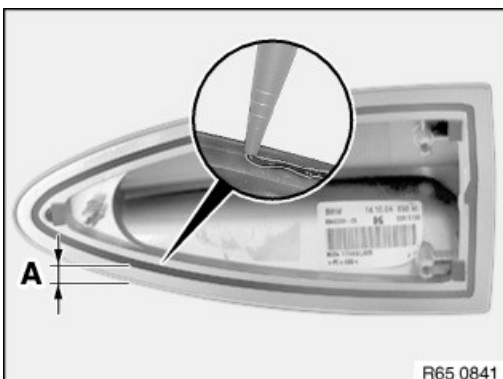
Apply trace of adhesive bead all round outer contour as follows.

To prevent the adhesive from leaking, the adhesive bead diameter must not exceed 2.5 mm to 3.5 mm.

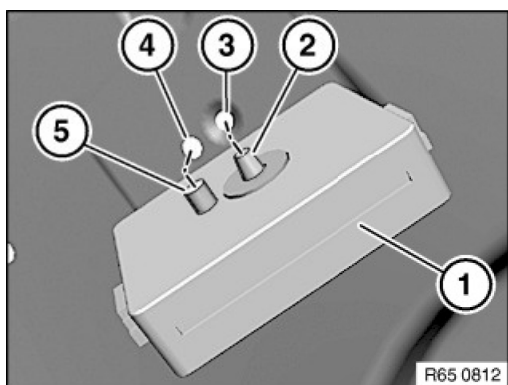
Fit interference suppression filter (1) so that screw (2) engages thread (3) and locating pin (4) engages in bore hole (5).

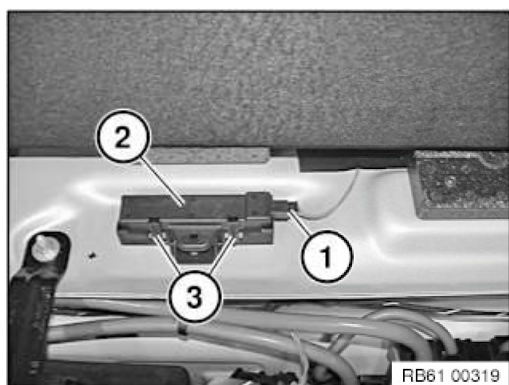
Disconnect plug connection (1).

Unlock and remove luggage compartment aerial (2) from bracket (3).

Make sure luggage compartment aerial (2) is seated correctly in bracket (3).

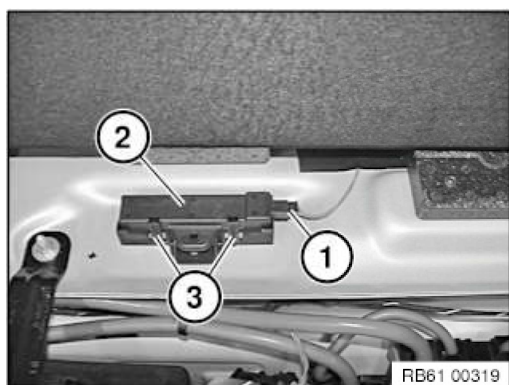
Disconnect plug connection (1).  
Unlock and remove luggage compartment aerial (2) from bracket (3).  
*Installation note:*  
Make sure luggage compartment aerial (2) is seated correctly in bracket (3).

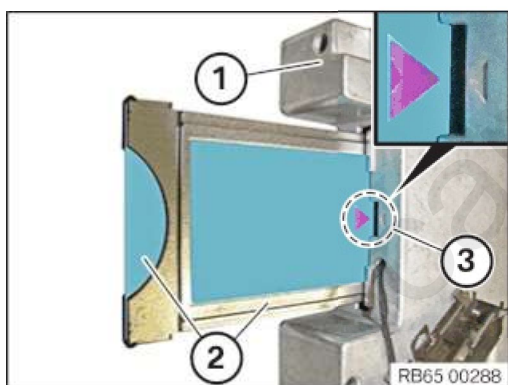
Position the Pay TV card with slot (2) as shown (3).

Insert Pay TV card with slot (2) in TV module (1).

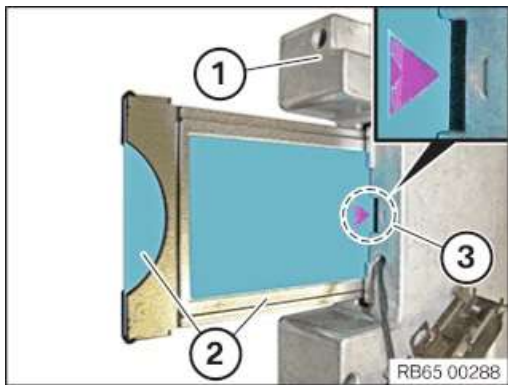
Position the Pay TV card with slot (2) as shown (3).  
Insert Pay TV card with slot (2) in TV module (1).

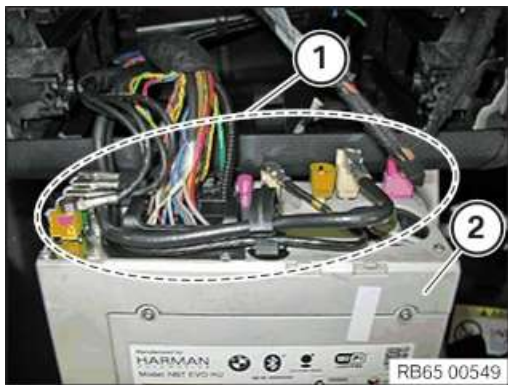
Unlock and disconnect all connectors (1) in marked area.  
Remove HU-H (2).

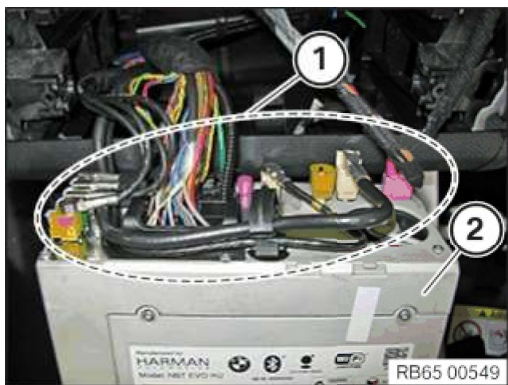
Position HU-H (2).  
Connect and lock all the connectors (1) in the marked area.

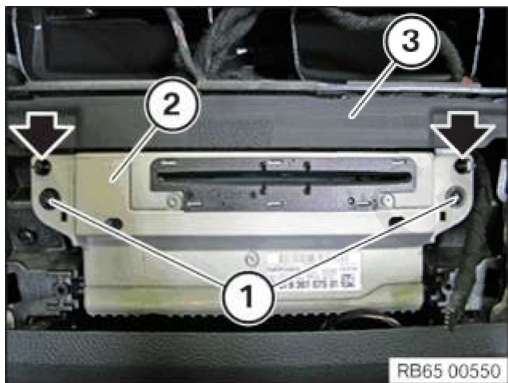
Slide the HU-H (2) toward the back into the instrument panel (3).  
Tighten down screws (1).

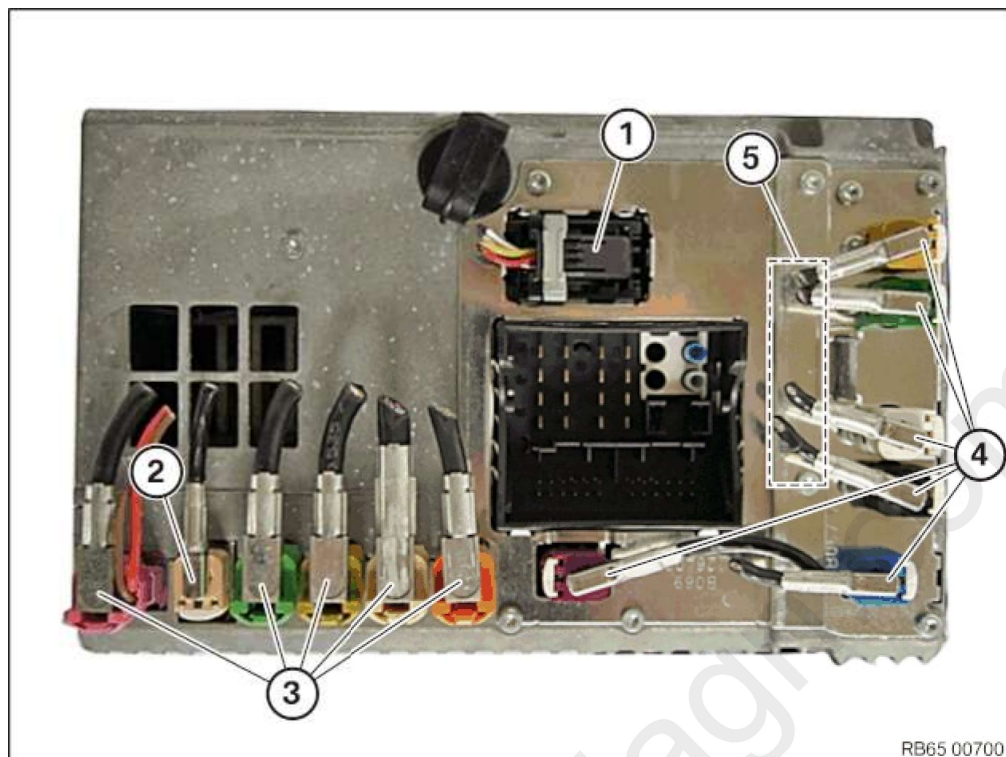
The figure shows a stolen head unit with connectors and disconnected line parts. Disconnected lines without a connector remain in the vehicle.

The number and arrangement of lines can vary according to the equipment.

If **lines are disconnected** in the vehicle interior during a theft of electronic components, the disconnected lines **are to be individually repaired or replaced**.

Replacement **of the complete audio wiring harness is not permitted**.

All parts necessary for repair are available in the Electronics Parts Catalogue.

1. Repair connector with lines with the "TV module" repair kit.
- 2./4. If the (5) coaxial lines (aerial lines) are cut close to the connector, attach a new connector. Otherwise, completely replace coaxial lines (aerial lines) (line extension not possible).  
**Exception:** The connector cannot be repaired on **RG174** lines.
3. Completely replace HSD lines (repair not possible).
