**2002 ES 300**

**Front Brake Tube (Left Hand)**

**Special Service Campaign 1LF**

**M/N 00241-10006-1LF**

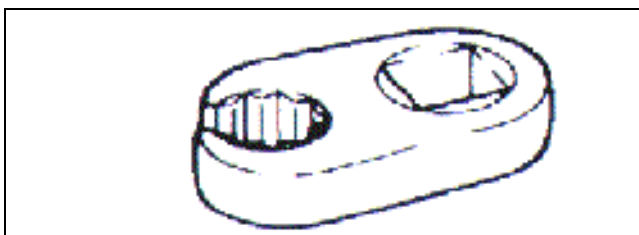
#### B. TOOLS

- Standard Hand Tools
- Torque Wrench
- SST: 09023 – 00100 Union Nut Wrench (or equivalent)

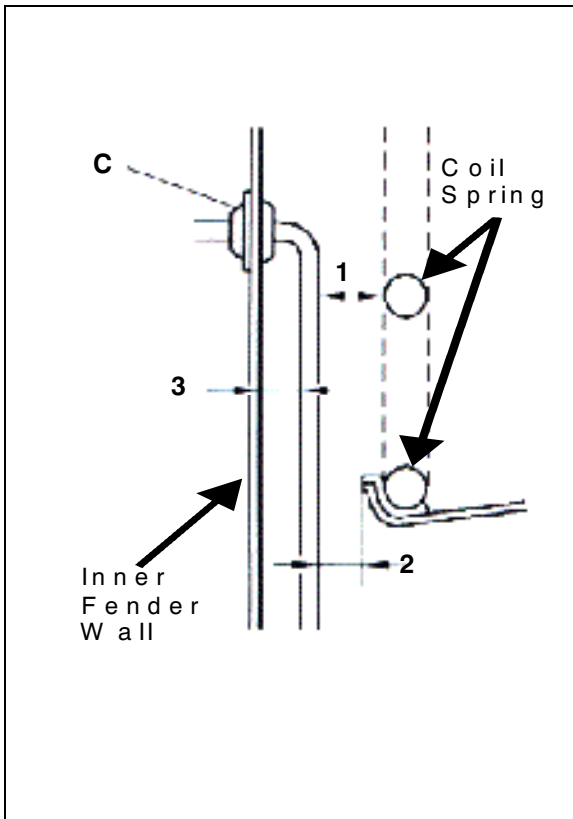
## 4. INSPECTION PROCEDURE

### 1. INSPECT LEFT FRONT BRAKE LINE CLEARANCES

(a) Inspect the clearance of the following components around the left front brake line:

(b) Inspect the front brake line for damage  
**OK, if paint is not removed.**

**If the clearances are not as specified or the brake line is damaged, replace the left front brake line.**

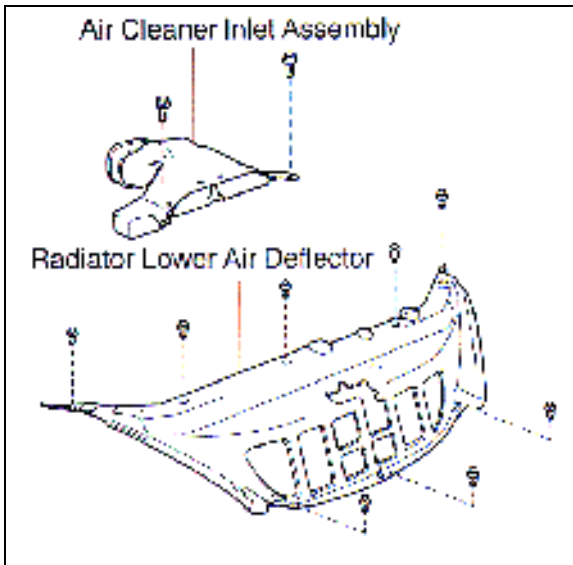
### 1. REMOVE LOWER RADIATOR AIR DEFLECTOR

- Open the hood and remove the 8 plastic clips that retain the lower radiator air deflector.
- Remove the lower radiator air deflector.
- Remove the wire harness clip and 2 vacuum lines that are secured to the air cleaner inlet assembly.
- Remove the 2 bolts that secure the air cleaner inlet assembly and slide the assembly out of the air cleaner housing.

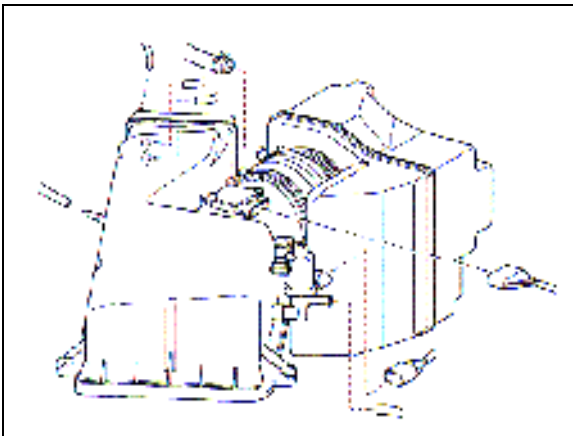
### 2. REMOVE AIR CLEANER ASSEMBLY

- Mark all vacuum lines prior to removal to assure correct reconnection.
- Remove the vacuum lines and electrical connectors on top of the air cleaner assembly.
- Remove the 2 bolts that secure the top of the air cleaner housing assembly.
- Remove the top of the air cleaner housing assembly.
- Remove the air filter.
- Remove the vacuum lines and electrical connectors from the bottom half of the air cleaner housing.  
Take note of where these vacuum lines are routed to ensure proper re-assembly.

Some ES 300 models may have a strut support bar that could interfere with intake air hose removal. The intake air hose and plastic air box can be removed with the strut support bar installed in the vehicle.

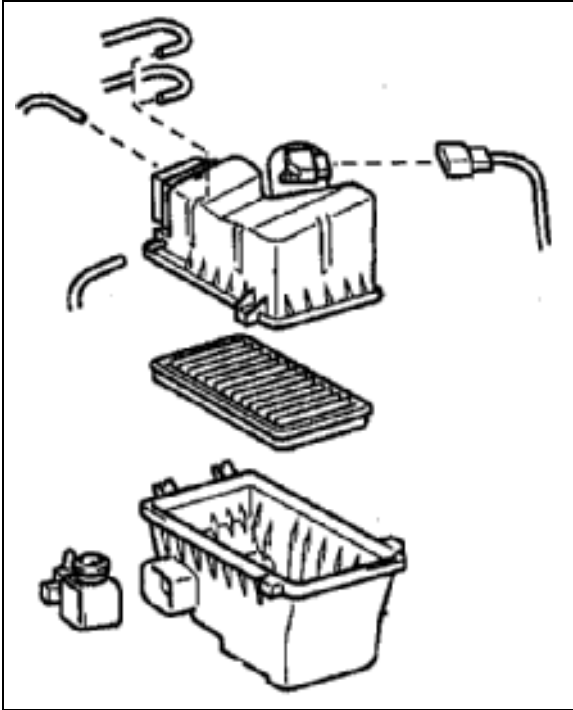
To avoid wire harness damage, release the wire and hose retainers on the back of the air cleaner housing prior to air cleaner housing removal.

- (g) Remove the 3 bolts in the bottom of the air cleaner assembly.
- (h) Remove the bottom of the air cleaner housing.
- (i) Disconnect the intake hose from the throttle body.

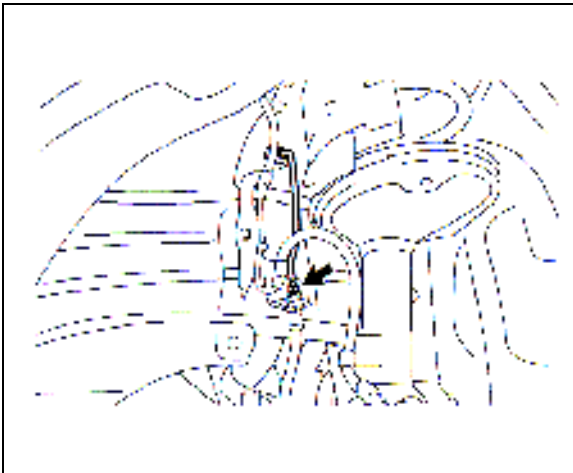
**3. FRONT LEFT BRAKE LINE NO. 5 REPLACEMENT**

- (a) Attach a drain hose to the left front caliper bleeder valve.
- (b) Open the bleeder valve.
- (c) Loosen front brake line No. 5 from the flexible hose in the wheel well using a line wrench or SST.

Upon loosening the flare nut on the brake line brake fluid will begin to drain.

- (d) Drain brake fluid.
- (e) Disconnect the No. 5 brake line from the flexible hose.

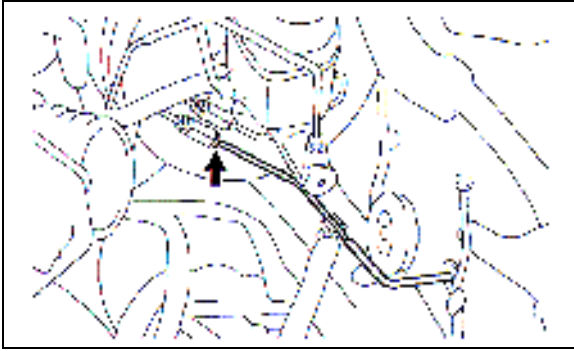
### 4. REMOVE BRAKE LINE FROM 2-WAY CONNECTOR

- (a) Using a line wrench disconnect the other end of the No. 5 brake line from the 2-way connector.
- (b) Carefully remove the No. 5 brake line from the vehicle. To prevent brake fluid from dripping on the vehicle, cover the ends during removal.
- (c) Carefully remove any brake fluid from the brake line unions with brake cleaner.

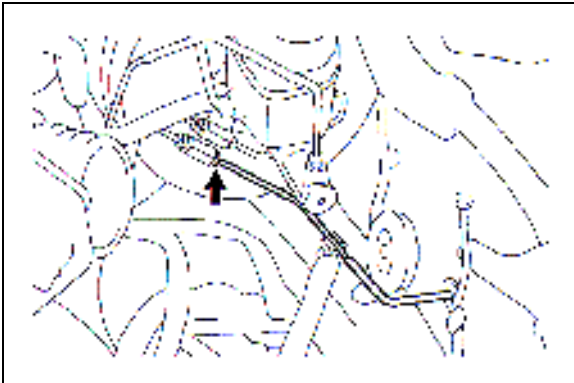
### 5. INSTALLING NEW NO. 5 BRAKE LINE

- (a) Install the new No. 5 brake line.

**SST: 09023-00100**

**TORQUE: 15 N•m (155 kgf•cm, 11 ft•lbf)**

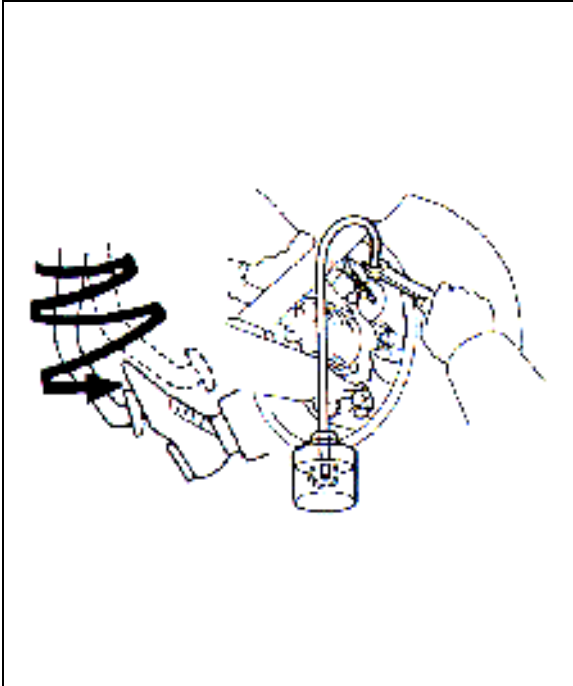
## 6. BLEED THE BRAKE SYSTEM

- (a) Check and correct the brake fluid level in the brake master cylinder reservoir.

**Immediately clean off any brake fluid spilled on painted surfaces. Brake fluid will damage the vehicle's finish. Do not let the brake fluid reservoir go empty.**

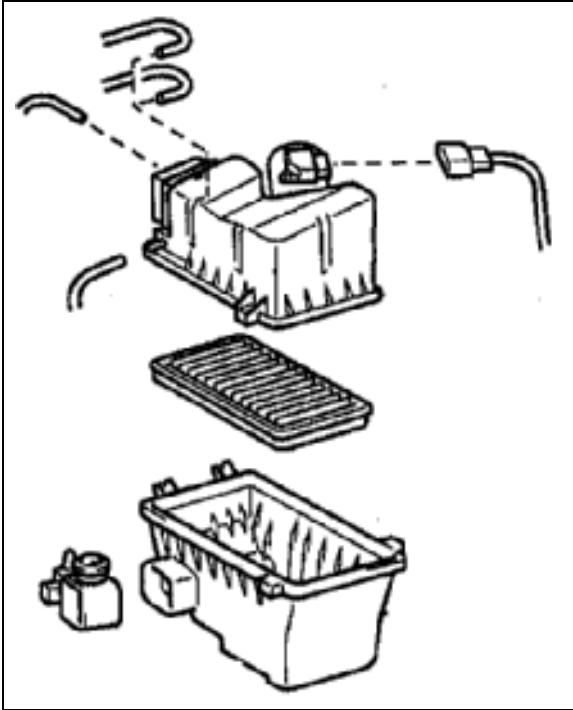
#### 8. REINSTALL THE BOTTOM HALF OF AIR CLEANER HOUSING

- (a) Secure the wire harness to the backside of the air cleaner housing using the 2 attached wire clips.
- (b) Reinstall the 3 bolts in the bottom of the air cleaner assembly.
- (c) Reinstall rubber intake hose onto throttle body and tighten hose clamp.
- (d) Reinstall the vacuum lines and electrical connectors to the bottom half of the air cleaner housing.

Some ES 300 models may have a strut support bar that could interfere with intake air hose reinstallation. The intake air hose and plastic air box can be reinstalled with the strut support bar installed in the vehicle.

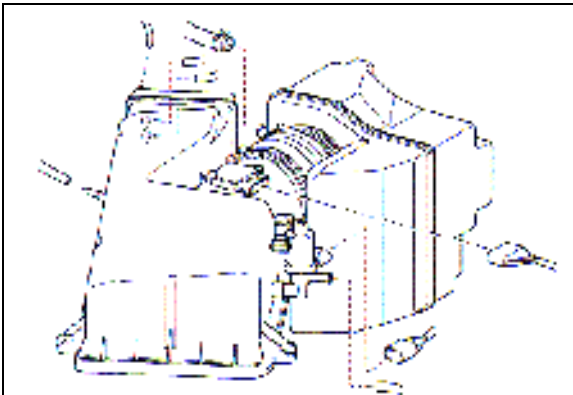
#### 9. REINSTALL TOP OF AIR CLEANER HOUSING

- (a) Reinstall air filter.
- (b) Reinstall vacuum lines and electrical connectors on the top of the air cleaner assembly.

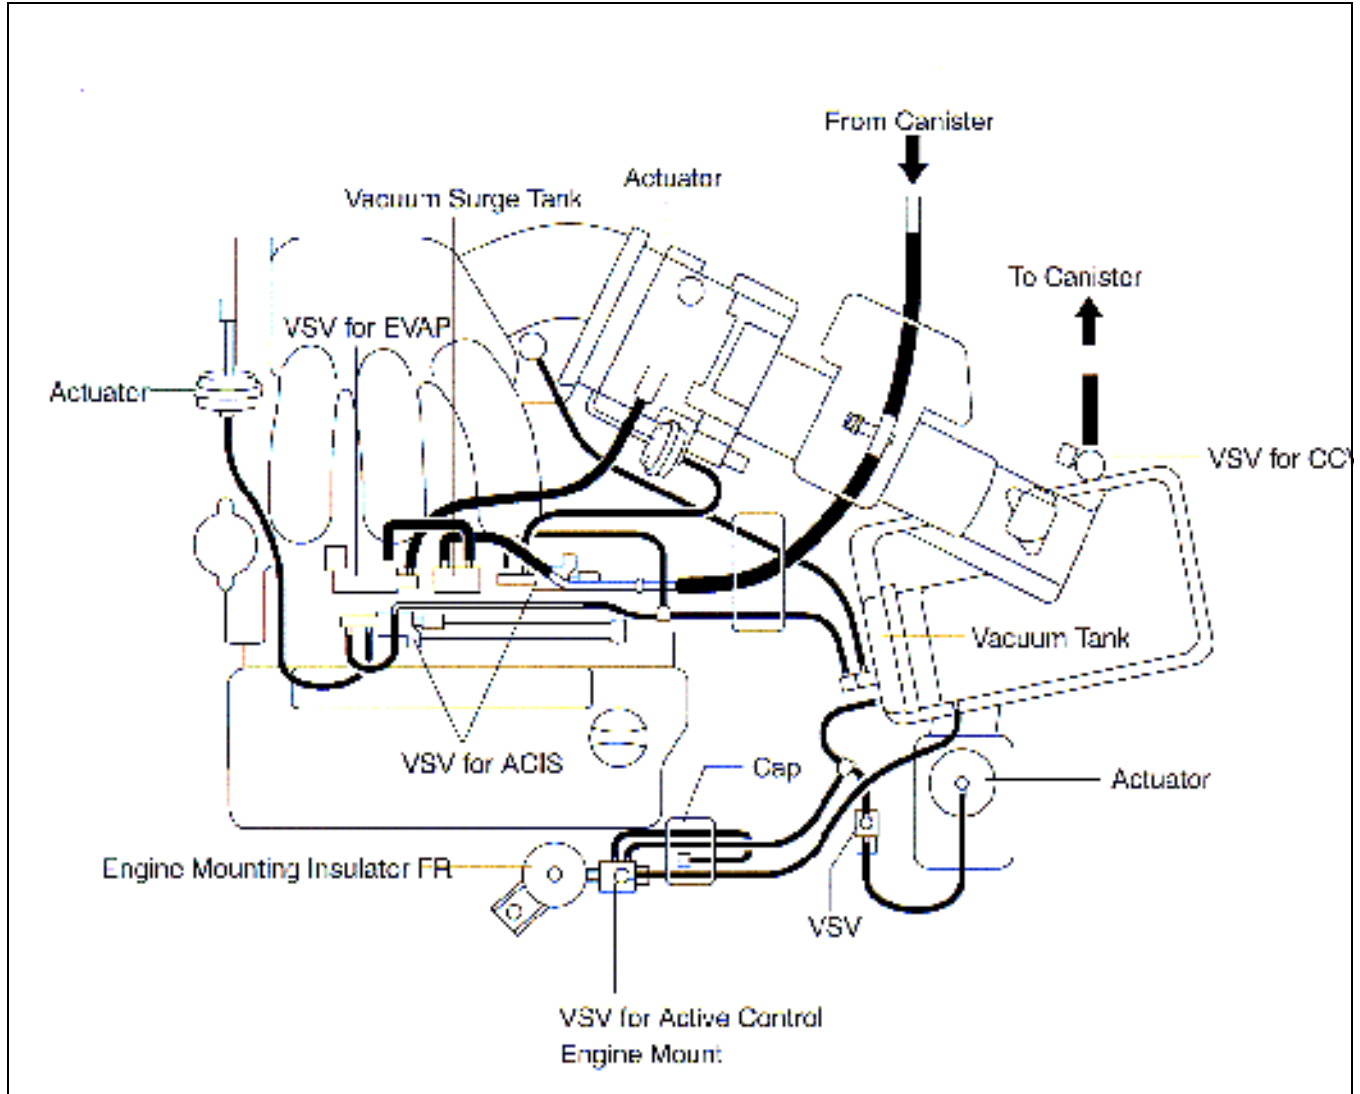
**10. CONFIRM VACUUM LINE ROUTING**

- (a) Confirm that all of the vacuum lines are properly reinstalled. Reference the diagram below.

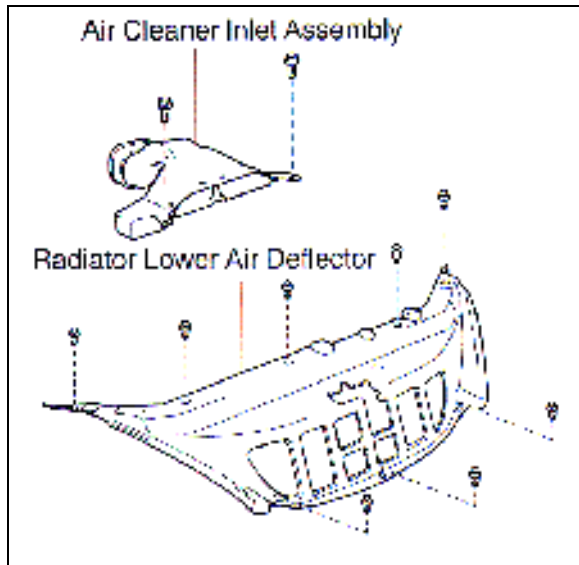
#### 11. REINSTALL RADIATOR LOWER AIR DEFLECTOR

- Slide the air cleaner intake into the air cleaner housing and reinstall the 2 bolts that secure the air cleaner inlet assembly.
- Reinstall the wire harness clip and 2 vacuum lines that are secured to the air cleaner inlet assembly.
- Position radiator lower air deflector over mounting holes and reinstall 8 plastic clips that retain the radiator lower air deflector to vehicle.
