# ESVA Model Report

| Make and Model | Honda Stepwagon<br>Automatic |

**002/00180**

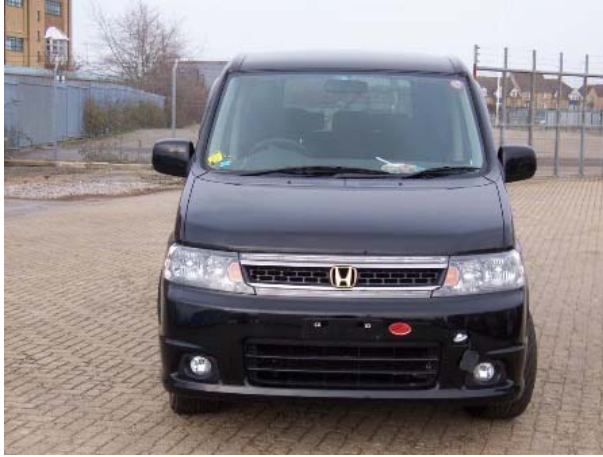
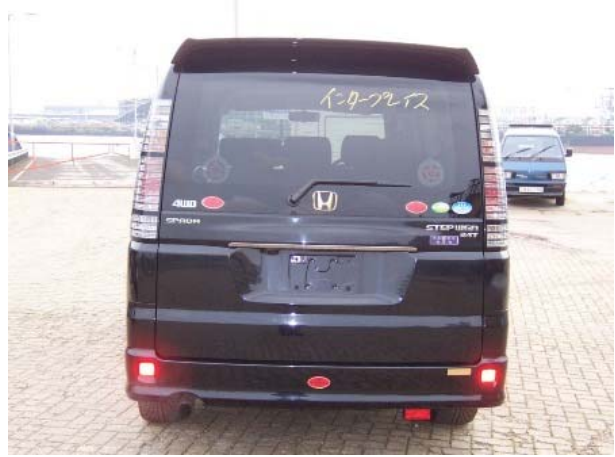
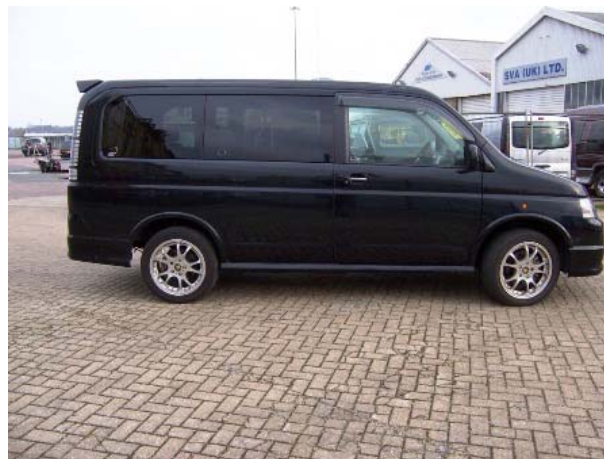
^ (Photos 1), Views of Honda Stepwagon

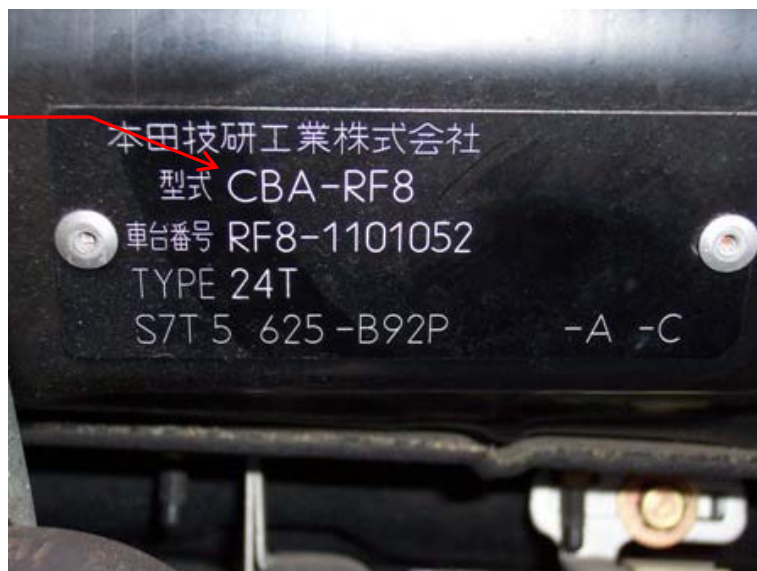
| Feature / Part | | Number / Description | Critical Item "Y" | Modified from original |
|---|---|---|---|---|
| 1.3 | Model Code / Applied<br>Model Code | CBA-RF8<br>As on VIN Plate<br><b>(Photos 2)</b> | Y | N |

^ (Photo 2), View of Honda Stepwagon VIN Plate

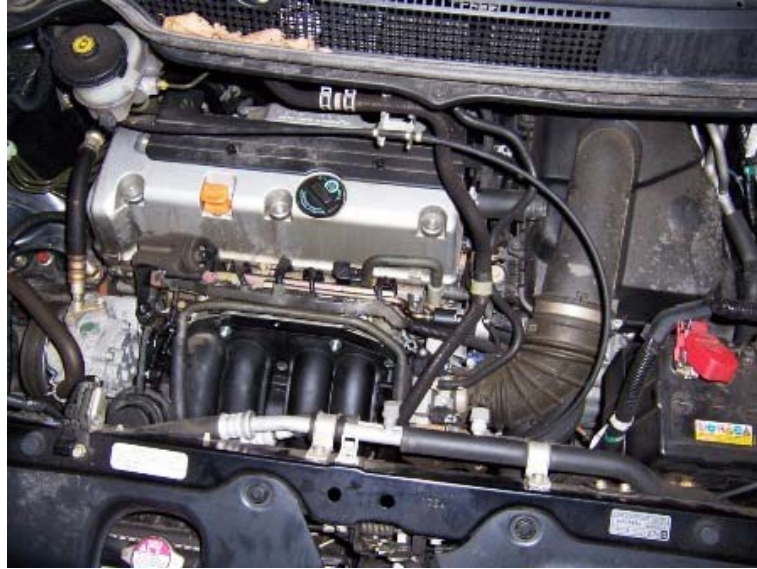
| Feature / Part | | Number / Description | Critical Item "Y" | Modified from original |
|---|---|---|---|---|
| 4.4<br>4.8 | No of cylinders,<br>Configuration & Fuel type | 4 valves per cylinder, 4 in-line, transversely<br>mounted<br>Petrol<br><b>(Photo 3)</b> | Y | N |

^ (Photo 3), View of Honda Stepwagon Engine Compartment

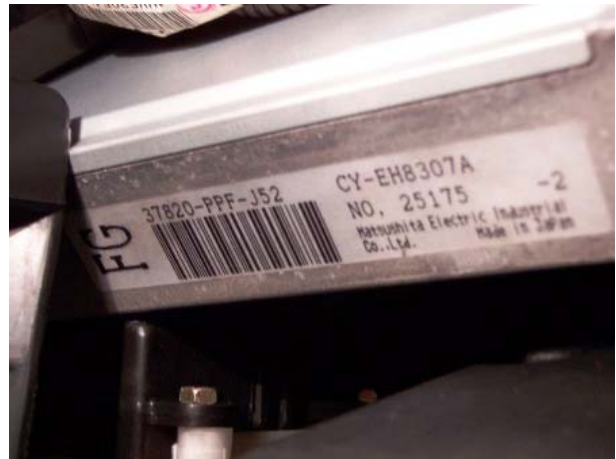
| Feature / Part | | Number / Description | Critical Item "Y" | Modified from original |
|---|---|---|---|---|
| 6.1-<br>6.4 | Engine Management ECU<br>make & part Number | Matsushita Electrical Industrial<br>37820-PPF-J52<br><b>(Photos 4)</b> | Y | N |
| 6.3 | Location & Access of<br>ECU | Behind centre console. Remove centre<br>console and ECU carrier to identify<br><b>(Photos 4)</b> | Y | N |

^ (Photos 4), Views of Honda Stepwagon ECU location and label

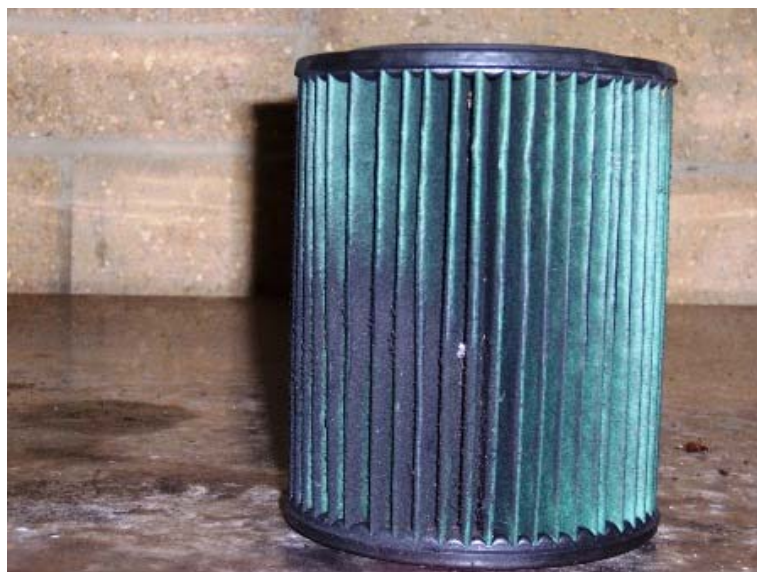
| Feature / Part | | Number / Description | Critical Item "Y" | Modified from original |
|---|---|---|---|---|
| 8.7-<br>8.9 | Air Filter dimensions &<br>Type | 136mm diameter x 167mm length<br>Various Materials used in construction<br><b>(Photo 5)</b> | Y | N |

^ (Photo 5), View of Honda Stepwagon Air Filter

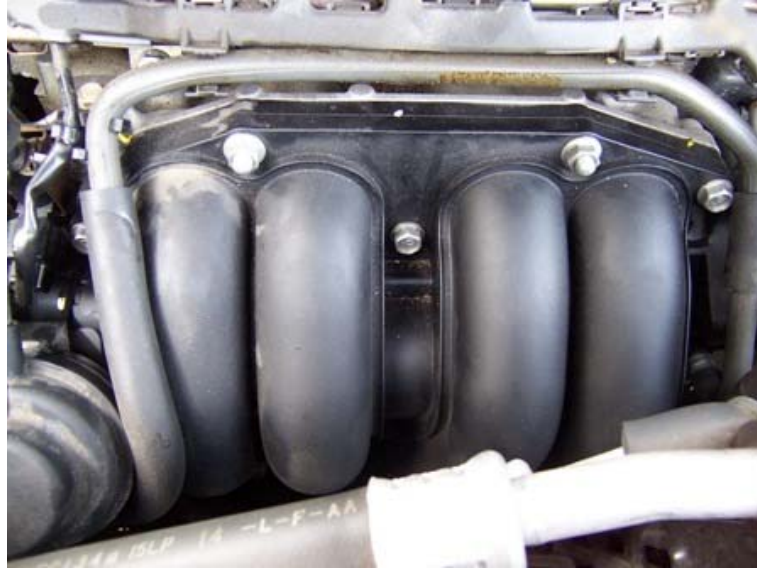
| Feature / Part | | Number / Description | Critical Item "Y" | Modified from original |
|---|---|---|---|---|
| 8.6 | Intake System / Manifold | Single entry, plastic 4 branch manifold.<br><b>(Photo 6)</b> | Y | N |

**^ (Photo 6), View of Honda Stepwagon Intake Manifold**

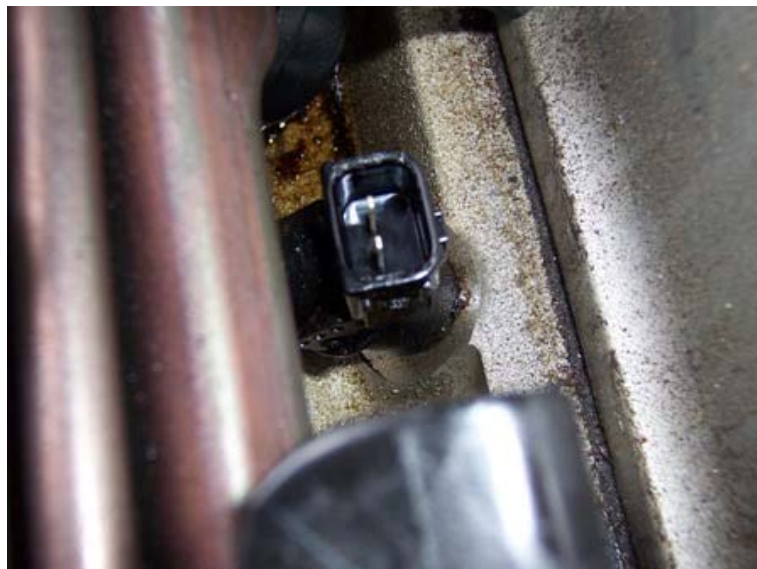
| Feature / Part | | Number / Description | Critical Item "Y" | Modified from original |
|---|---|---|---|---|
| 5.7<br>5.8 | Injector ID numbers | No Make Found<br>TA08 BBST<br><b>(Photo 7)</b> | Y | N |

**^ (Photo 7), View of Honda Stepwagon Injector**

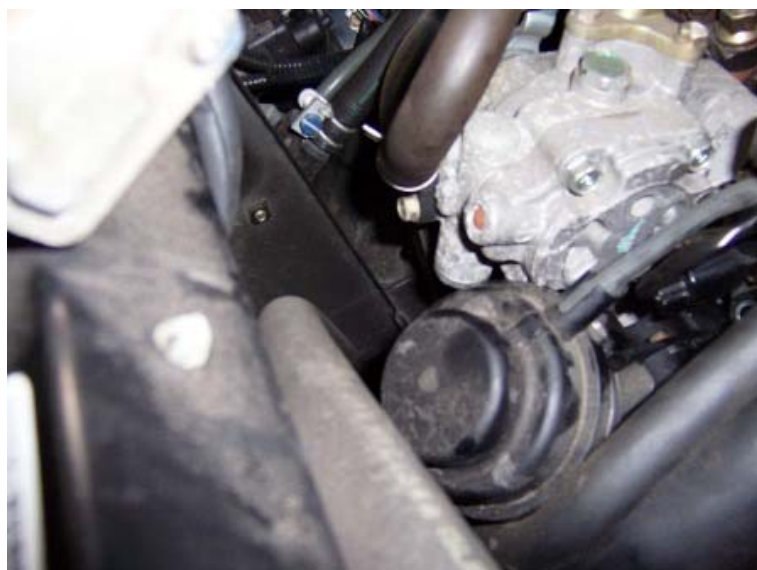
| Feature / Part | | Number / Description | Critical Item "Y" | Modified from original |
|---|---|---|---|---|
| 5.13 | Type of Fuel Pressure<br>Regulator & Location | Electronic<br>Located on N/S of fuel rail<br><b>(Photo 8)</b> | Y | N |

**^ (Photo 8), View of Honda Stepwagon Fuel Pressure Regulator**

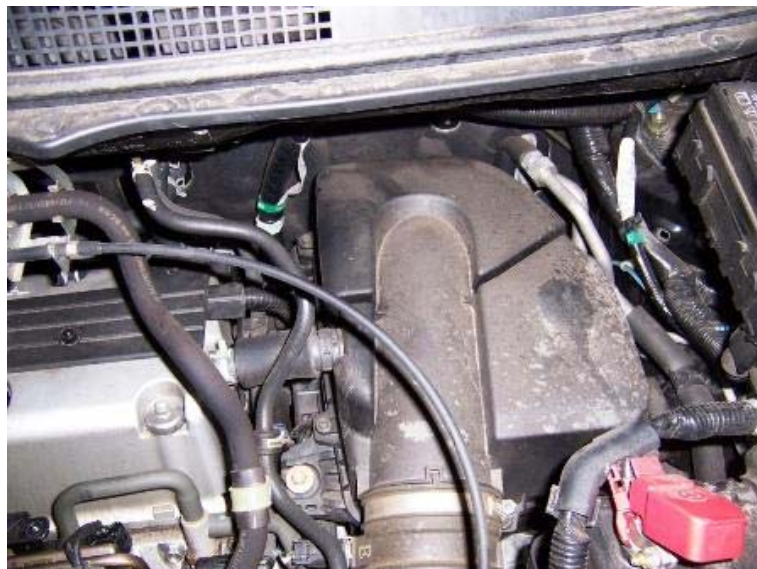
| 9.4 | Device for recycling crankcase gases | Pipe from RH side of cam cover to airbox before air filter<br><b>(Photo 11)</b> | Y | N |

**^ (Photo 11), View of Honda Stepwagon Airbox and Crankcase Pipe**

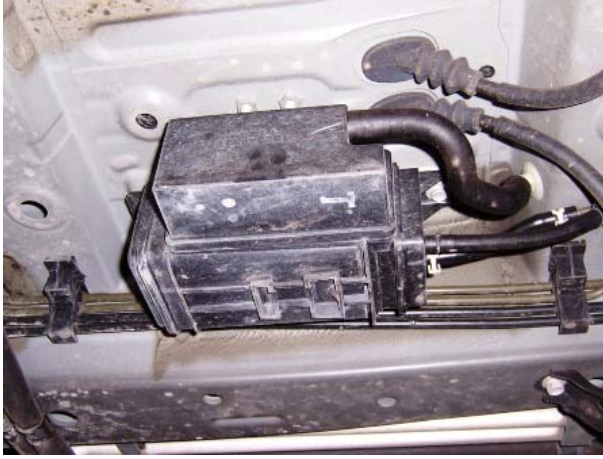
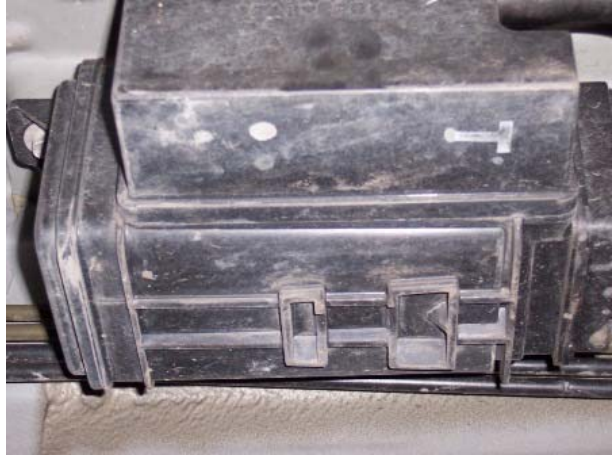
| 9.14 | Evaporative Emissions Control System. | Vacuum Controlled<br>Located in front of fuel tank when viewed from rear of vehicle<br><b>(Photo 12)</b> | Y | N |

**^ (Photos 12), Views of Honda Stepwagon EVAP Canister**

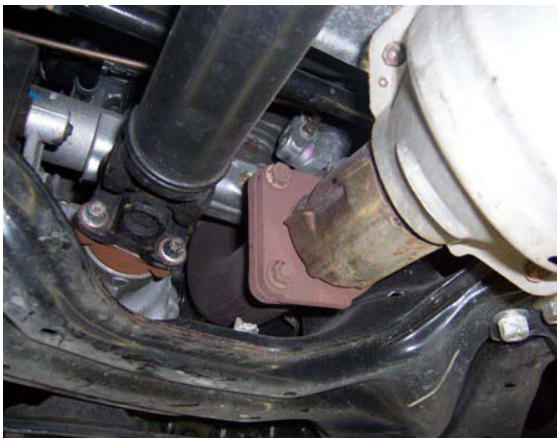
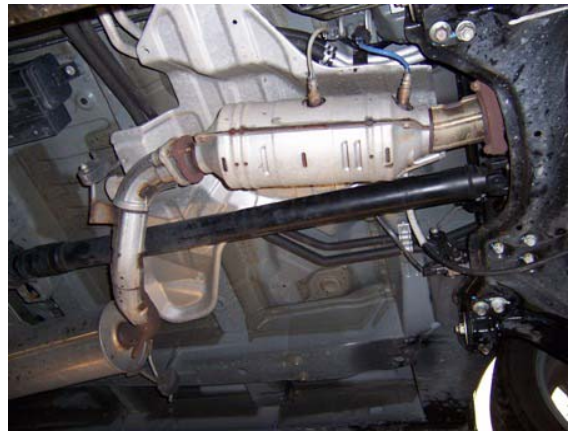
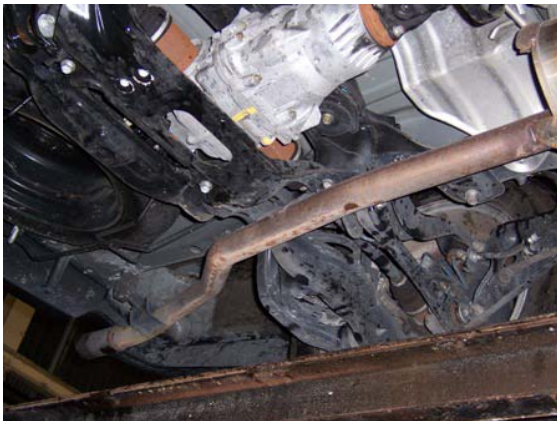
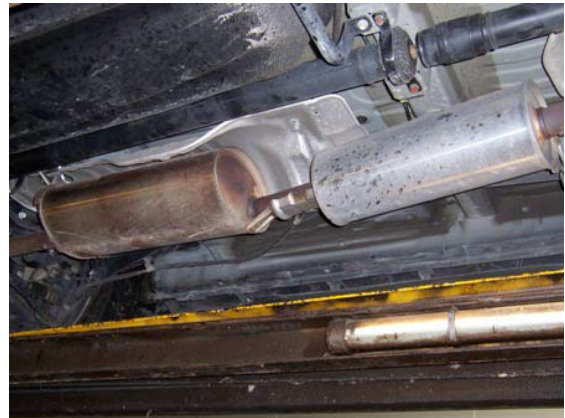
| 9.1 | Exhaust System Description | 4 branch cast manifold into single downpipe, to catalyst, into primary silencer and then to main silencer. Exhaust exits LH side when viewed from rear.<br><b>(Photos 13)</b> | Y | N |
| 9.2 | Primary Muffler / s Main Muffler | Primary Muffler;<br>463mm length x 350mm circumference<br>Inlet and Outlet Pipes – 55mm diameter<br><br>Main Muffler;<br>534mm length x 682mm circumference<br>Inlet Pipe – 55mm diameter<br>Outlet Pipe – 52mm diameter<br>Tailpipe – 65mm diameter | Y<br><br>Y | N<br><br>N |

**^ (Photos 13), Views of Honda Stepwagon Exhaust System**

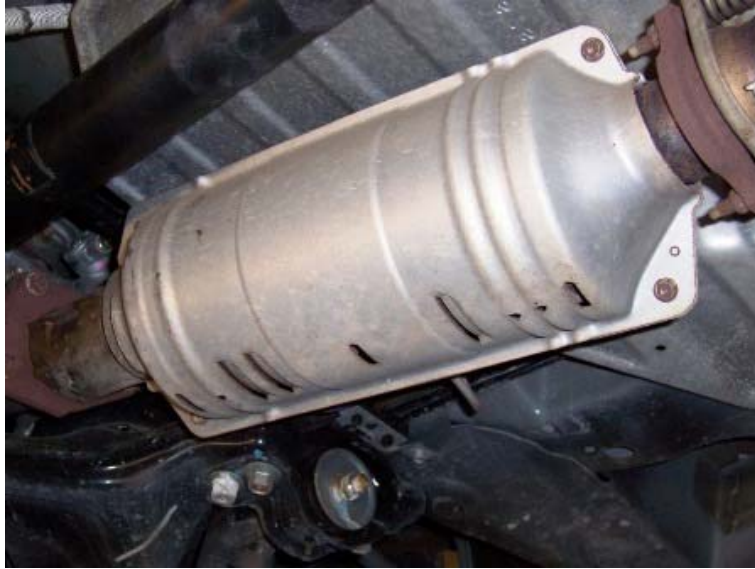
| 9.6 | Catalyst Details | Length 370mm x 472mm circumference (inc heat shield)<br>Inlet Pipe – 65mm diameter<br>Outlet Pipe – 55mm diameter<br><b>(Photo 14)</b> | Y | N |
| 9.7 | Location of catalytic converter | Located at bottom on downpipe.<br>514mm forward of primary muffler | Y | N |

**^ (Photo 14), View of Honda Stepwagon Catalyst**

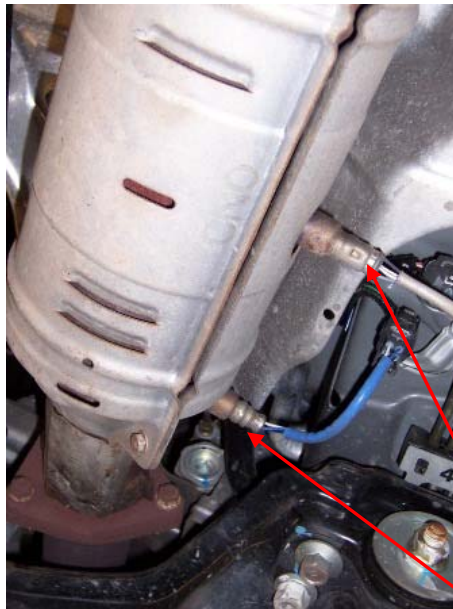
| 9.8<br>9.10 | Oxygen Sensors Make / Description / Location | Sensor 1;<br>4 wires – 1 blue, 2 black and 1 white<br>No Make found<br>Located in front of catalyst<br><br>Sensor 2;<br>4 wires – 3 white and 1 black<br>No make found<br>Located in middle of catalyst<br><b>(Photos 15)</b> | Y<br><br>Y | N<br><br>N |

**^ (Photo 15), View of Honda Stepwagon Oxygen Sensors**

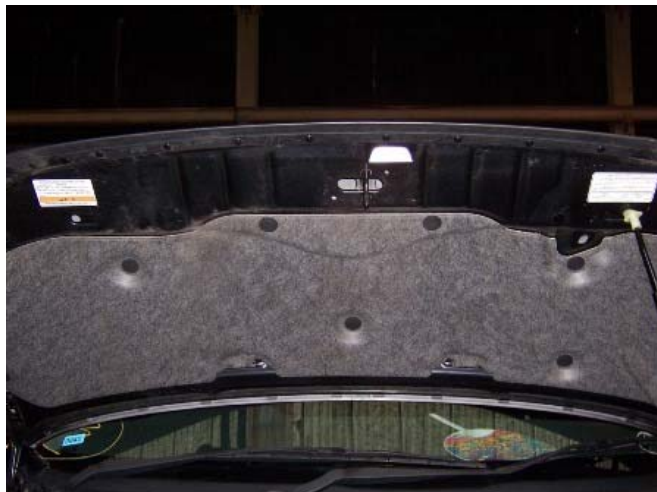
| 14.1<br>/<br>14.3 | Sound Insulation:-<br>Under Bonnet | Under bonnet;<br>Fibre sound insulation<br>1330mm length x 365mm width<br>Measured at largest points<br><br>Fibre sound insulation on bulkhead. Unable to measure | Y<br><br>Y | N<br><br>N |
| | Under Body and Engine Compartment | No Under body or Engine Compartment Insulation found<br><b>(Photos 16)</b> | | |

**^ (Photo 16), View of Honda Stepwagon Underbonnet Insulation**
