# CLUTCH

REFER TO 1988 CELICA REPAIR MANUAL (Pub. No. RM071U)

# CLUTCH UNIT

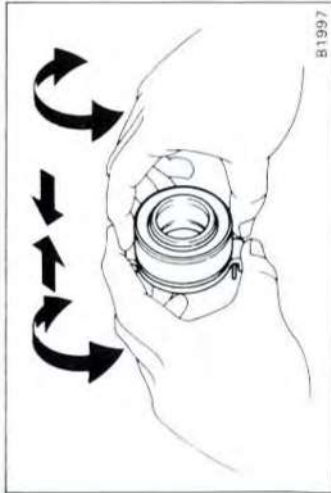
5. INSPECT RELEASE BEARING

Turn the bearing by hand while applying force in the axial direction.

**NOTE:** The bearing is permanently lubricated and requires no cleaning or lubrication.

If a problem is found, replace the bearing together with the hub.

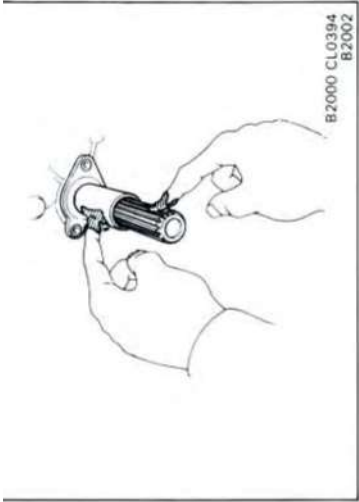
3. APPLY MOLYBDENUM DISULPHIDE LITHIUM BASE GREASE (NLGI NO.2) AS SHOWN
