### Audio driving instructions cannot be heard

# Troubleshooting

## '00 - 01 Models (cont'd)

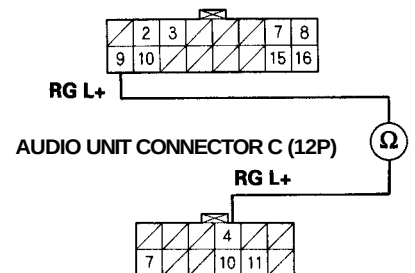
NAVIGATION UNIT CONNECTOR B (16P)

Wire side of female terminals

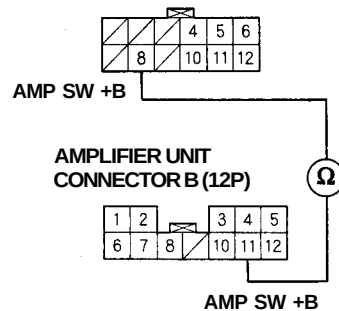
NAVIGATION UNIT CONNECTOR A (12P)

Wire side of female terminals
