## EXHAUST SYSTEM

### GENERAL DESCRIPTION - V6

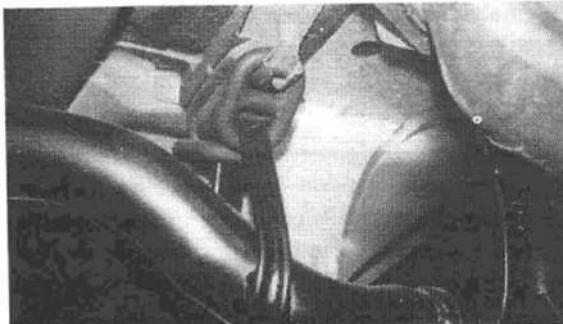
Exhaust mounting brackets

Centre muffler

Rear muffler

All the pipe joints have a peg and a notch which must be equal to gain correct alignment.
