## A/C system, On Board Diagnostic (OBD)

### Function

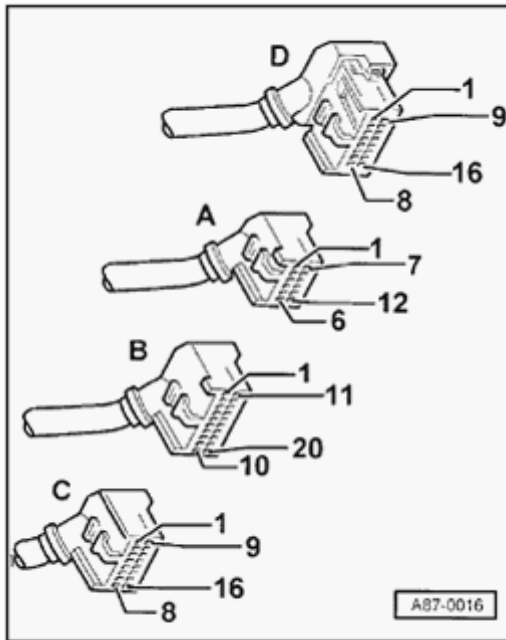
## VAG1598 test box, connecting

- Switch off ignition.
- Remove A/C control head -E87- and disconnect all connectors, -A-, -B-, -C- and -D- ⇒ [page 87-120](#) .

- Connect VAG1598/11 and 12 adapter cables to corresponding connectors of the vehicle wiring harness (to -E87-).
- Connect VAG1598 test box to the respective adapter cable for performing measurements.

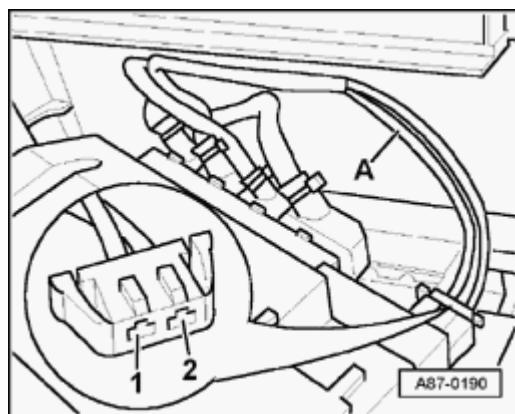
- Switch ignition off.
- Connect harness connector E at A/C control head -E87-.

- Route wire -A- to harness connector E through current probe on VAG1715.

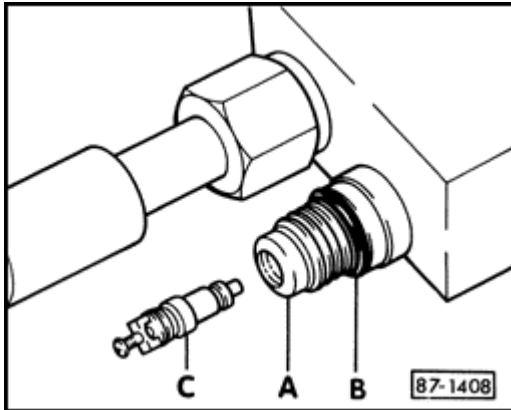
### Valve connections for pressure switches

A Schrader valve is installed under A/C system pressure switches to allow replacement without discharging the refrigerant system.

- A/C system low and high pressure switches use different size threads.
- Use only the correct switches and O-ring seals specified for use with R-134a refrigerant and PAG oil.

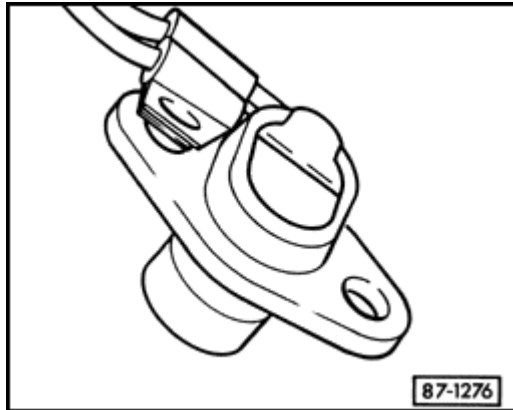
⚡ **A/C compressor speed sensor -G111-, (Zexel compressors only)**

- Inductive sensor (4 pulses per compressor rotation)
- Determines A/C compressor speed; the A/C compressor clutch control module (Manual A/C) or the A/C control head (Automatic climate control) compares compressor speed to engine speed and calculates belt slippage (as a percentage) and switches compressor OFF if slippage is too large (for example, if belt is too loose.)

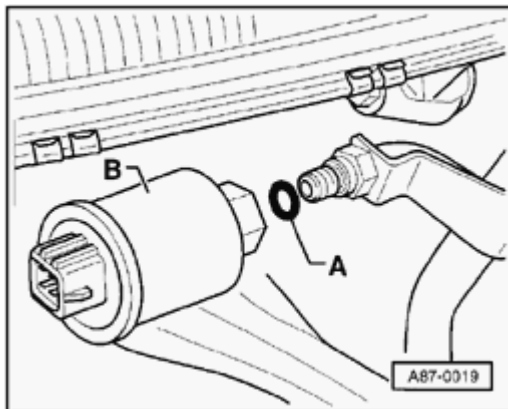
*Beginning with m.y. 1997, A/C pressure switch - F129- replaces pressure switches -F23-, and - F118- ⇒ [page 87-67](#) .*

- ⚡ Both switches are incorporated into a single housing.

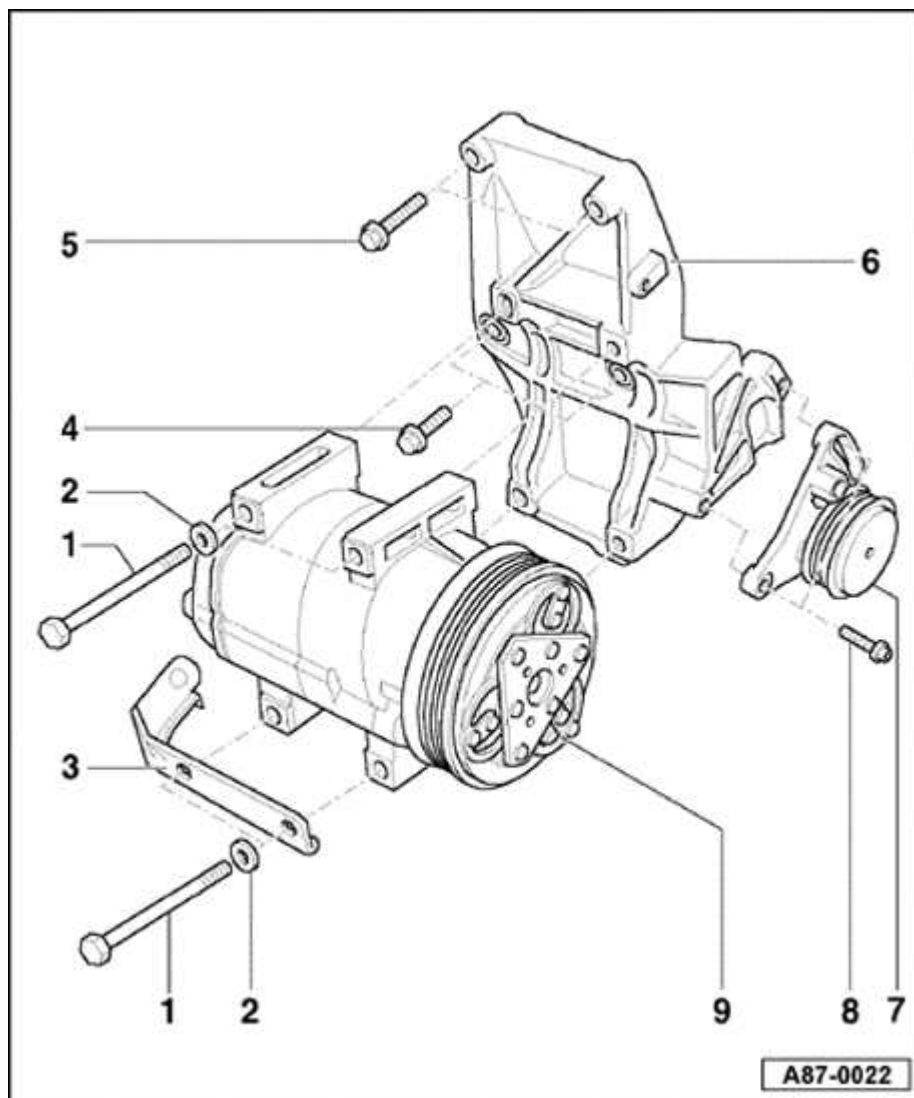
87-77

**1 - Bolt**

- ◆ 25 Nm (18 ft lb)

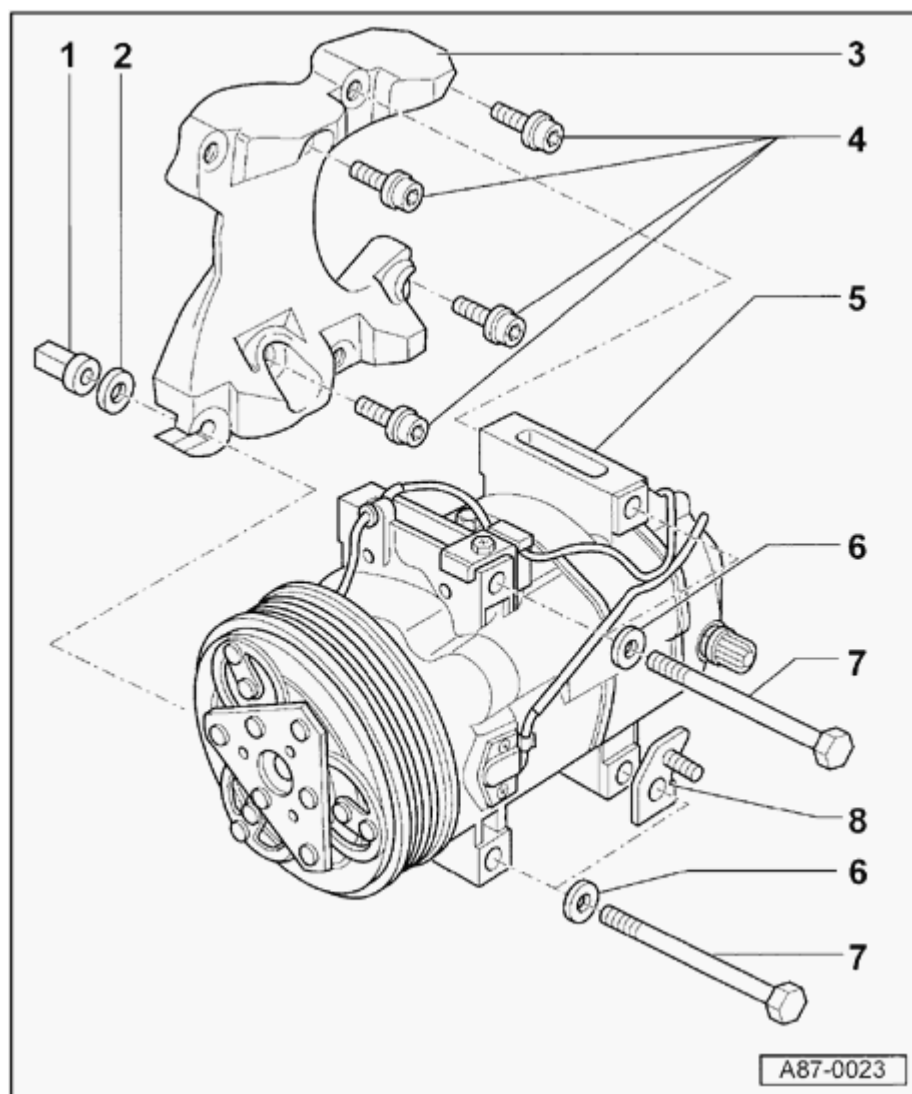
87-80

**6 - Washer****7 - Bolt**

◆ 25 Nm (18 ft lb)

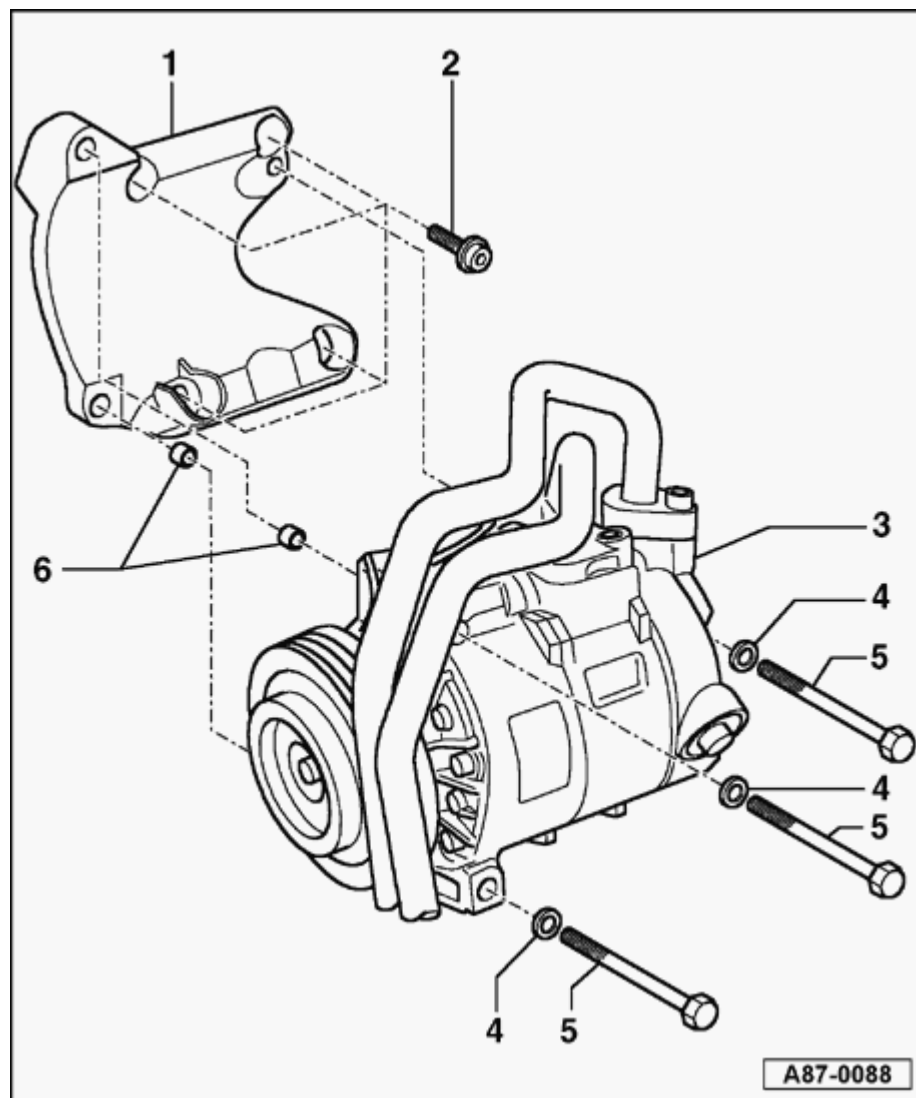
87-83

**1 - Compressor mounting bracket**

**2 - Hex socket bolt with washer**

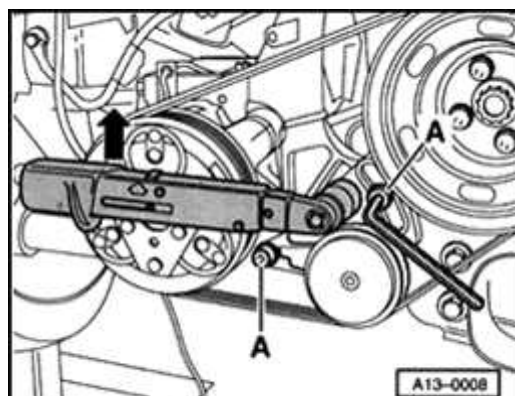
**Mark running direction of ribbed belt before removing (if belt is installed in the opposite running direction, belt damage may result).**

- Loosen both hex socket bolts -A-.

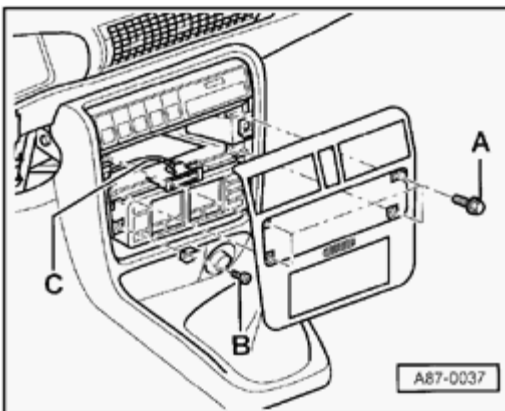
- Remove screws -A-.

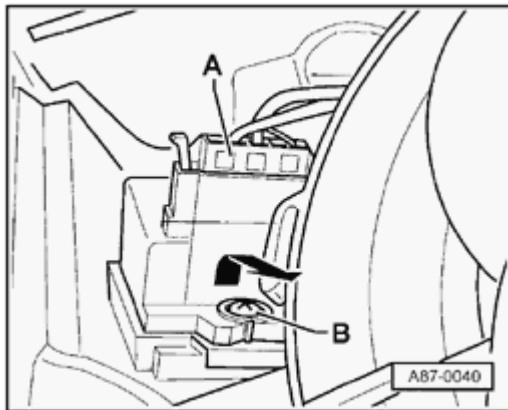
- Unplug electrical connector -A-.
- Remove screw -B- and remove module in direction of arrow.
- Install in reverse order of removal.

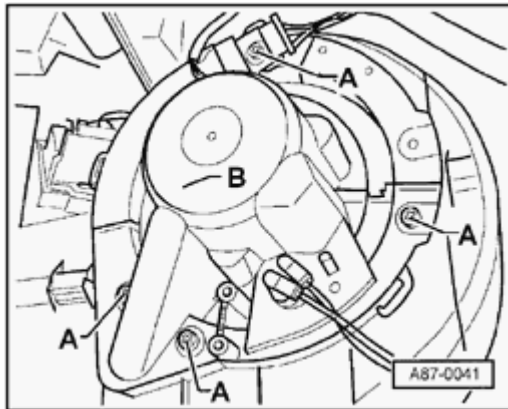
- Remove 4 screws -A- and remove fresh air blower from heater/air conditioner assembly.
- Install in reverse order of removal.

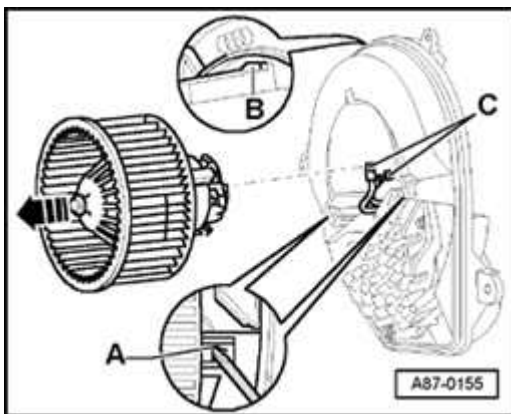
### Separating fresh air blower -V2- and mounting plate

- ◆ When re-installing the fresh air blower to the mounting plate, check for correct installation position of tabs -A- and -B-.
- ◆ After installation check for correct fit of fresh air blower in heater/air conditioner assembly.

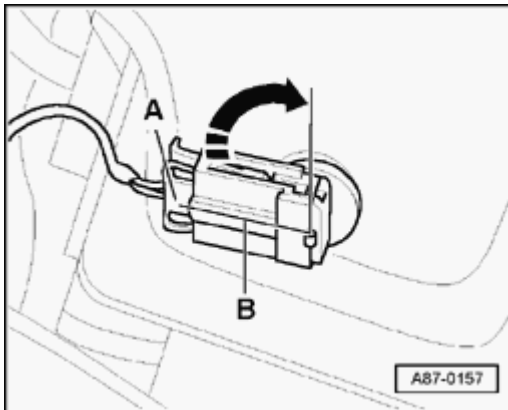
- Disconnect electrical connector -A-.
- Turn sensor -B- 90° and remove.

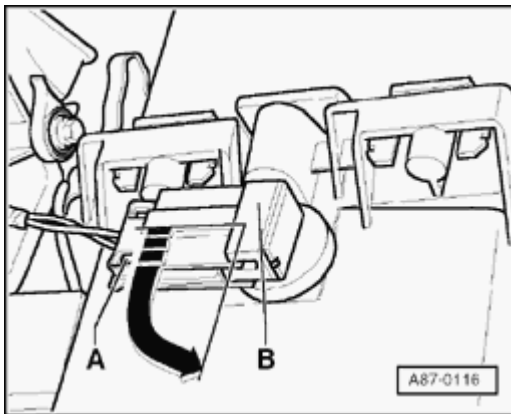
- Disconnect electrical connector -A-.
- Turn sensor -B- 90° and remove.

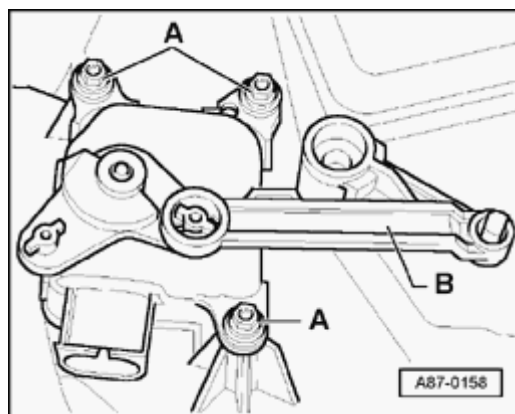
- Identify and mark electrical connectors at flap motor prior to disconnecting (to prevent mix up) and remove from motor.
- Remove 3 bolts -A-.
- Remove motor and unhook lever -B- (color: red).

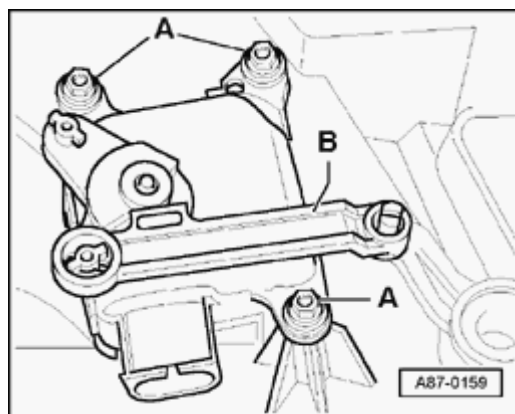
- Identify and mark electrical connectors at flap motor prior to disconnecting (to prevent mix up) and remove from motor.
- Remove 3 bolts -A-.
- Remove motor and unhook lever -B- (color: blue).

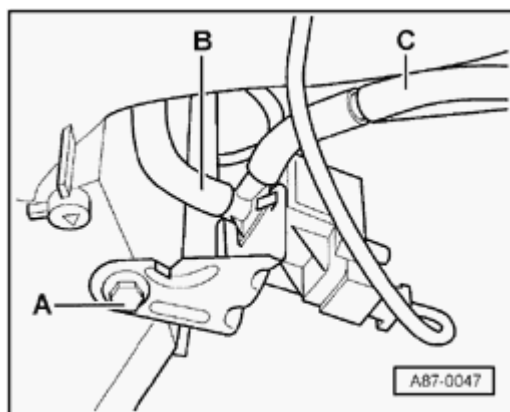
- Remove bolt -A-.
- Separate electrical connection.
- Install in reverse order of removal.

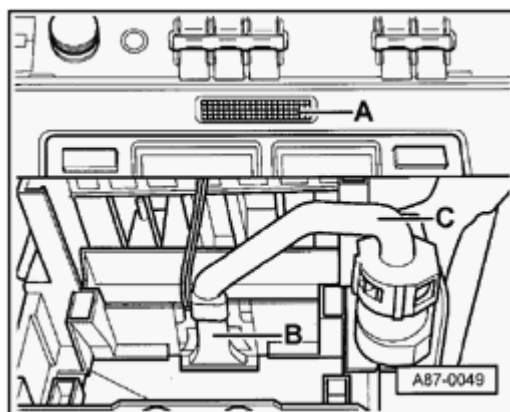
- ◆ Check temperature sensor intake -A- and intake hose -C-; air flow must not be restricted by dust or debris.
- ◆ Temperature sensor -B- is attached to switch mounting; replace complete unit.
- ◆ Electrical test ⇒ [page 01-115](#) .

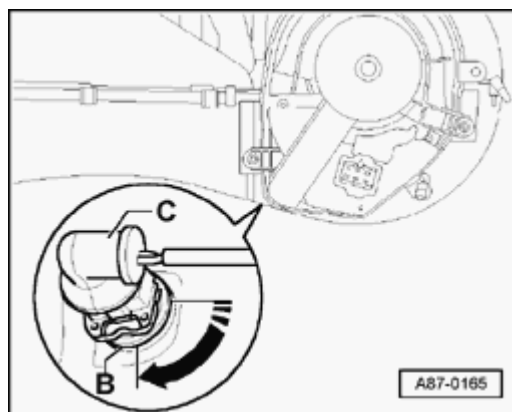
- Reach in-between heater/air conditioner assembly and bulkhead and turn sensor -B- 90° (arrow) (connector -C- remains connected).

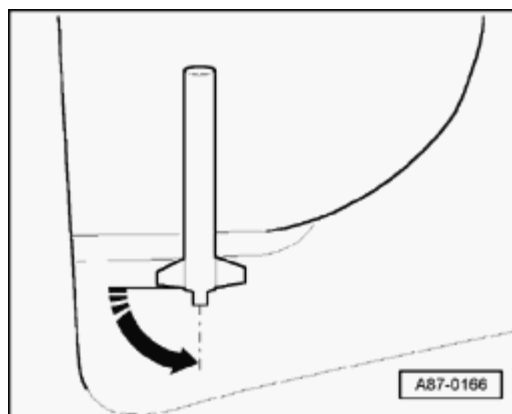
- Remove dust and pollen filter ⇒ [page 87-158](#) .
- Reach into intake and turn temperature sensor 90° .

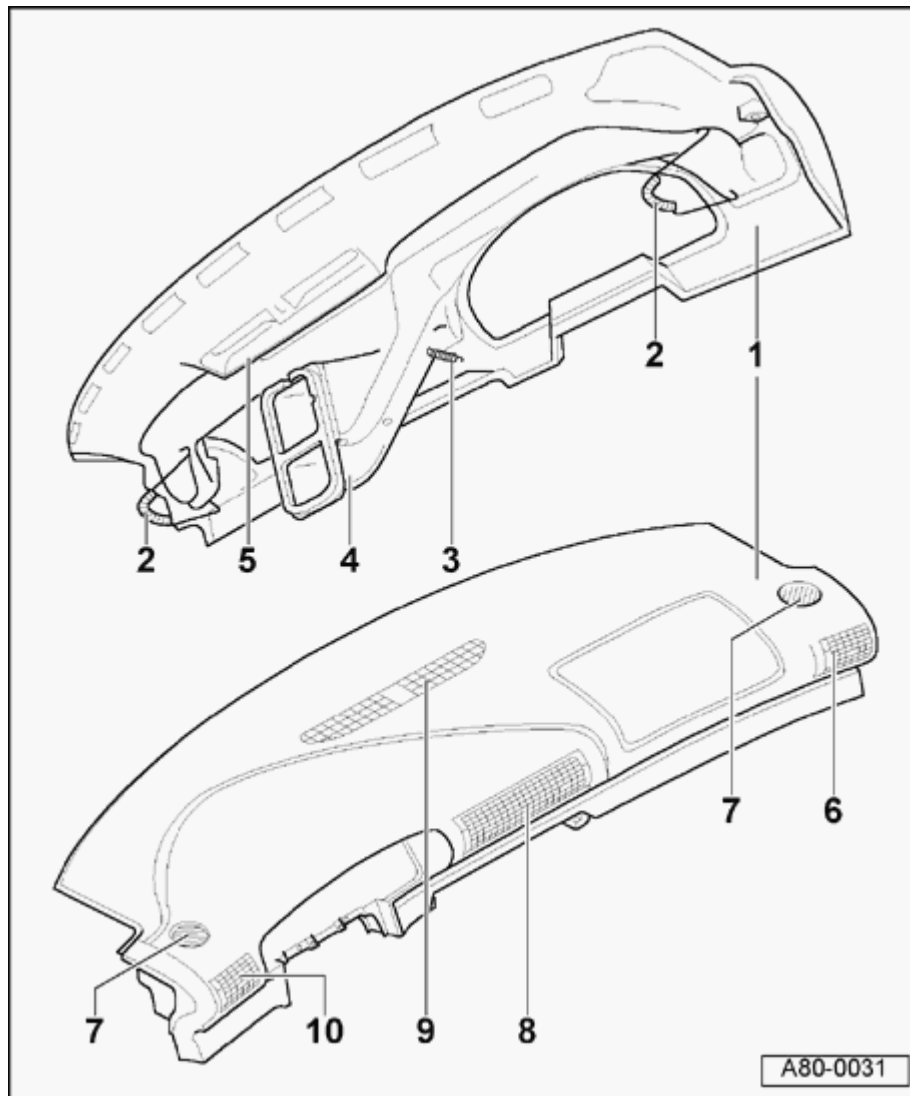
87-152

**3 - Retaining spring for air guide duct**

**5 - Defroster duct**

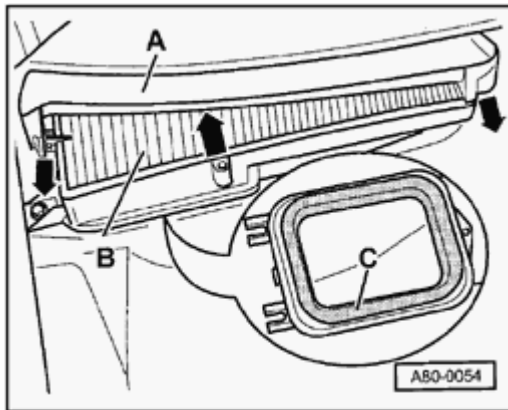
- Remove water guide -A-.
- Remove dust and pollen filter -B- from housing.

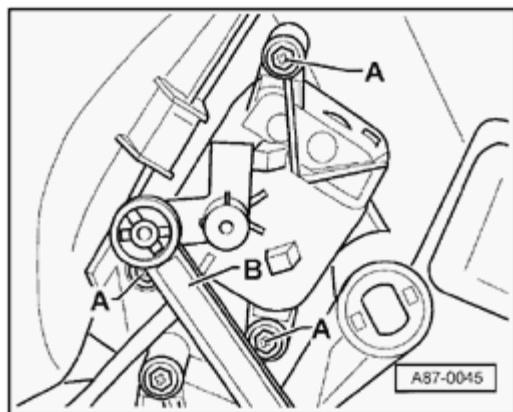
- ◆ When re-installing instrument panel and heater/air conditioner assembly, ensure the A/C system vacuum supply hose with heater core fixture, and low pressure switch electrical connector and evaporator fixture are inserted together through the plenum chamber openings.
- ◆ Ensure evaporator drain is correctly positioned  
⇒ [page 87-169](#).

- ◆ Ensure boot -C- is correctly installed.

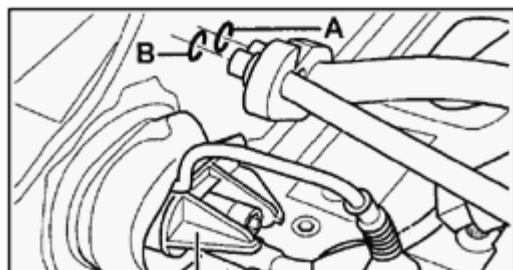
- ◆ Hose -A-: return flow to water pump (with vent hole).
- ◆ Hose -B-: supply from cylinder head.

- ◆ Replace refrigerant line O-rings -A- and -B-.
- ◆ Evaporator refrigerant line fixture bolt tightening torque: 15 Nm (11 ft lb).
- ◆ Ensure boot -D- and wiring to low pressure switch are correctly located and secured when installing.

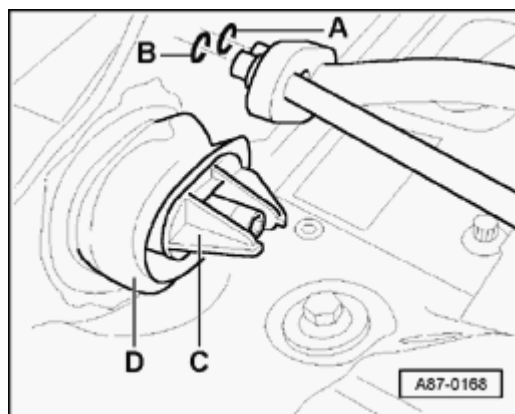
- A**
- Plug evaporator openings using cap supplied with replacement evaporator -C-.
  - Remove bulkhead grommet -D-.

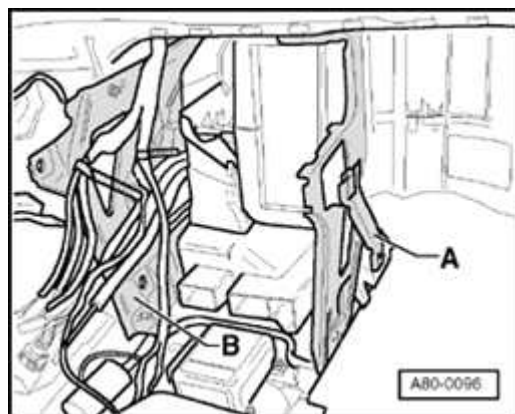
- A**
- Remove instrument panel support -A-.
  - Loosen instrument panel support -B- (the upper mounting bolt to the heater/air conditioning assembly can not be removed).
  - Remove floor outlet ⇒ [page 87-134](#) .

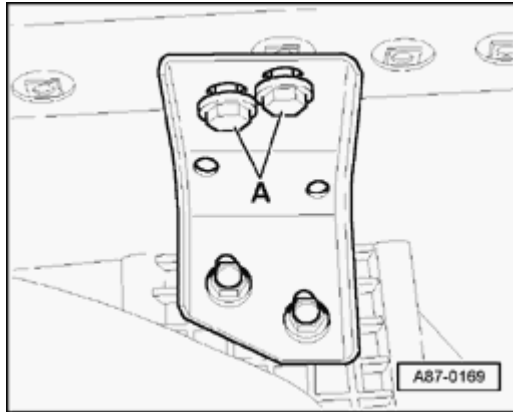
- Remove bolts -A-.
- Disconnect all electrical connections from instrument panel harness to heater/air conditioner assembly.

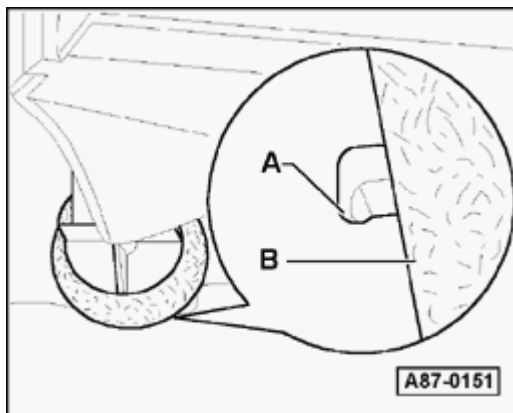
- ◆ Drip guide -A- on the evaporator housing drain prevents liquid from flowing back into the foam seal -B-.

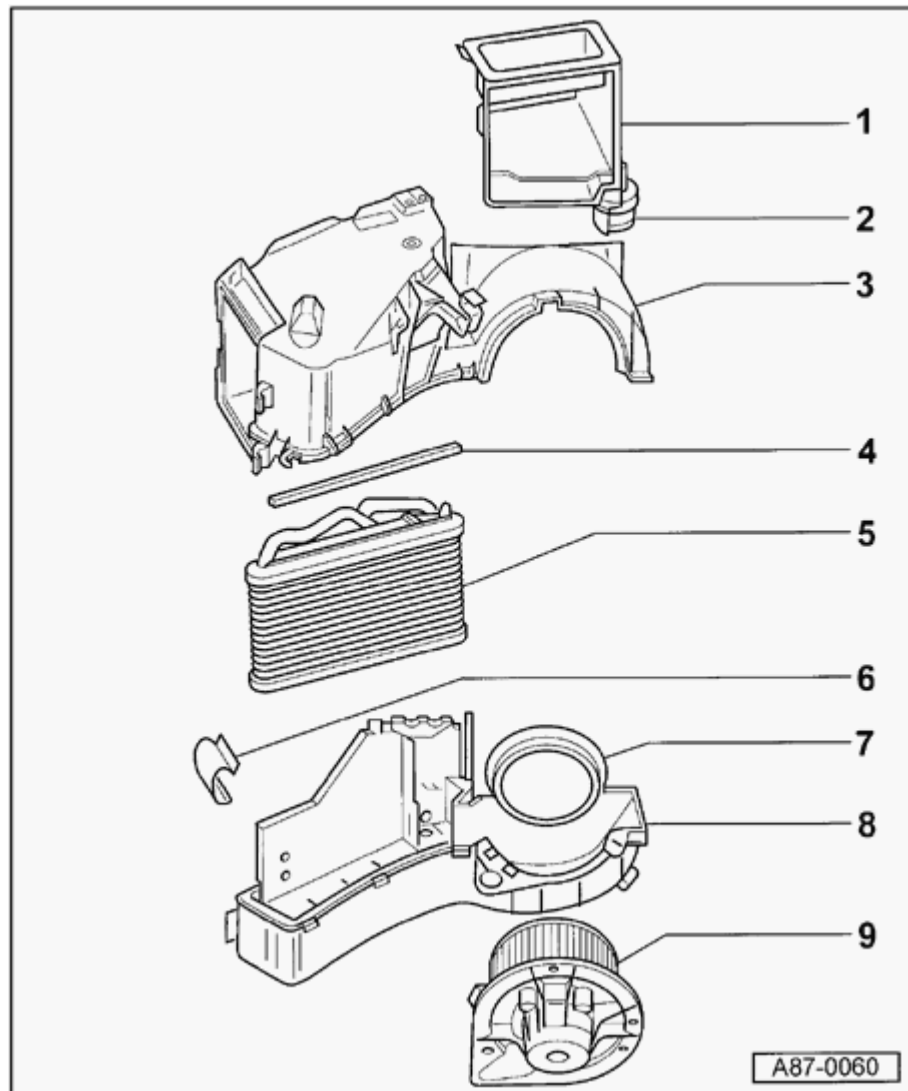
87-182

**7 - Intake ring**
