**2002 ES 300**

**Driver's Side Front Airbag**

**Special Service Campaign 1LG**

**M/N 00241 – 10006 – 1LG**

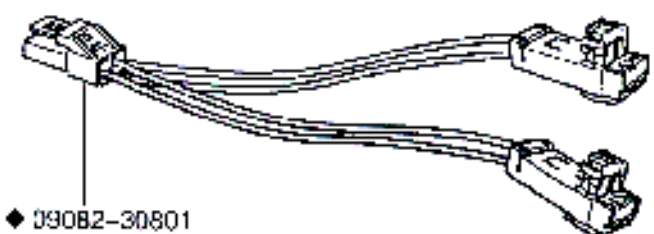
◆ 09082-30801

| Part Number | Part Description | Qty/<br>Vehicle |
|---|---|---|
| 09082-30801** | Wire C (for airbag deployment not reusable) | 1 |

◆ Non-reusable part

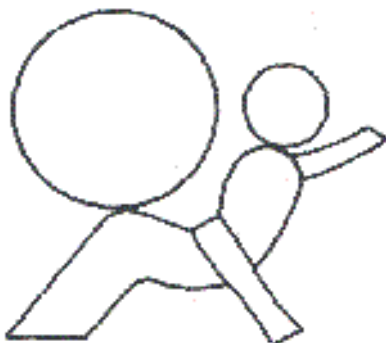
#### 6. CHECK SRS WARNING LIGHT

- Turn ignition switch to the **ON** or **ACC** position and check that the SRS warning light illuminates.
- Verify that the SRS warning light goes out after approximately 6 seconds.
