00 26 11 (731)

Brake fluid - Operating Fluids Specification

00 12 11 (696)

Brake fluid service - extension of the first brake fluid interval to 36 months

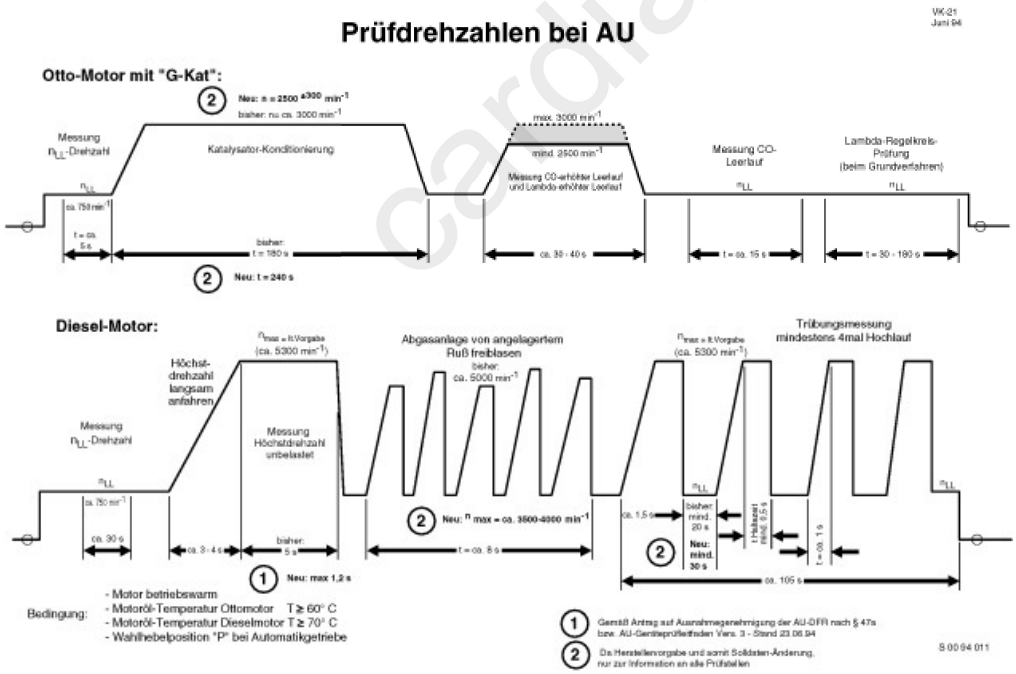
Effect: Primarily in the ZF type 4HP22 automatic transmission under the currently specified test conditions the disc set of the "A" clutch may be detrimentally affected to such an extent that forward travel is no longer possible after the exhaust emissions test has been completed.

Measure: With the vehicle stopped (selector lever in position "P") and with the ZF 4HP22 automatic transmission the following operating points (engine speed/time) must not be exceeded:

nengine = 2500 rpm --> max. 15 minutes

nengine = 3000 rpm --> max. 60 seconds

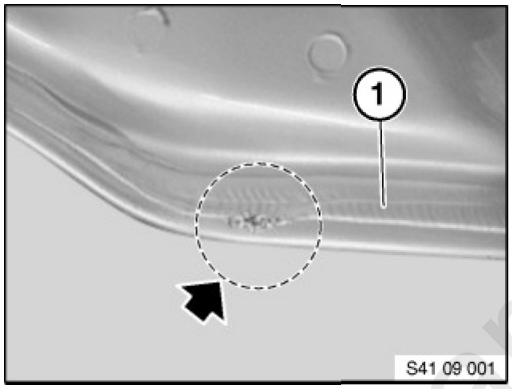
Situation: Min/max tolerance samples are available to enable improved pinpointing of paint and corrosion damage. They are a supplement to the BMW Paintwork publication announced in Service Information 41 01 08 (452) and published in October 2008.

Vehicles that are older than three years after the first registration date may only be repaired by replacing components if the damage exceeds a defined extent (see min/max tolerance samples). With immediate effect, certain paint damage patterns attributed to incipient corrosion may only be repaired by means of spot repairs as small as possible.

- **Paintwork damage with min/max tolerance sample A** (critical damage pattern)
- **Paintwork damage with min/max tolerance sample B** (minor damage pattern)
- **Paintwork damage with min/max tolerance sample C** (scrape marks)
- **Paint damage with tolerance sample D** (rubber grommets)
- **Paint damage with min/max tolerance sample E** (vehicle underbody)

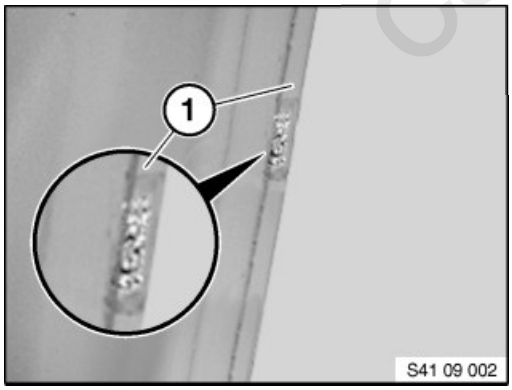
Sample A1:

Visible rusting on fold and its seal (1).

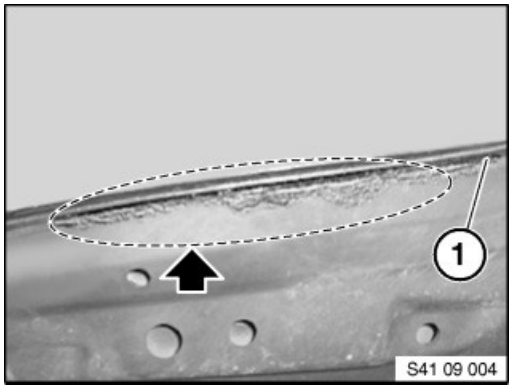
Sample A2:

Bubbling on outside (1) of fold seal.

Bubbling between fold seal and outer edge. The fold seal covers an approx. 5 mm wide strip at the edge of the component.

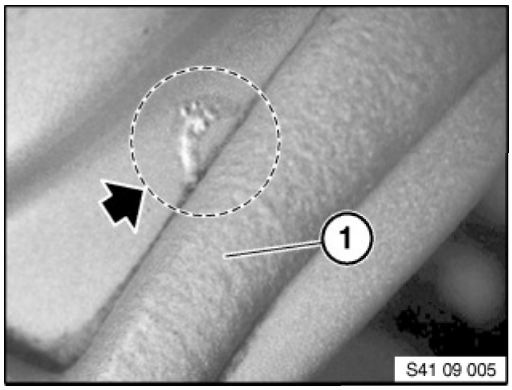
2. Min/max tolerance sample B (minor paintwork damage)

General appearance: Rust is **NOT** visible without scratching the surface.

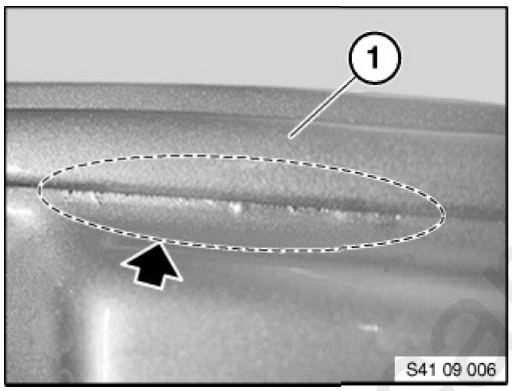
Sample B1:

Bubbling on the inside of the fold seal (1) is less extensive than the width. Lengthwise distribution is less than the width of the fold seal (1).

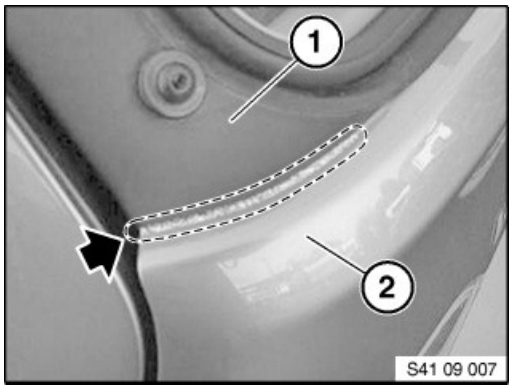
Sample B2:

Bubbling on the inside of the fold seal (1) is less extensive than the width. Lengthwise distribution is greater than the width of the fold seal (1).

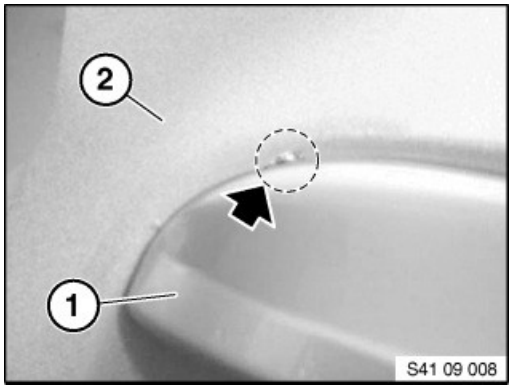
Sample C2:

Chafe marks on paint surface caused by tailgate handle strip (1) on tailgate (2).

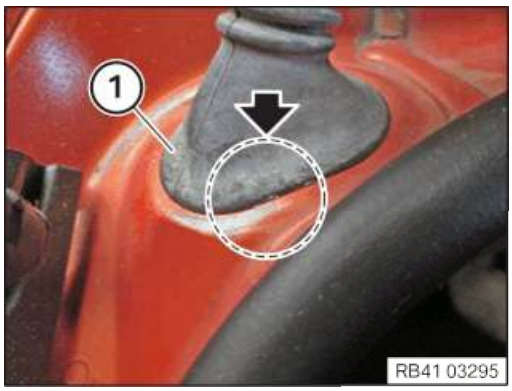
3. Tolerance sample D (rubber grommets)

Formation of blisters is not visible without lifting the rubber grommet (1).

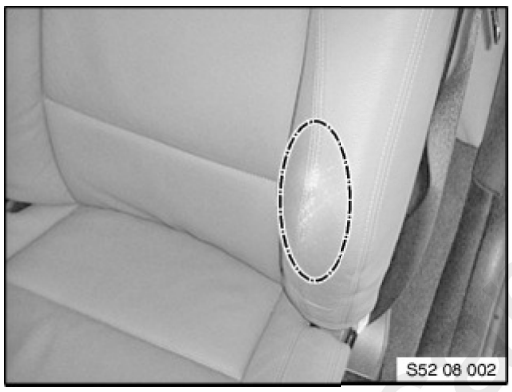
1. Discolouration and dirt contamination

Clothing (especially jeans and leather clothing in damp condition) can bleed colours onto the leather. Especially subject to this are special light coloured interior options

To prevent the leather from discolouration and dirt contamination, regular leather care is required (also refer to SI 510202834 and notes in the Owner's Handbook on leather care).

Using the care and cleaning set approved by BMW, these discoulorations and dirt contaminations can be removed in most cases. If is no longer the case, because it is at an advanced stage, the dirt contamination has already penetrated into the leather.

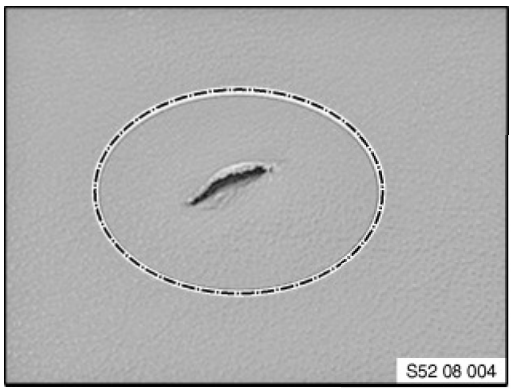
The fault pattern presents no product defect. The effected location can be repaired with the aid of the BMW leather repair kit.

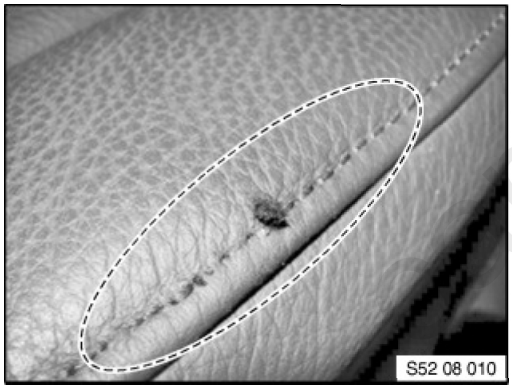
4. Tears and cuts

Obvious completely cut leather caused by sharp objects, such as keys or knives.

The fault pattern presents no product defect. Replacement of cover necessary.

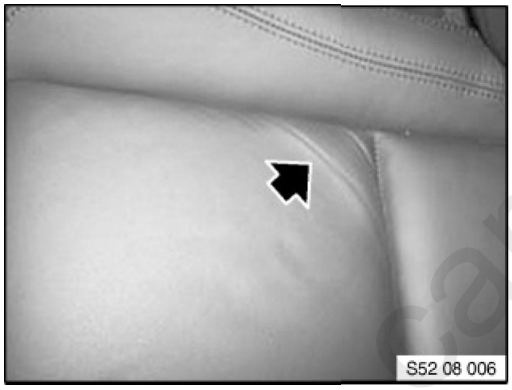
6. Ripples

A ripple in the surface is completely desired to emphasise the natural character of the leather. The ripples in the leather can change due to fluctuations in temperature and humidity.

In case of customer complaints, the customer should be advised of the natural character and design of the leather upholstery. A treatment of the effected spot has no purpose.

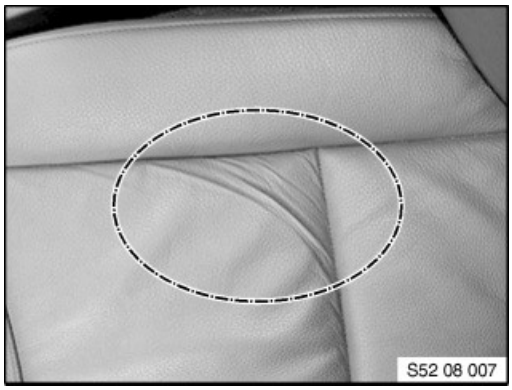
Depending on the cover design, the natural leather qualities (stretch) and the individual type of entering the vehicle, permanent creasing (without rollover of the material) of the seat cover can occur on the seat surface

a. Creasing without rollover of material is not a defect of the leather. Part replacement on warranty is not justified.
b. For creasing with rollover of material, in the case of customer complaint the effected part must be replaced on warranty.

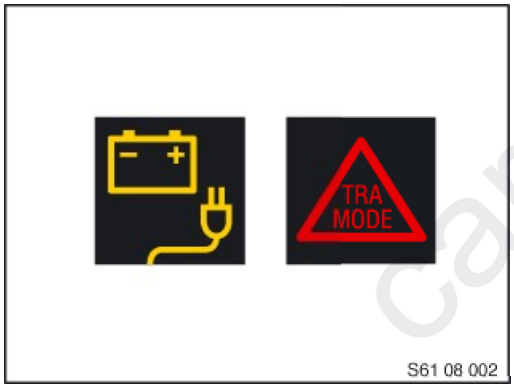
Vehicle battery OK.

Continue to recharge the battery on store and compound vehicles regularly in accordance with the battery charging calendar.

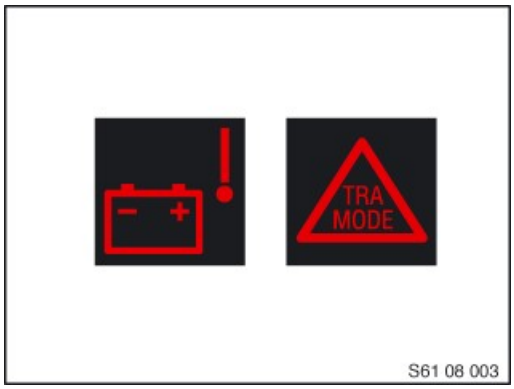
Battery charge state insufficient.

Recharge the battery without delay.

If a new vehicle is delivered through distribution chain with this display, this must be recorded in the truck delivery note and/or haulier handover report.
