00 26 11 (731)

Brake fluid - Operating Fluids Specification

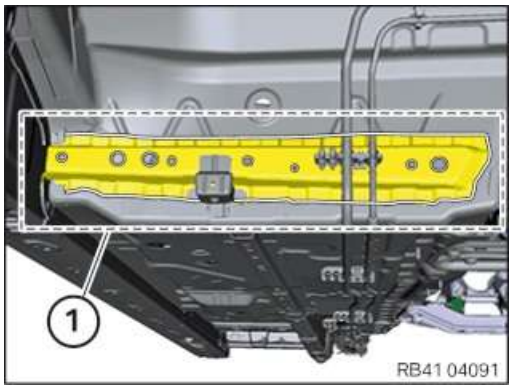
Measure: In case of a customer complaint the heel panels must be protected from advancing corrosion by coating and preserving.
Attention!

Replacement of the heel panels is not permissible in these cases!

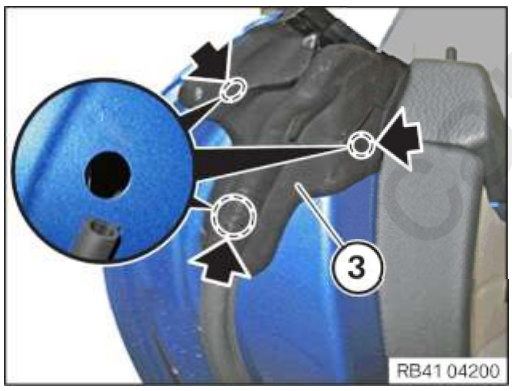
Inner door panel repair (edge corrosion)

Situation: Edge corrosion may occur on the inner door panel around bore holes/holes (see images).

Remove the door.

Remove the window cavity seal.

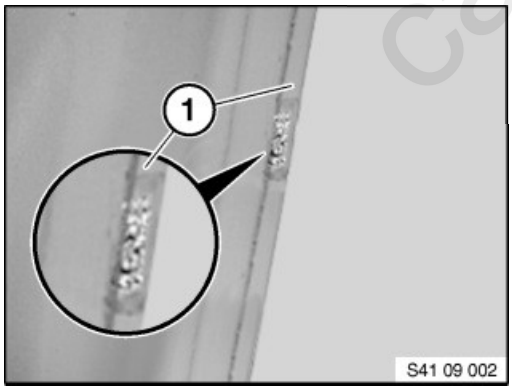
Sample A1:

Visible rusting on fold and its seal (1).

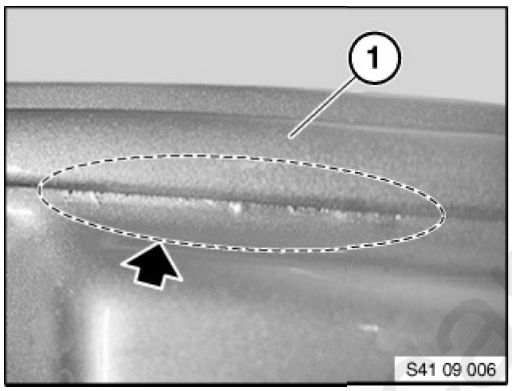
Sample B1:

Bubbling on the inside of the fold seal (1) is less extensive than the width. Lengthwise distribution is less than the width of the fold seal (1).

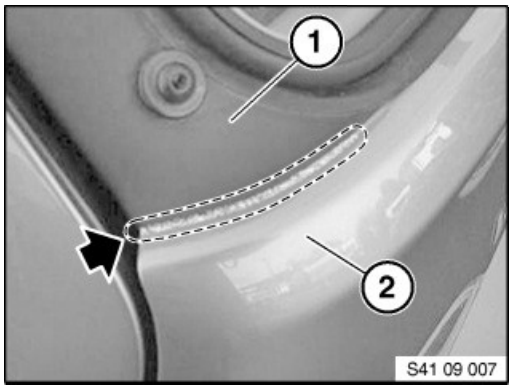
Sample B2:

Bubbling on the inside of the fold seal (1) is less extensive than the width. Lengthwise distribution is greater than the width of the fold seal (1).

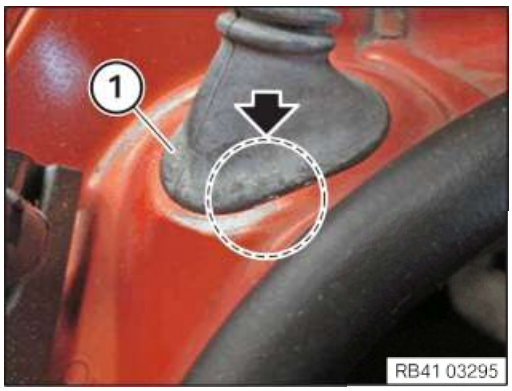
3. Tolerance sample D (rubber grommets)

Formation of blisters is not visible without lifting the rubber grommet (1).

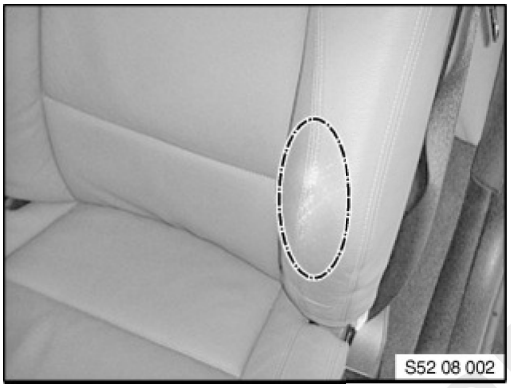
1. Discolouration and dirt contamination

Clothing (especially jeans and leather clothing in damp condition) can bleed colours onto the leather. Especially subject to this are special light coloured interior options

To prevent the leather from discolouration and dirt contamination, regular leather care is required (also refer to SI 510202834 and notes in the Owner's Handbook on leather care).

Using the care and cleaning set approved by BMW, these discoulorations and dirt contaminations can be removed in most cases. If is no longer the case, because it is at an advanced stage, the dirt contamination has already penetrated into the leather.

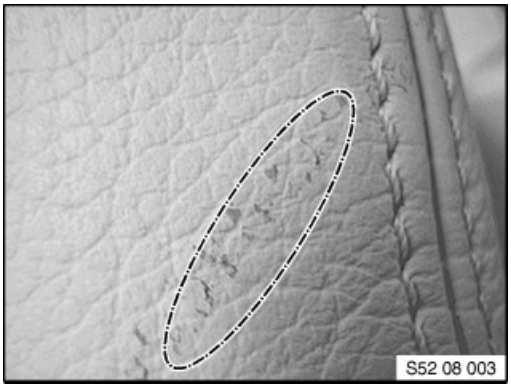
Wear marks, e.g. on the seat bead, can occur by continual mechanical stress and the used geometries.

The effected location can be repaired with the aid of the BMW leather repair kit.

Only for repeated customer complaints is the effected part to be replaced.

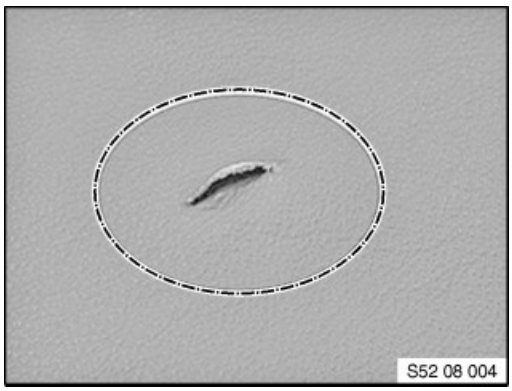
The fault pattern presents no product defect. The effected location can be repaired with the aid of the BMW leather repair kit.

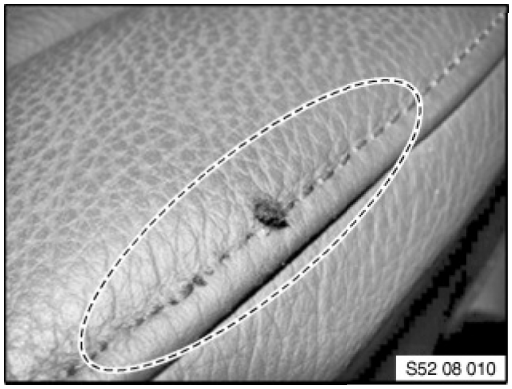
Obvious completely cut leather caused by sharp objects, such as keys or knives.

The fault pattern presents no product defect. Replacement of cover necessary.

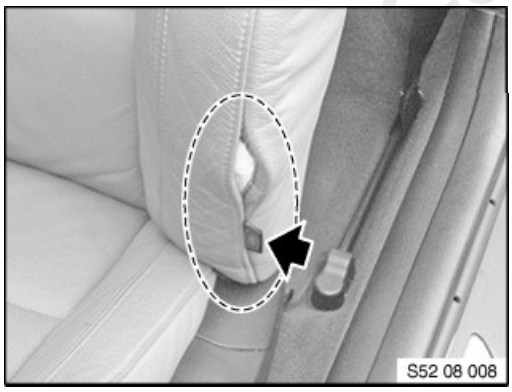
Open seams -general

Damaged or open seams caused by pointed or sharp objects.

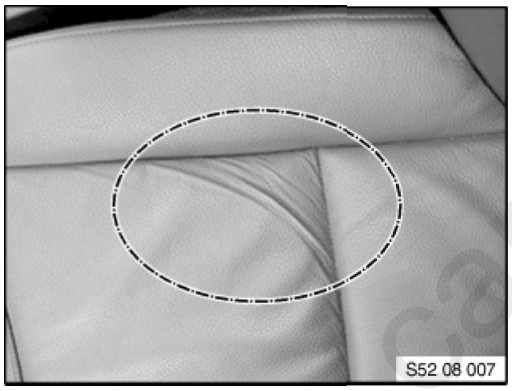
Depending on the cover design, the natural leather qualities (stretch) and the individual type of entering the vehicle, permanent creasing (without rollover of the material) of the seat cover can occur on the seat surface

a. Creasing without rollover of material is not a defect of the leather. Part replacement on warranty is not justified.
b. For creasing with rollover of material, in the case of customer complaint the effected part must be replaced on warranty.

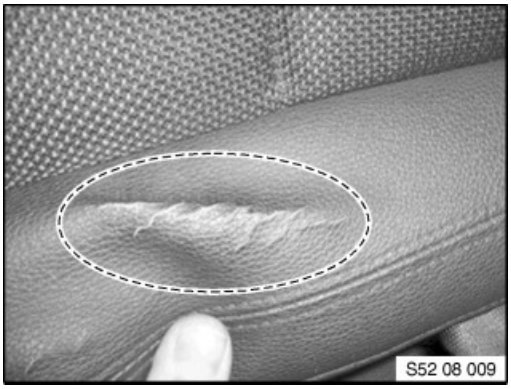
Heavy creasing (with rollover of material) on the seat surface is caused by extreme stress.

To compensate for possible colour variations, the adjacent leather surfaces must be treated with the leather care kit.
