Brake fluid - Operating Fluids Specification

Brake fluid service - extension of the first brake fluid interval to 36 months

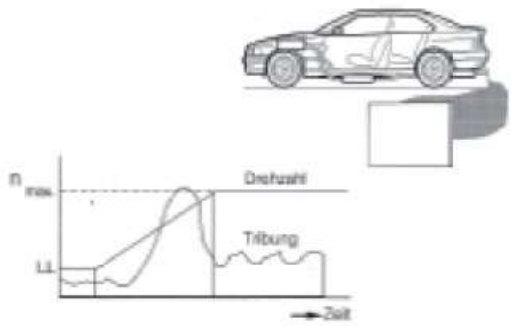
Determining the exhaust gas opacity at the exhaust system tailpipe during “free acceleration” at operating temperature, i.e. with engine oil temperature at minimum 60 °C with selector lever position in “Neutral”. Free acceleration is defined as revving the engine from idle up to maximum speed at no load in response to a swift opening of the throttle. The accelerator pedal must be depressed quickly and continuously within max. 1 second from the idle stop to the full load stop. To determine the actual opacity state (opacity coefficient k in m-1), it is necessary to create the arithmetical mean from three engine start-ups. If the opacity value of 1st engine start-up is at least 30 % below the limit value, further start-ups can be omitted.

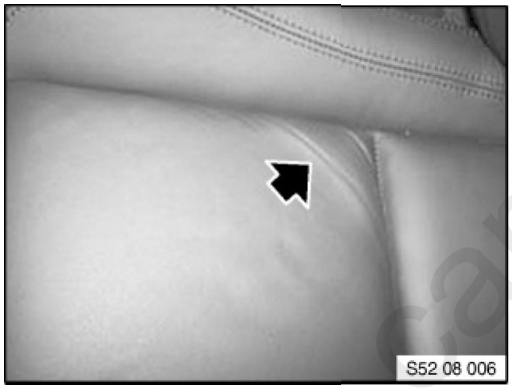
6. Ripples

A ripple in the surface is completely desired to emphasise the natural character of the leather. The ripples in the leather can change due to fluctuations in temperature and humidity.

In case of customer complaints, the customer should be advised of the natural character and design of the leather upholstery. A treatment of the effected spot has no purpose.

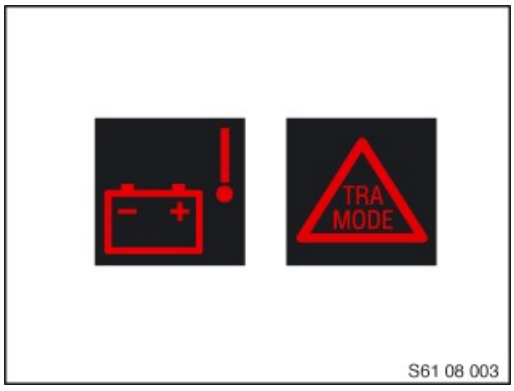
Battery charge state insufficient.

If a new vehicle is delivered through distribution chain with this display, this must be recorded in the truck delivery note and/or haulier handover report.

Recharge the battery without delay.
