## **Service Information**

**Rolls-Royce & Bentley  
motor cars**

TSD 4446

## SERVICE INFORMATION SHEETS INDEX FOR TSD 4446

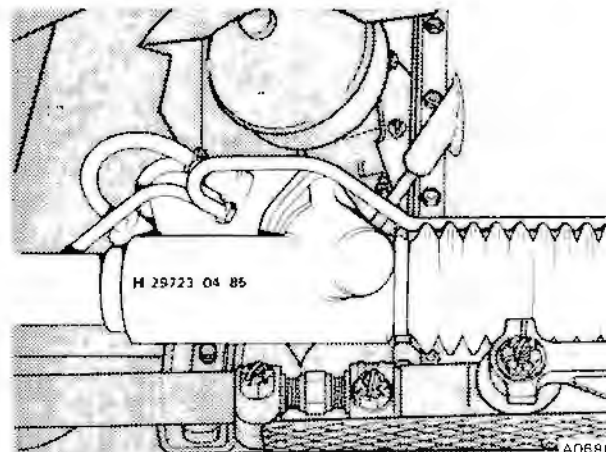
Fig. 10 Steering rack identification - Bentley Turbo R

This is achieved by increasing the diameter of the spool valve torsion bar. Externally, the steering rack assembly is unchanged and the new type rack can be identified by the letter 'H' stamped on the casing as part of the serial number (see fig. 10).

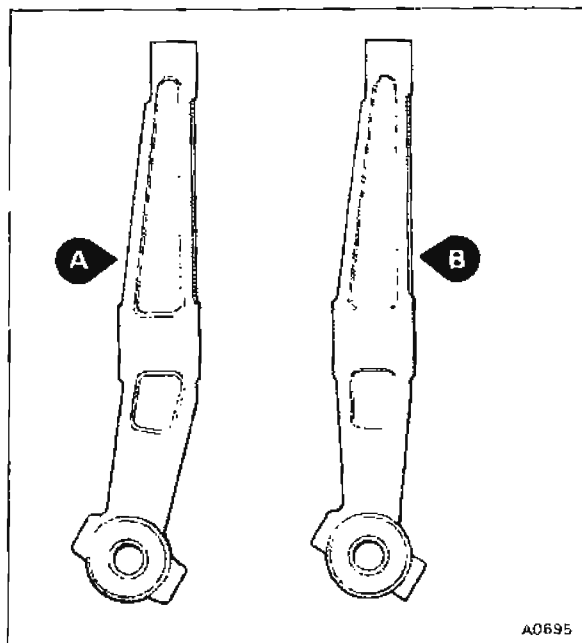
Fig. 11 Side steering levers

The side steering levers are modified to accommodate the new wider alloy road wheels (see fig. 11).

- A Modified steering lever  
B Standard steering lever

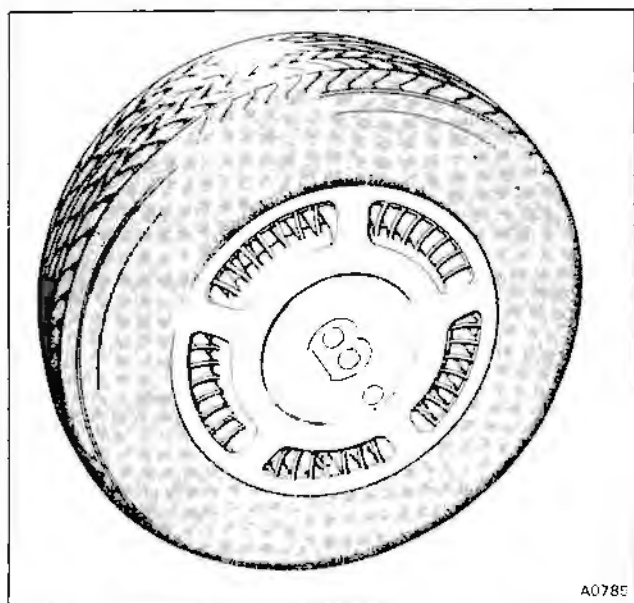
Fig. 12 Aluminium road wheel  
and Pirelli tyre

It should be noted that only Epoxy Coated balance weights must be used with the new aluminium road wheel to prevent the possibility of bi-metallic corrosion.

The new wheels are fitted with alloy valve casings. ONLY alloy or plastic valve caps may be fitted to these valves. Fitting steel valve caps can result in corrosion taking place between the two metals and preventing the removal of the cap without damage to the valve.

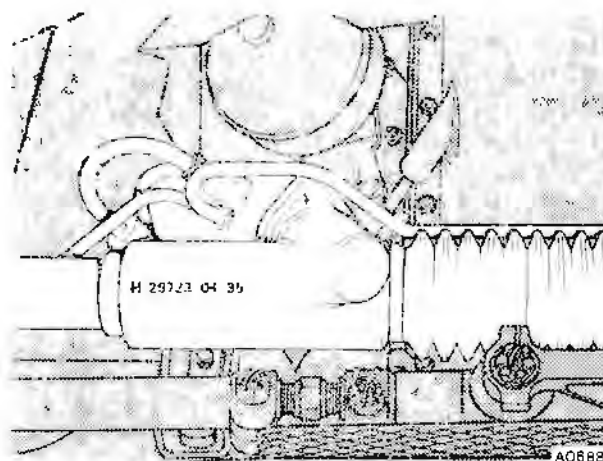
Fig. 13 Steering rack identification

The new rack features a revised internal specification providing a more positive and subjective slightly heavier feel. To identify the new rack, the letter 'H' is stamped on the casing as part of the serial number (see fig. 13).

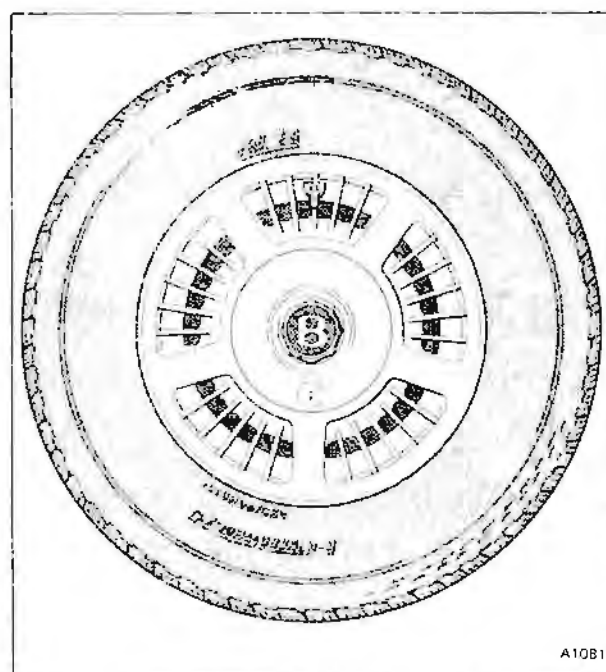
Fig. 15 Aluminium alloy road wheel and lockable trim

All Bentley Mulsanne and Mulsanne L motor cars will be fitted with new aluminium alloy road wheels with lockable wheel trims, (see fig. 15). The new wheel is similar in appearance to the Bentley Turbo 'R' road wheel but is of 6.5 in x 15 in size and will be fitted with 235/70 HR15 tyres.

These valves must not be fitted to aluminium alloy road wheels.

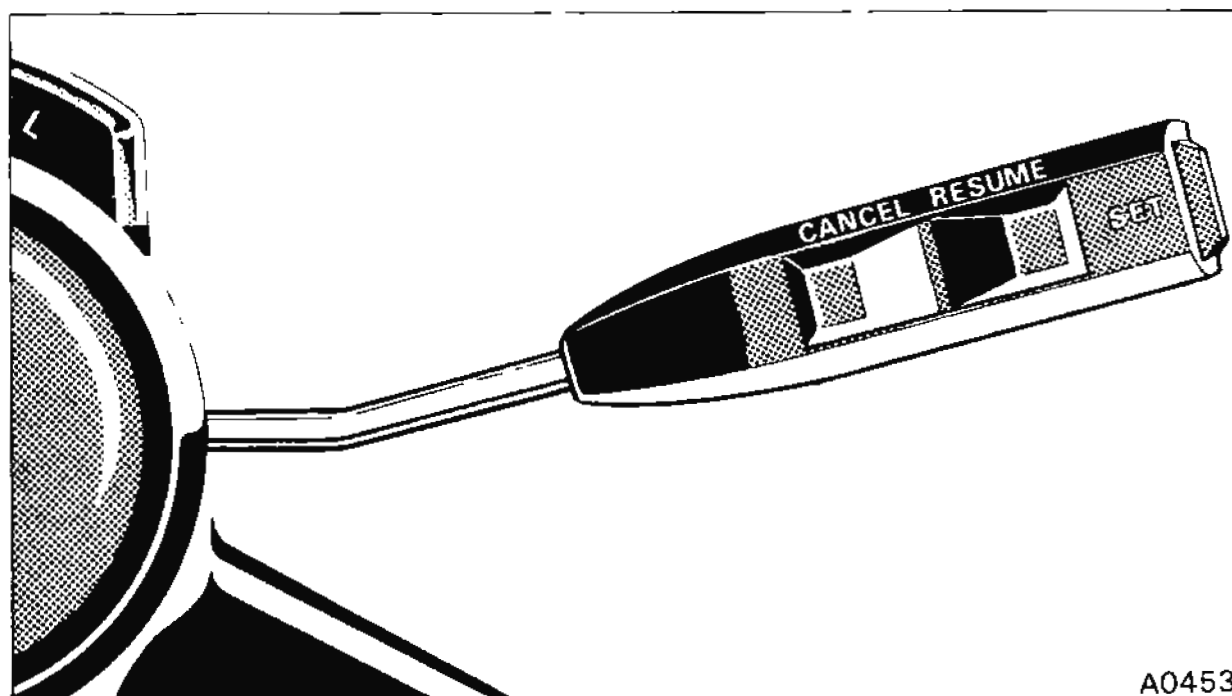
Fig. 8 Speed control switch

Earlier type electronic control boxes MUST NOT be fitted to these cars.

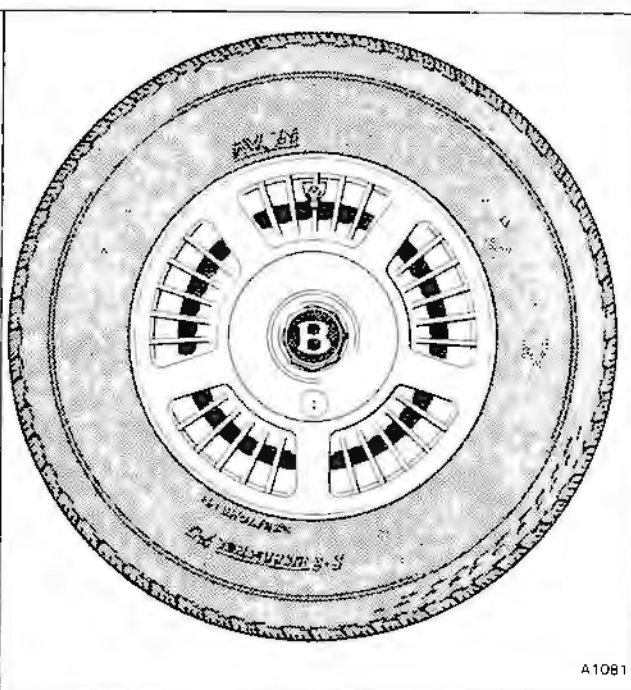
Fig. 15 Aluminium alloy road wheel and lockable trim

All Bentley 'Continental' motor cars will be fitted with 6.5 in x 15 in aluminium alloy road wheels with lockable wheel trims (see fig. 15).

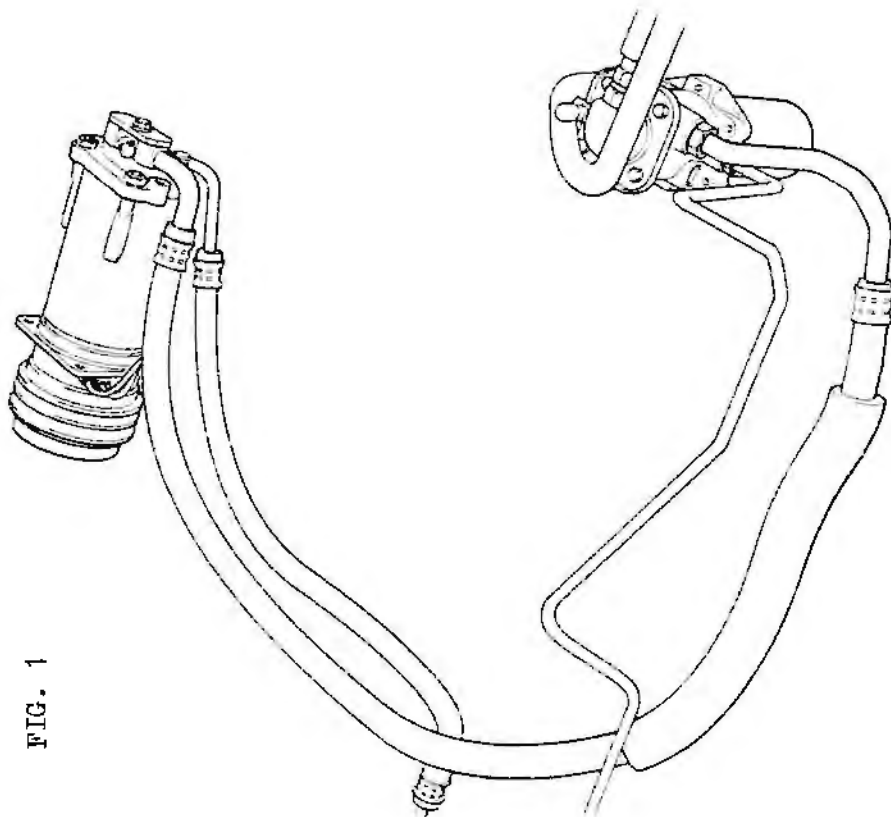
FIG. 1

The cause of the noise is liquid refrigerant coming from the evaporator, through the EEVIR unit (EE model valves-in-receiver) and lying in the compressor suction line. As soon as the engine is running and the Air Condition Unit switched on, the compressor attempts to compress this liquid, which is not possible. At this point there is an extremely rapid rise in pressure in the compressor and this in turn opens the discharge valve. The compressor which is designed to compress vapour, cannot cope with the liquid volume and pressure. A hydraulic shock wave is sent through the compressor and discharge line.

2. Remove the left-hand blower motor and fan assembly.
  3. Remove the left-hand blower motor and fan housing.
  4. Disconnect the compressor suction line from the compressor and Valves-in-Receiver unit and remove it from the motor car. Seal the compressor and VIR unit to prevent the ingress of dirt and moisture. Make absolutely certain that the refrigeration system is fully discharged before this operation is carried out. (see fig. 1).

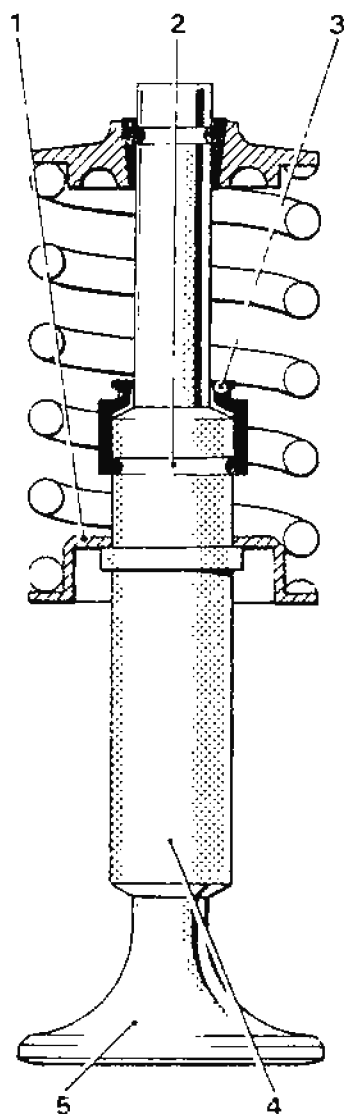
Fig 1.

The previously used, 'waxed string asbestos' type valve stem oil seal, has been replaced by a simplified rubber type lip seal which offers improved oil control.

1. Revised bottom washer
2. Valve seal locating groove
3. Rubber type lip seal
4. Revised valve guide
5. Valve - with specially treated valve stems

Should it be necessary during overhaul to replace the valves, there is no necessity to lubricate the blue coated stem of the new valve during assembly, as the coating has its own lubricating properties for initial running. However, should valves be removed and refitted, or have the valve seals changed for any reason during service, then it is essential that the valve stems are generously lubricated with engine oil mixed with an assembly lubricant such as 'Rocol MTS 1000'

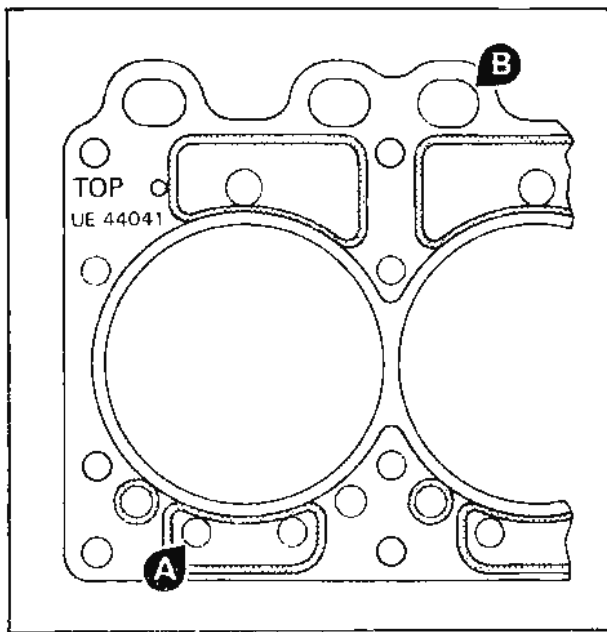
Fig 1 Early Bentley Mulsanne  
Turbo Gasket (UE 44041)

'Dry' assembly of this cylinder head gasket can result in coolant leakage.

- A Two coolant passage holes
- B Size of push rod hole

During replacement, gasket UE 31004 should be coated on both sides with Wellseal prior to assembly.

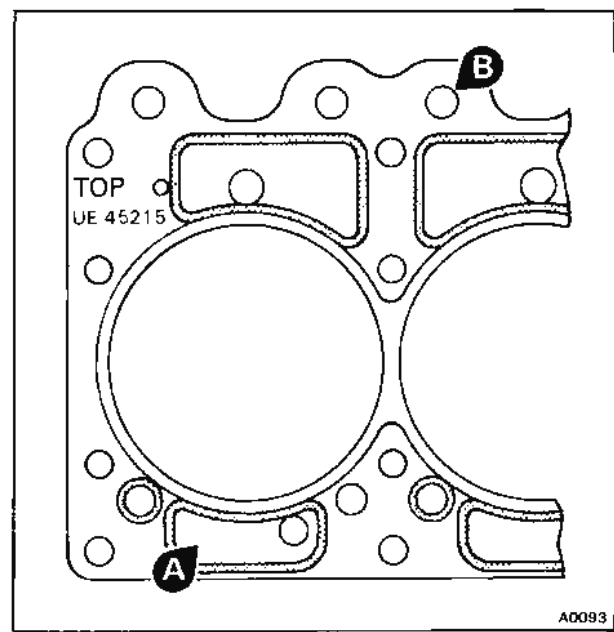
Fig 3 New Gasket Now Used on  
ALL Engines (UE 45215)

- A One hole has been deleted
- B Push rod hole decreased  
in size

The new gasket (UE 45215) should be assembled dry.

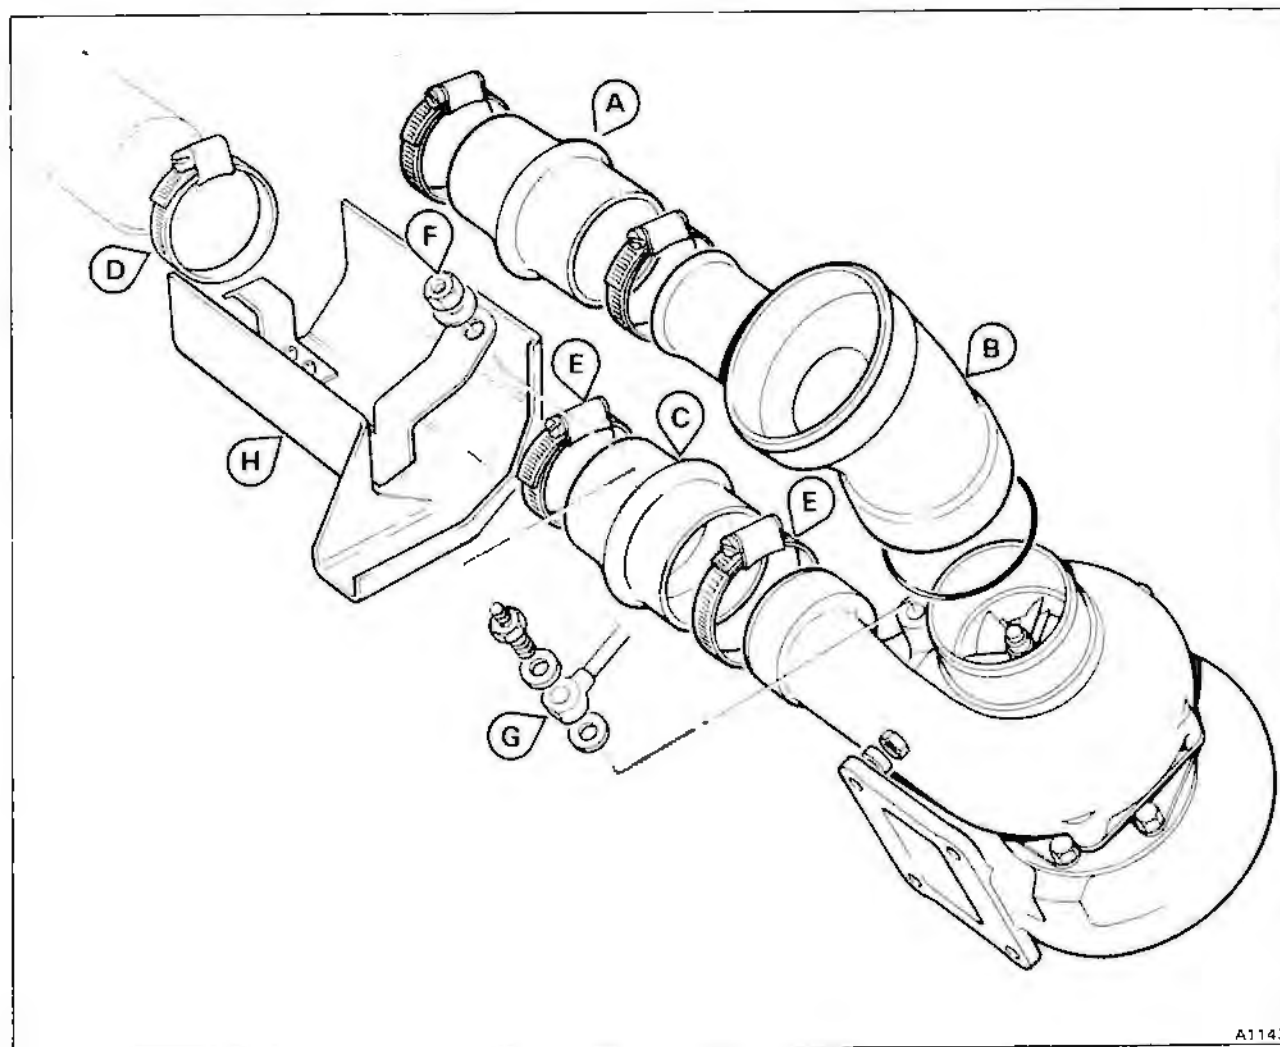
Fig. 1 New Heatshield, Hose and Clipping Arrangement

- A Upper convoluted hose (dump valve line)
- B Intake elbow
- C Lower convoluted hose (turbocharger to air chest feed line)
- D Heatshield retaining hose clip
- E Lower convoluted hose retaining hose clips
- F Nut and washer securing heatshield and intake elbow
- G Boost signal pipe
- H Heatshield

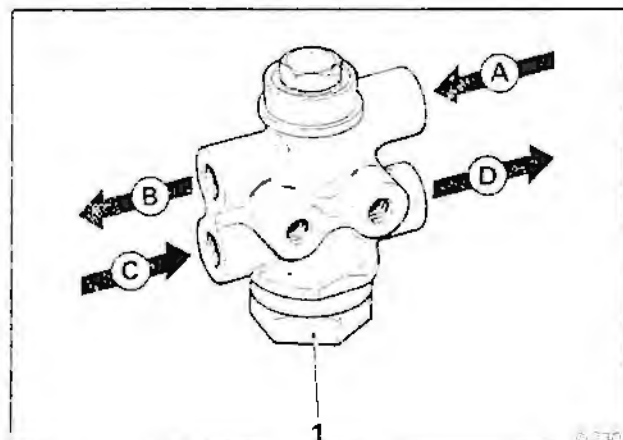
FIG 2.

- 1. Large end cap (letter 'R' or 'R1' etched on cap denotes later GMF 1095 minimum pressure valve for use with restrictor).
- A. High pressure feed from height control valve via restrictor.
- B. High pressure feed to strut.
- C. Seepage return line from strut.
- D. Seepage return line to reservoir via priority valve.

It is essential that the minimum pressure valve(s) are fitted correctly with the smaller end cap uppermost and the feed port (see fig. 2) connected via the restrictor to the height control valve.

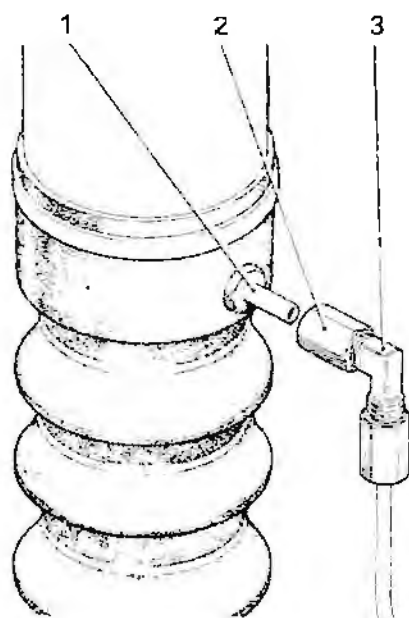
Fig. 1.

- 1. Low pressure adapter
- 2. Nut
- 3. Elbow

1. Hold the 90° elbow with a suitable spanner (see fig. 1, item 3).
2. While holding the elbow, unscrew the nut (see fig. 1, item 2) which secures the elbow (item 3) to the low pressure adapter (item 1).
3. If the nut and ferrule cannot be removed from the low pressure adapter without damaging the adapter, then the nut and ferrule should be left on the displaced strut and a new nut and ferrule fitted to the replacement strut.

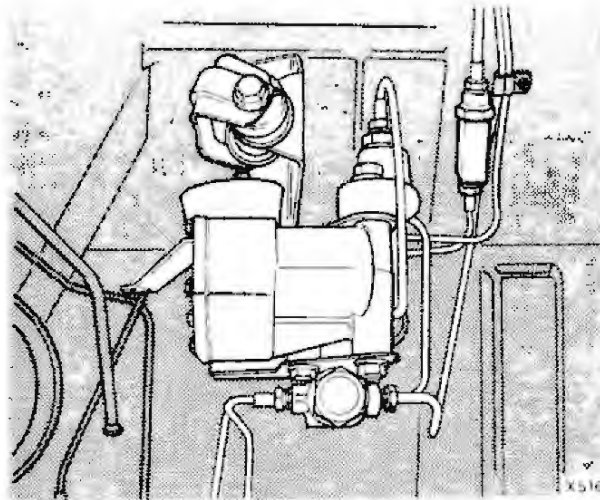
Fig. 1

Since the introduction of the new hydraulic system using Mineral Oil in 1979 it has been found that the height control valves (HCV) are sensitive to dirt ingress.

This results in one or the other of the needle valves inside the assembly not sealing properly or jamming. In turn this causes loss of pressure from the hydraulic system, or malfunction of the levelling on that same side of the car.

If for any reason the height control valve (HCV) is dismantled the needle valves can be removed and the filters blown through with an air line to remove any dirt that has been collected by the filter.

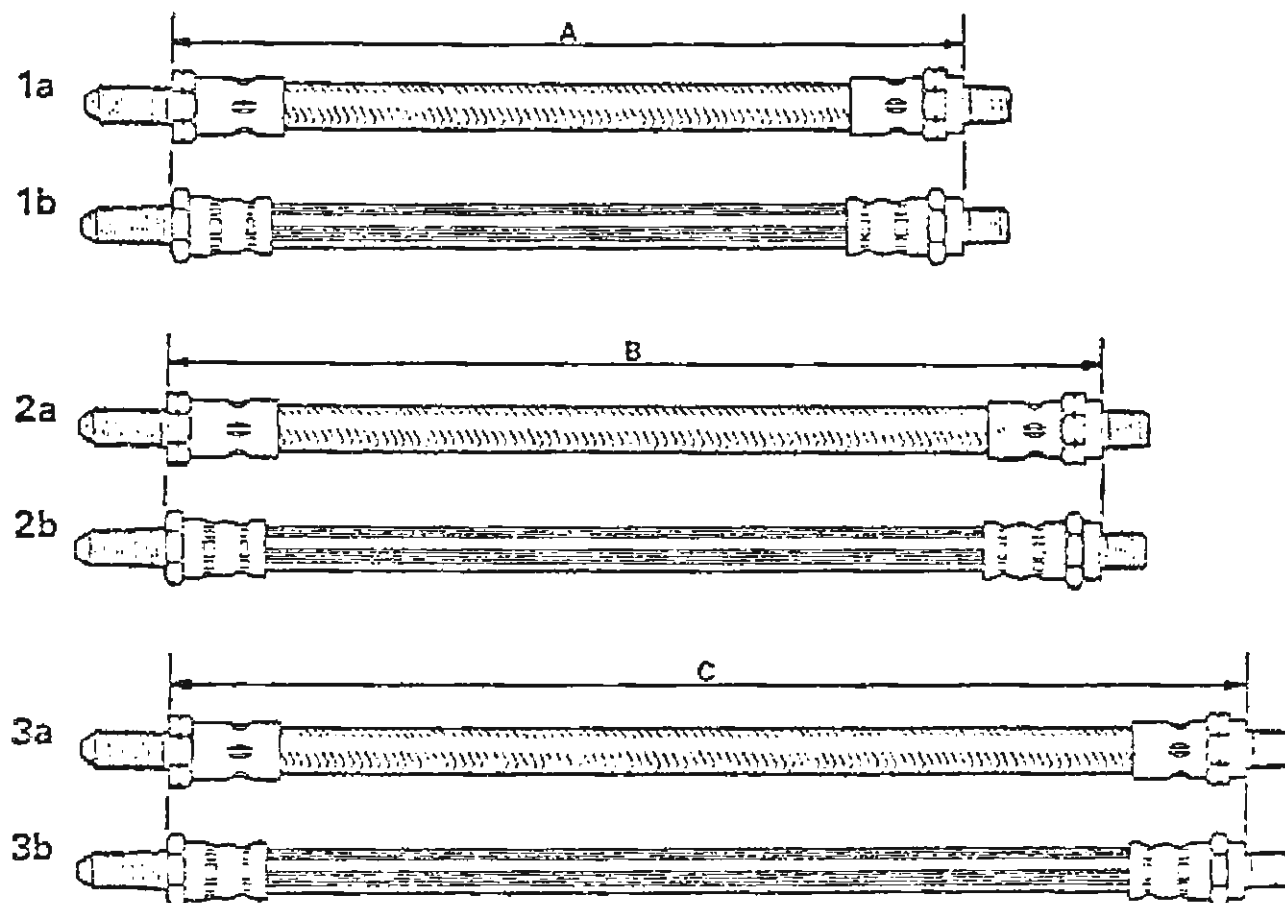
Fig. 1

The replacement hoses can be identified by the longitudinal pattern of the exterior of the tubing, as opposed to the herringbone pattern and green trace on the earlier hose. (see Fig 1.)

Refer to figure 1    Original hoses designated 1a, 2a and 3a  
                         Replacement hoses designated 1b, 2b and 3b

These hoses are of an improved material and are a direct replacement to the previous type.

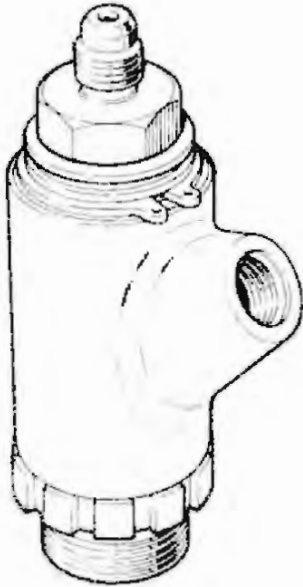
Fig. 1

Early type pump with  
hexagon outlet adapter

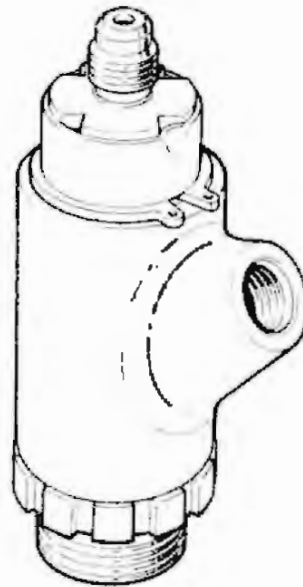
Fig. 2

Revised pump with round  
staked outlet adapter

The revised pump is a non-serviceable item except for the replacement of the pump housing 'O' rings. In the event

of a fault developing (other than leaking pump housing 'O' rings) the complete assembly must be renewed.

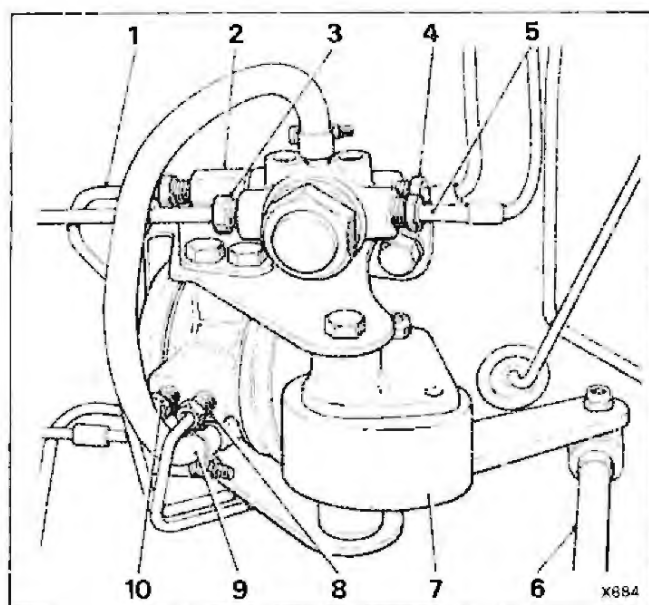
Fig. 1

A rubber drain hose is connected to the underside of the valve body at one end, and to the minimum pressure valve at the other end (see fig. 1). This enables designed oil leakage within the height control valves (necessary to provide lubrication) to be returned to the reservoirs through the return line from the minimum pressure valve (see fig. 1).

The individual valve should then be replaced on the assembly, off the car. Should a fault develop with the height control valve, it must be renewed as the valve is a non-serviceable item.

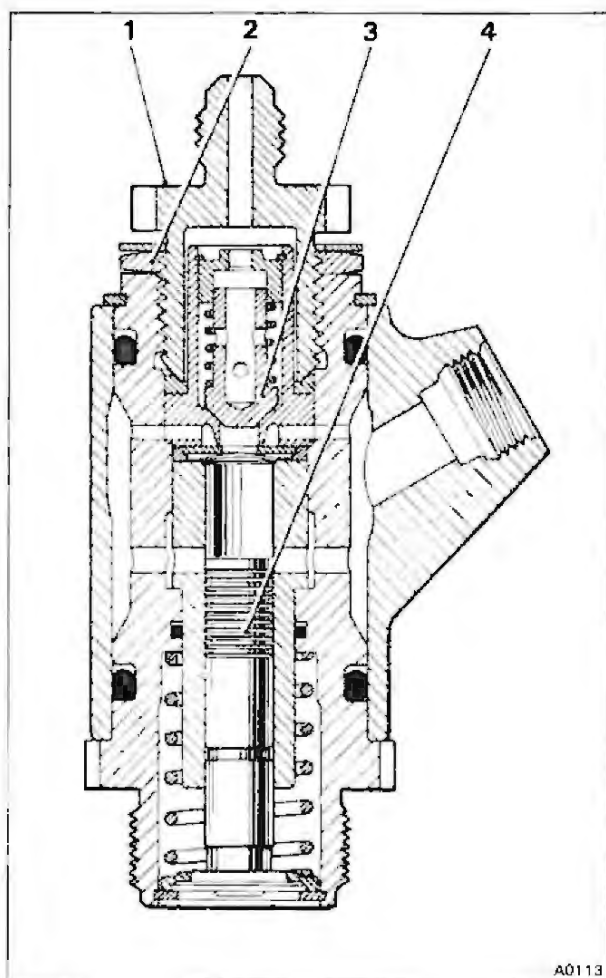
Fig. 2

A reduction in the designed mineral oil seepage has been achieved by introducing a multi-grooved pump plunger. This enables the mineral oil which seeps past the plunger and which would normally become mixed with the engine oil, to be returned to the low pressure side of the pump (see figs. 2 and 3).

The groove in the face of the non-return valve has been deleted, thereby providing a positive seal. This prevents accumulator back pressure acting upon the pump plunger when either the engine is running or stationary (see figs. 2 and 3).

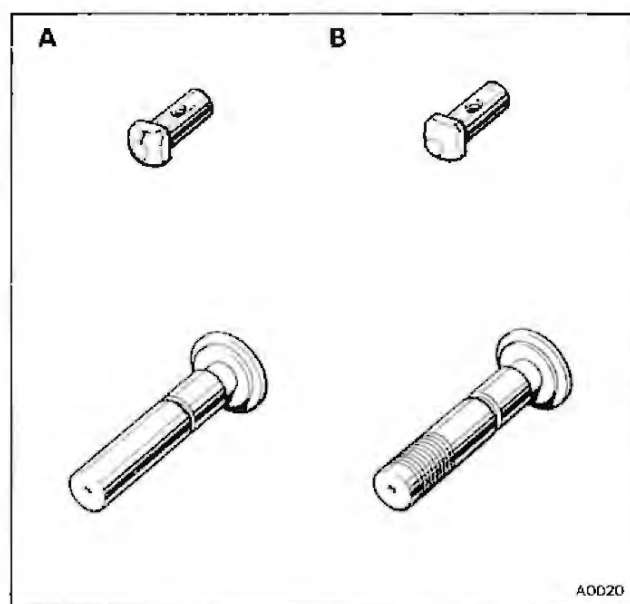
Fig. 3

- A Early Type - Grooved Non-Return Valve and Plain Plunger
- B Revised Type - Plain Non-Return Valve and Multi-grooved Plunger

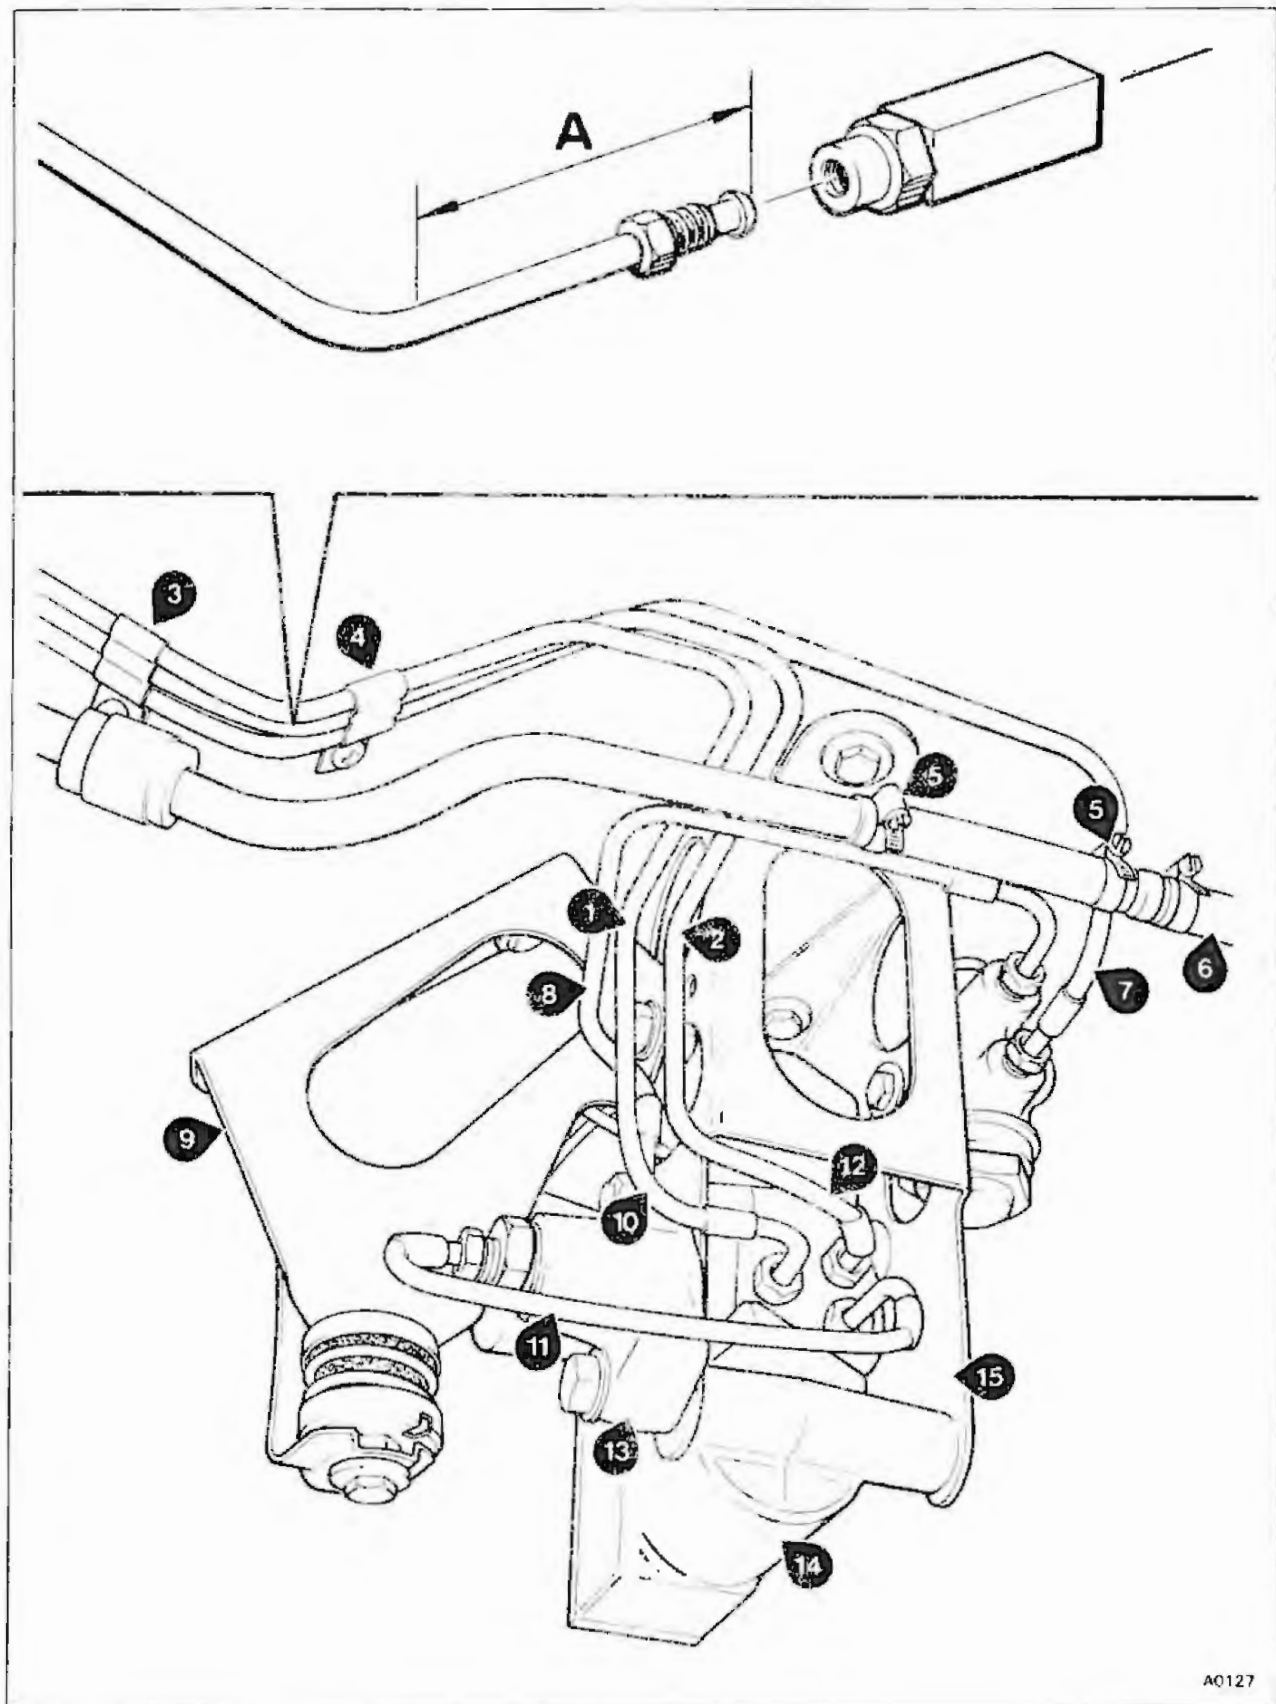
Fig. 1

Cleanliness is of the utmost importance if component failure is to be avoided. Therefore, it is imperative that the pipes are checked for the presence of swarf or dirt before making a connection.

- 12 On earlier cars without filters, cut and flare the priority valve to height control pipe (see fig. 1, item 12) at the position marked A in figure 1 i.e. 44mm (1.75 in) from the bend. The filter can then be fitted in the position indicated.
- 13 Lower the height control valve to reservoir return pipe (see fig. 1, item 10). Cut the pipe (see fig. 1, item 1), fit a unified pipe union and reflare the pipe.

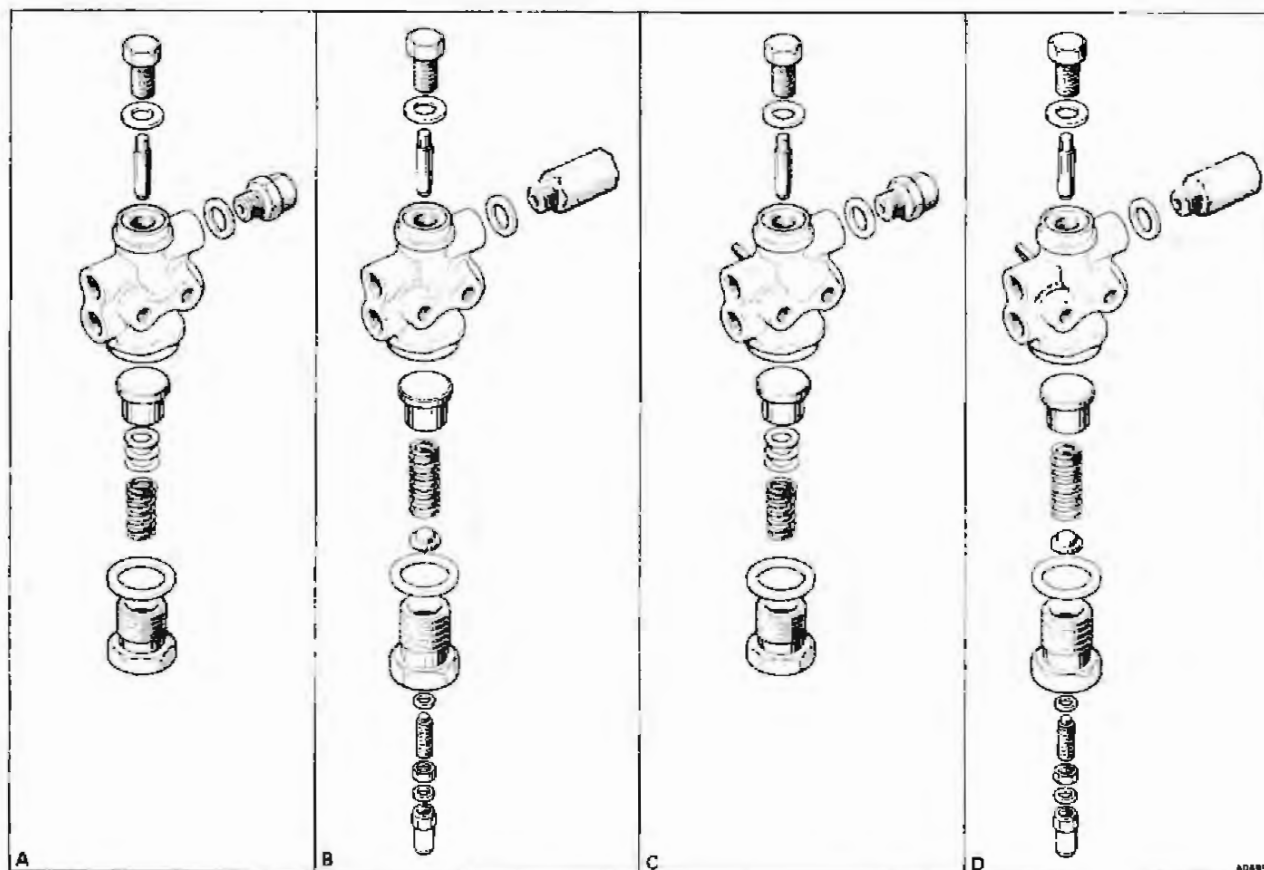
The later minimum pressure valves types B and D (see figs. 1 and 2) are similar in appearance to the earlier minimum pressure valves, types A and C (see figs. 1 and 2). As the later type of minimum pressure valves are adjustable, this enables the minimum pressure setting to be set to the required pressure, whilst the minimum pressure valve is in situ on the car.

Fig. 1 Minimum pressure valve  
A Early type  
B Later type-adjustable

Fig. 2 Minimum pressure valve  
C Early type  
D Later type-adjustable

The later valves will be supplied for all replacement purposes when existing stocks have been used up.

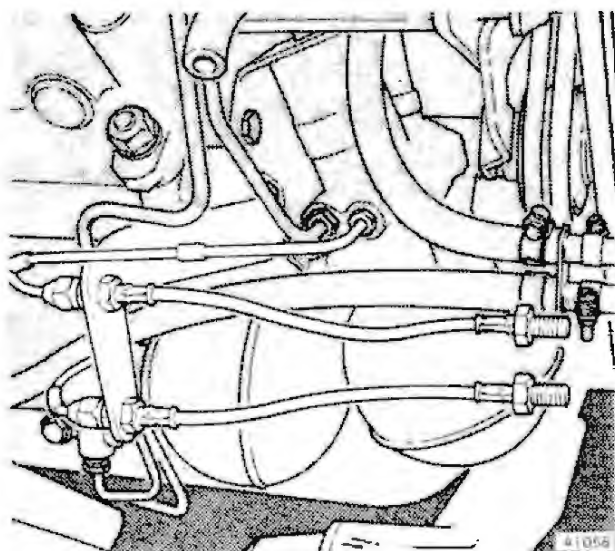
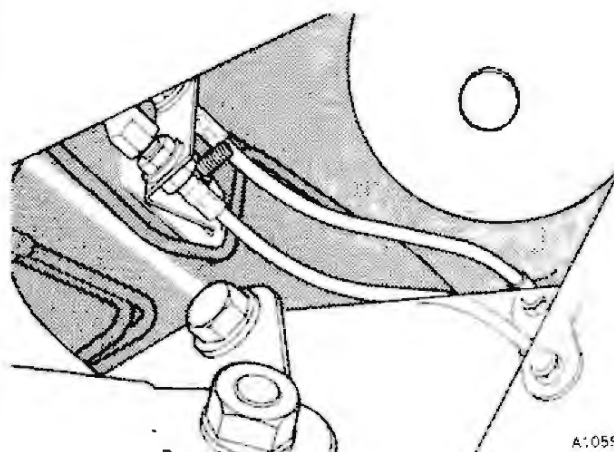
Revised high pressure hoses from engine to frame have been introduced in order to minimise the risk of leakage as a result of hose nuts relaxing in service.

The revised hoses incorporate male end fittings as opposed to the previously used female swivel nuts.

In order to accommodate the revised hoses, changes to the mounting brackets and some hydraulic pipes have been made (see figs. 1 and 2).

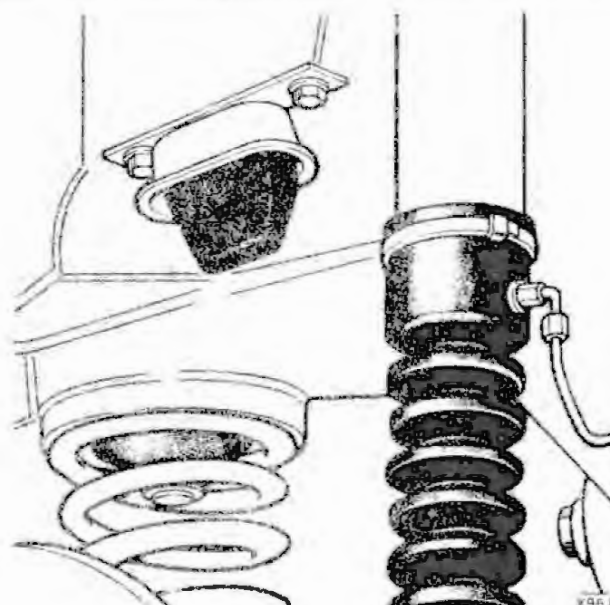
Fig. 2 Rubber bump stop

If expanded polyurethane bump stops are fitted, they are the most likely cause of the knock. They should be tested to ascertain whether further investigation is necessary.

The rubber bump stop will be issued for all replacement purposes.

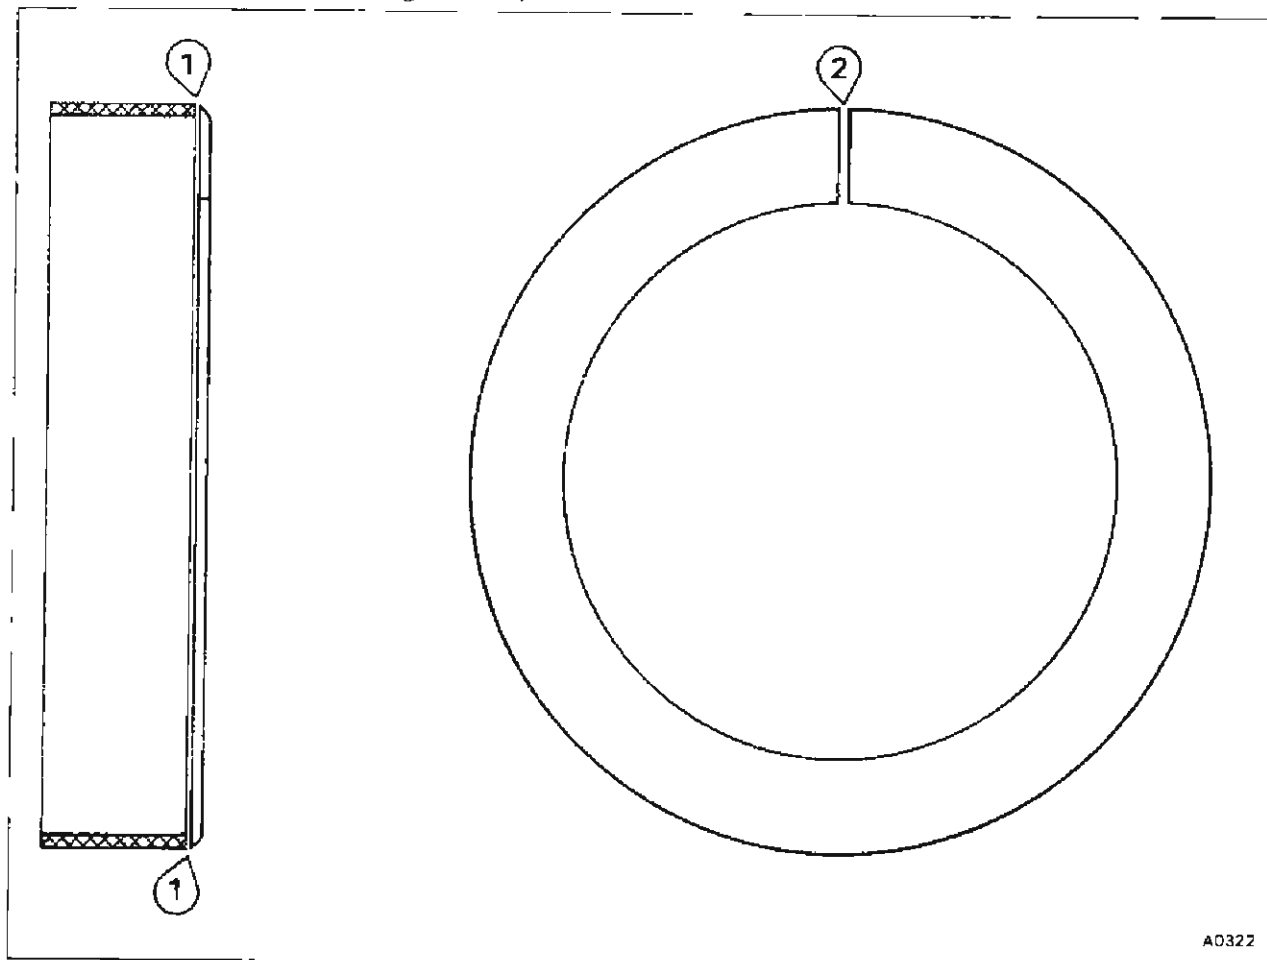
Fig. 1 Flexible spring seat

The noise is produced when the chamfered ends of the first coil make and break contact with the second coil of the spring. In order to eliminate this condition, it has been necessary to remove the chamfered part of the spring leaving the ends cut square.

- 1 Remove the rear road spring as described in the relevant Workshop Manual.
- 2 Decompress the spring using service tool numbers RH 7909 and RH 9504.
- 3 Obtain four flexible rear road spring seats (part number UR 20847) remove the rim, then cut the remaining flat circular washer as illustrated in figure 1, items 1 and 2.

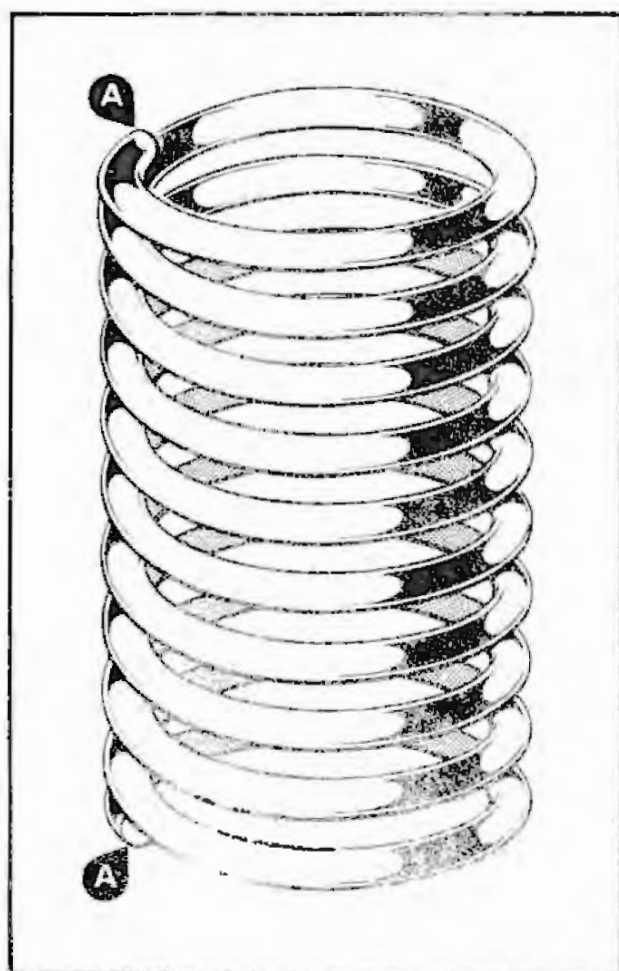
Fig. 2 New Spring

A Square cut coil ends

The new spring will be supplied for all replacement purposes.

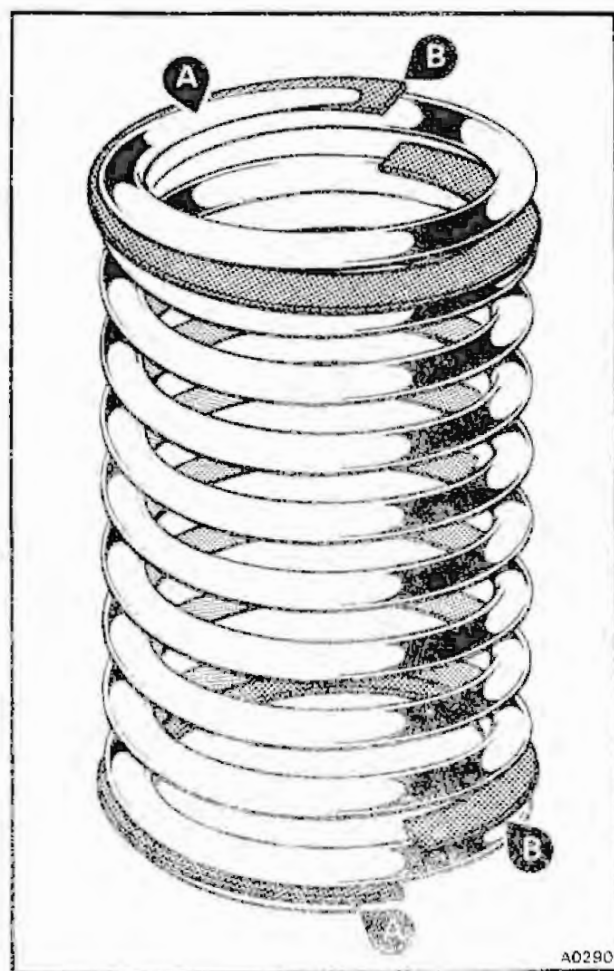
Fig. 3 Early Spring

A Chamfered coil ends  
B Flexible washer

- 4 Place the flexible washers between the first and second coils at each end of the springs (see fig. 3).
- 5 Compress the springs, and refit them to the car.

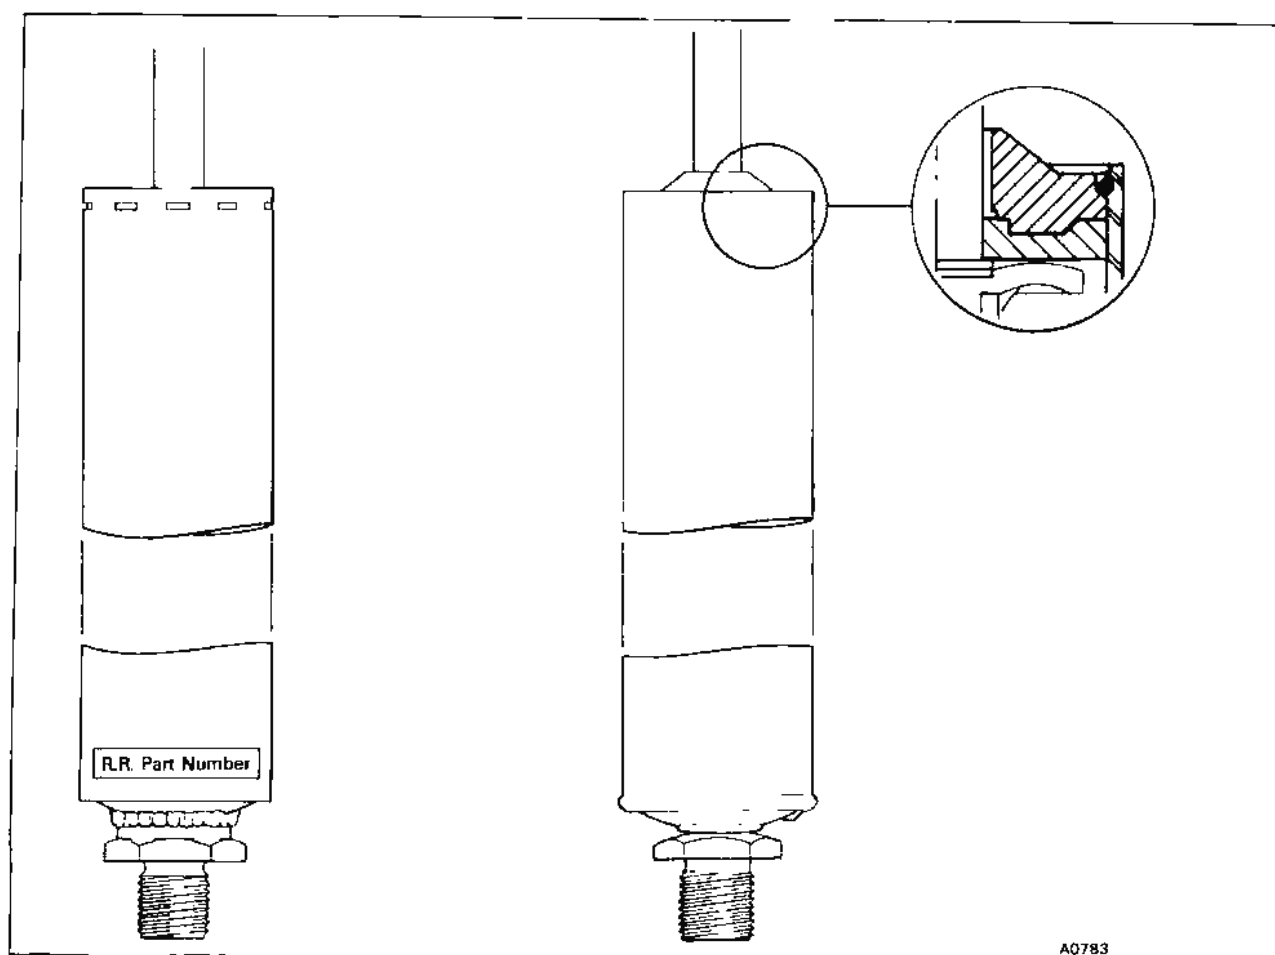
The new damper can be identified by the part number which can be found on the lower periphery of the damper and by the crimping at the top of the damper (see fig. 1).

The old type damper can be identified by an internal circlip at the top of the damper (see fig. 1).

This information sheet is to advise service personnel that an alternative damper is available and will be supplied for all replacements.

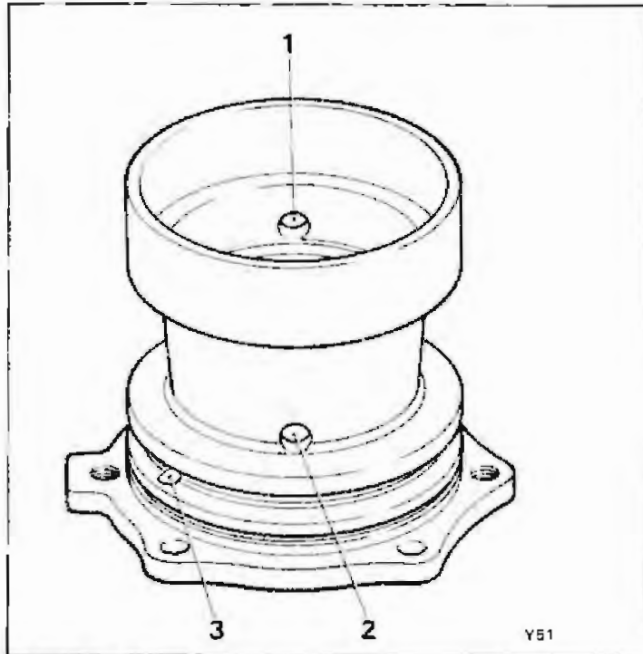
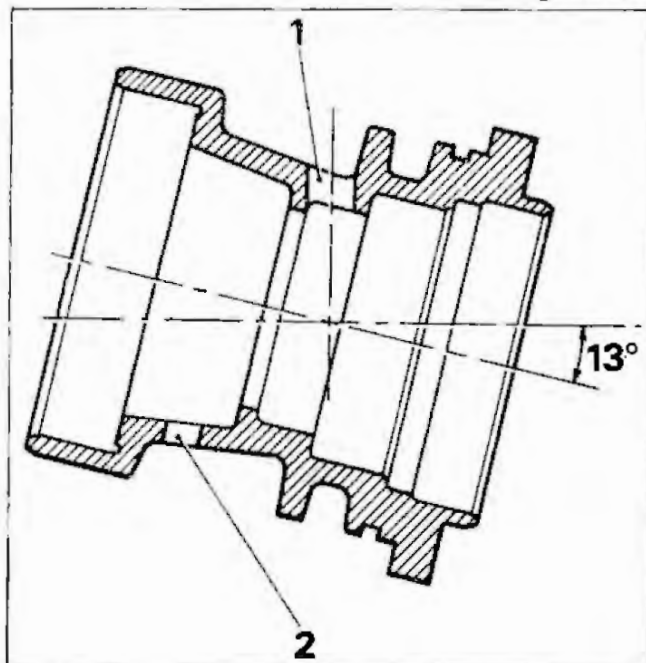
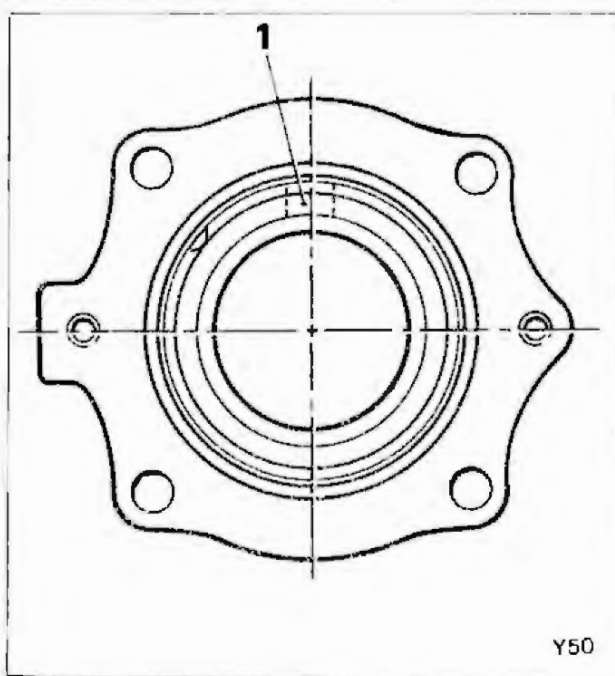
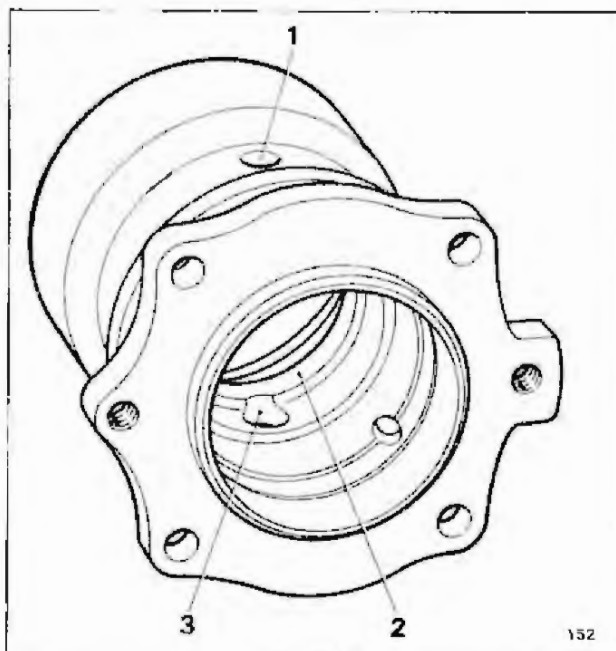
- 1 Oil delivery hole - pinion centre bearing
- 2 Oil delivery hole - pinion tail bearing
- 3 Oil return hole - pinion tail bearing

- 1 Oil delivery hole - pinion tail bearing - drilled at revised angle.
- 2 Oil delivery hole - pinion centre bearing

- 1 Position of oil delivery hole when secured for drilling.

- 1 Oil delivery hole - pinion centre bearing  
2 Wall of oil reservoir - tail bearing  
3 Revised oil delivery hole - tail bearing

5 Ensure that the hole is free of burrs and swarf.

6 Thoroughly clean the housing and reassemble.
