## **Service Information**

**Rolls-Royce & Bentley  
motor cars**

TSD 4446

## SERVICE INFORMATION SHEETS INDEX FOR TSD 4446

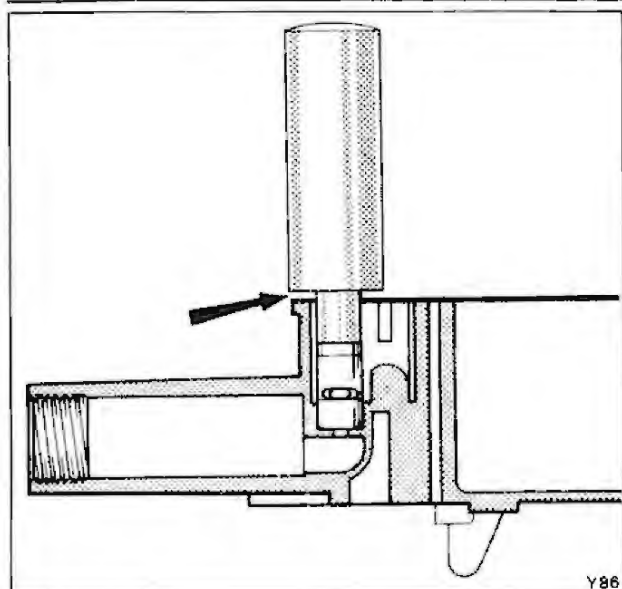
| Number | Description | Time |

When dealing with complaints of 'poor engine performance' and 'poor idle qualities', and all standard checking and setting procedures have been exhausted, the problem may be due to the carburetter float needle valve seating being loose. The problem mainly manifests itself during high ambient operating temperatures.

Using mandrel to check correct height of needle valve seat. Mandrel should be flush with the top of the carburetor body

- 1 Remove the carburetter cover and gasket.
- 2 Remove the float and needle valve assembly.
- 3 Check the height of the valve seat in the carburetter housing (see fig. 1) with a mandrel. Should the face of the mandrel not rest flush with the surface of the carburetter housing, then the seat has loosened and will have to be removed. In some cases it is necessary to thread the seat using an 8mm screw. Blow out the seat housing in both directions and also the entire float chamber, then remove all traces of swarf or dirt.
- 4 There are two sizes of oversize valve seats. The correct oversize seat can be determined using the grooved plug gauge (see fig. 2B). Each seat can be identified by either one or two annular grooves.

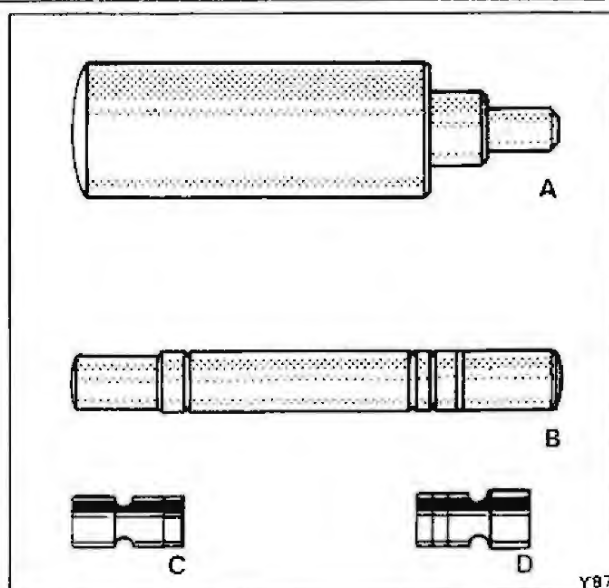
Fig. 2

A = Mandrel  
 B = Plug gauge (each end identified by:  
 One groove - oversize 1  
 Two grooves - oversize 2  
 C = Oversize seat - 1 groove  
 D = Oversize seat - 2 grooves

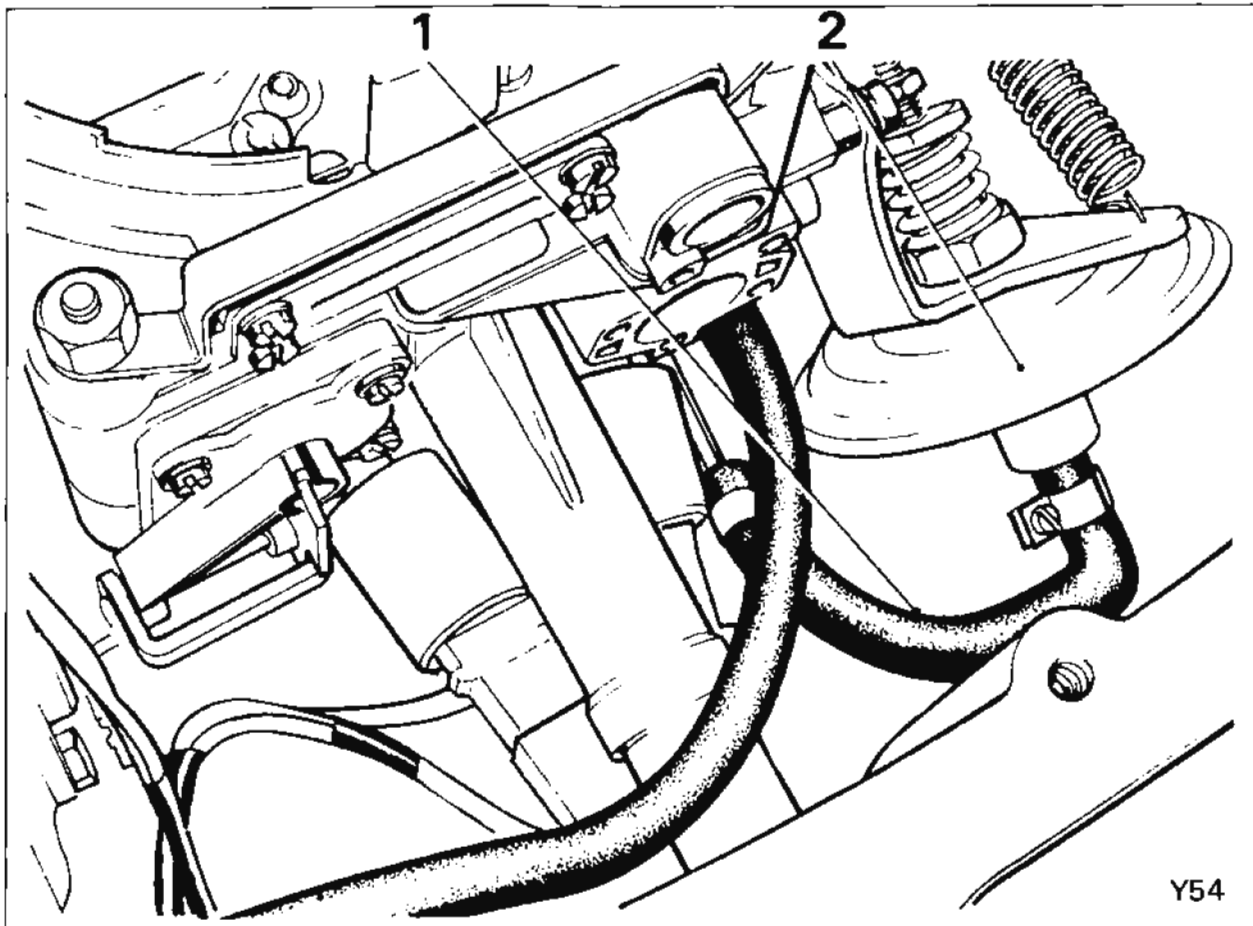
There have been a number of complaints in service of the throttle jack/damper vacuum signal hose splitting. This is caused by the severe angle that the hose is required to adapt to. To overcome this, a new moulded rubber hose has been introduced instead of the straight hose used on earlier cars (see fig. 1).

A split or cracked hose will result in the engine running at a fast-idle speed, and could cause the engine to 'run-on' when the ignition is switched off.

Fig 1 New throttle jack/damper vacuum signal hose

The new hose will be issued for all replacement purposes.

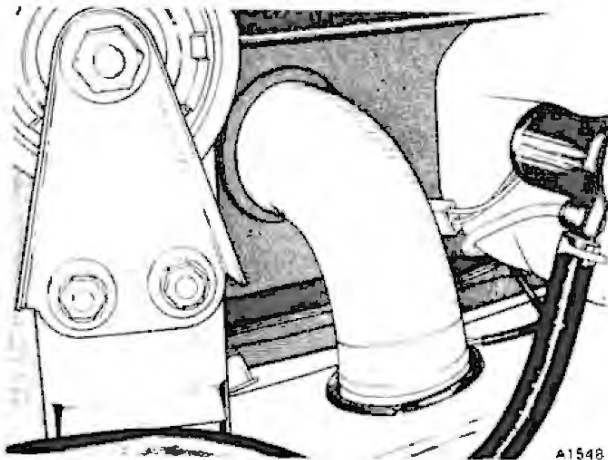
Fig. 1 Cold air pick-up hose - Right-hand side front wing

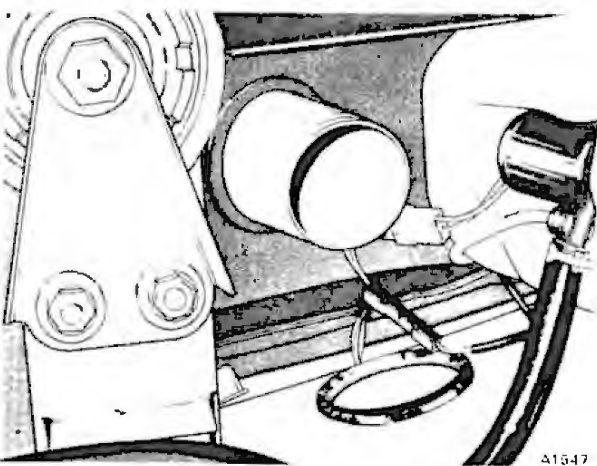
Fig. 2 Revised cold air pick-up hose - Right-hand side front wing

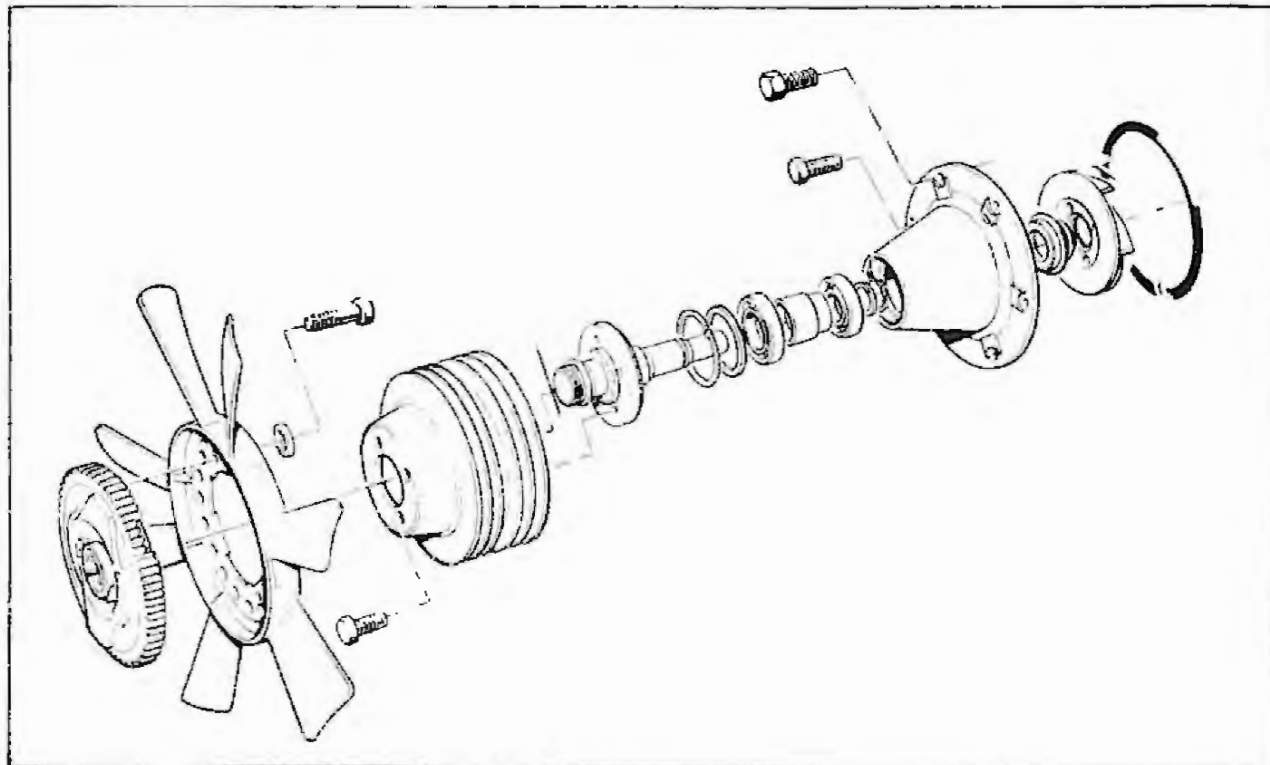
Fig. 1

The coolant pump spindle has been modified to provide a threaded location for the viscous coupling.

It should be noted that in this new arrangement the viscous drive is mounted forward of the fan assembly (see fig. 1).

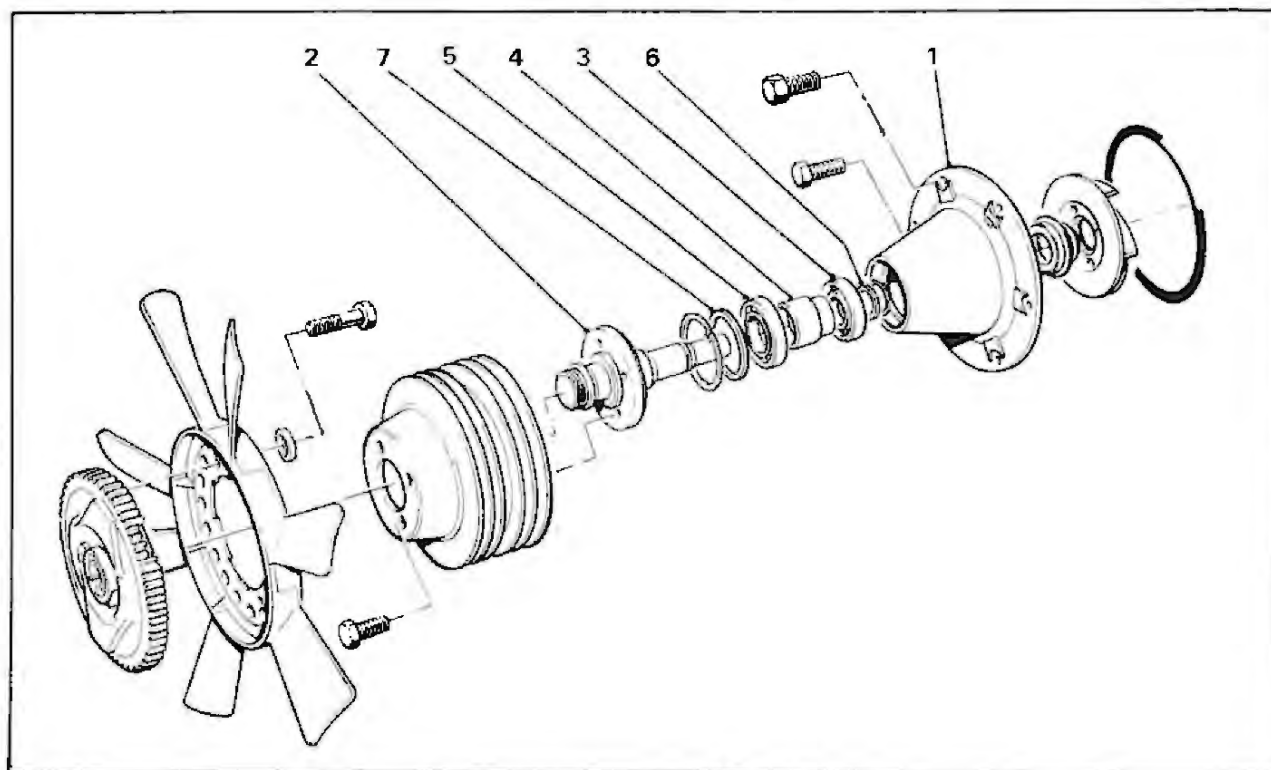
Fig. 1

The new impellor assembly, features bearing races which are sealed for life. To accomodate the new bearings it has been necessary to modify the bearing housing and the pump spindle. (see fig. 1).

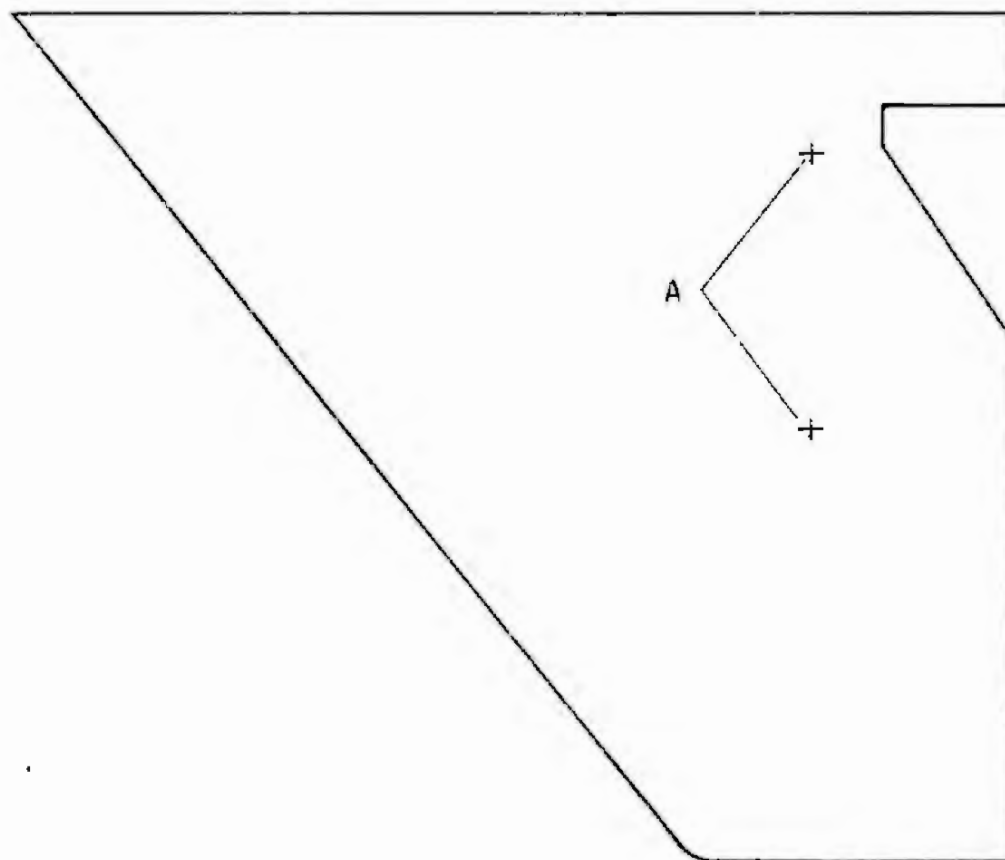
Fig. 1 Template

A 2 holes 8 mm (0.312 in) dia.

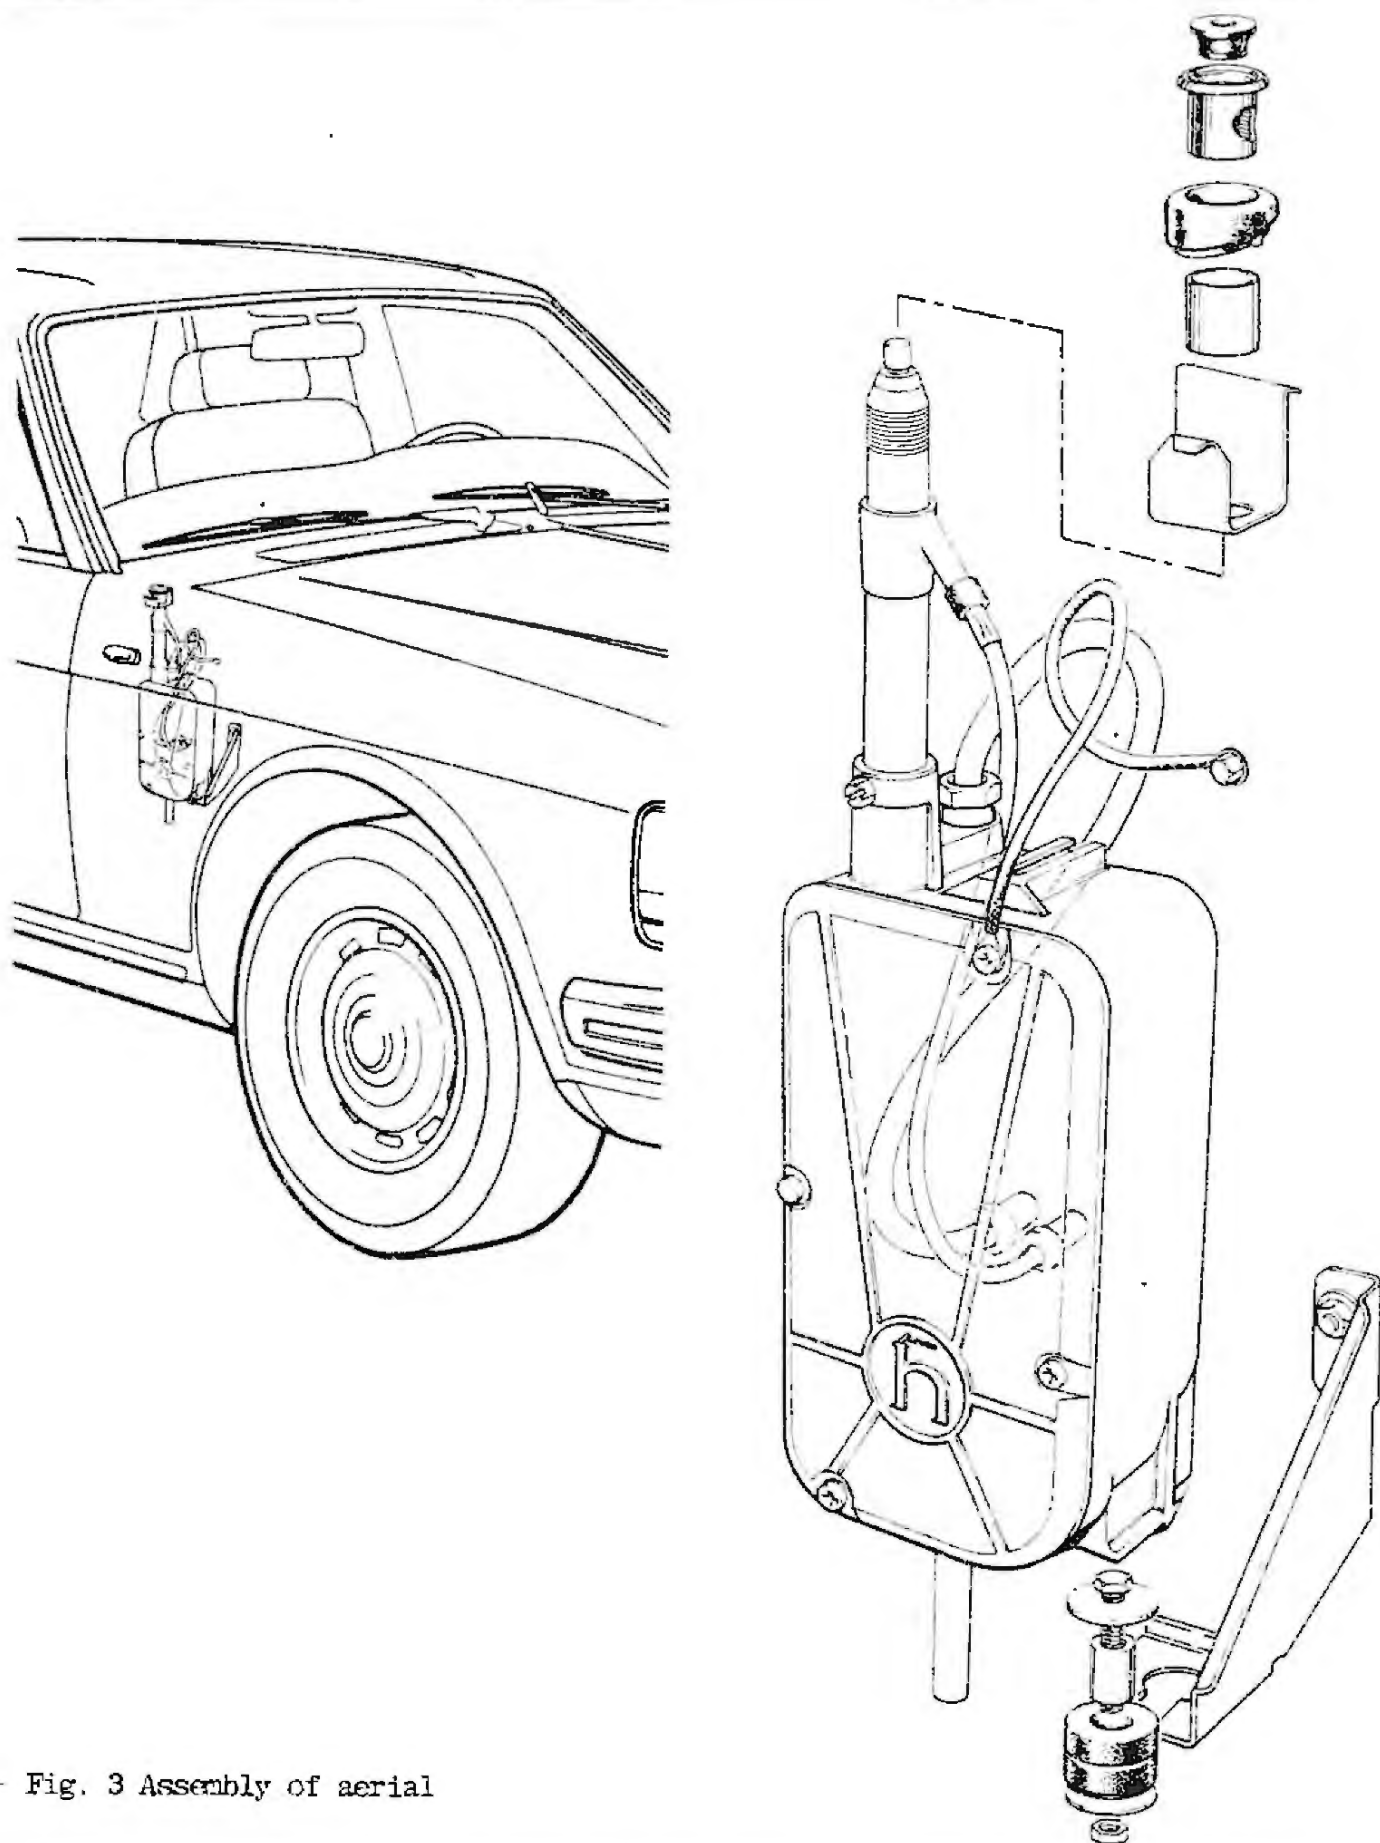
- Fig. 3 Assembly of aerial

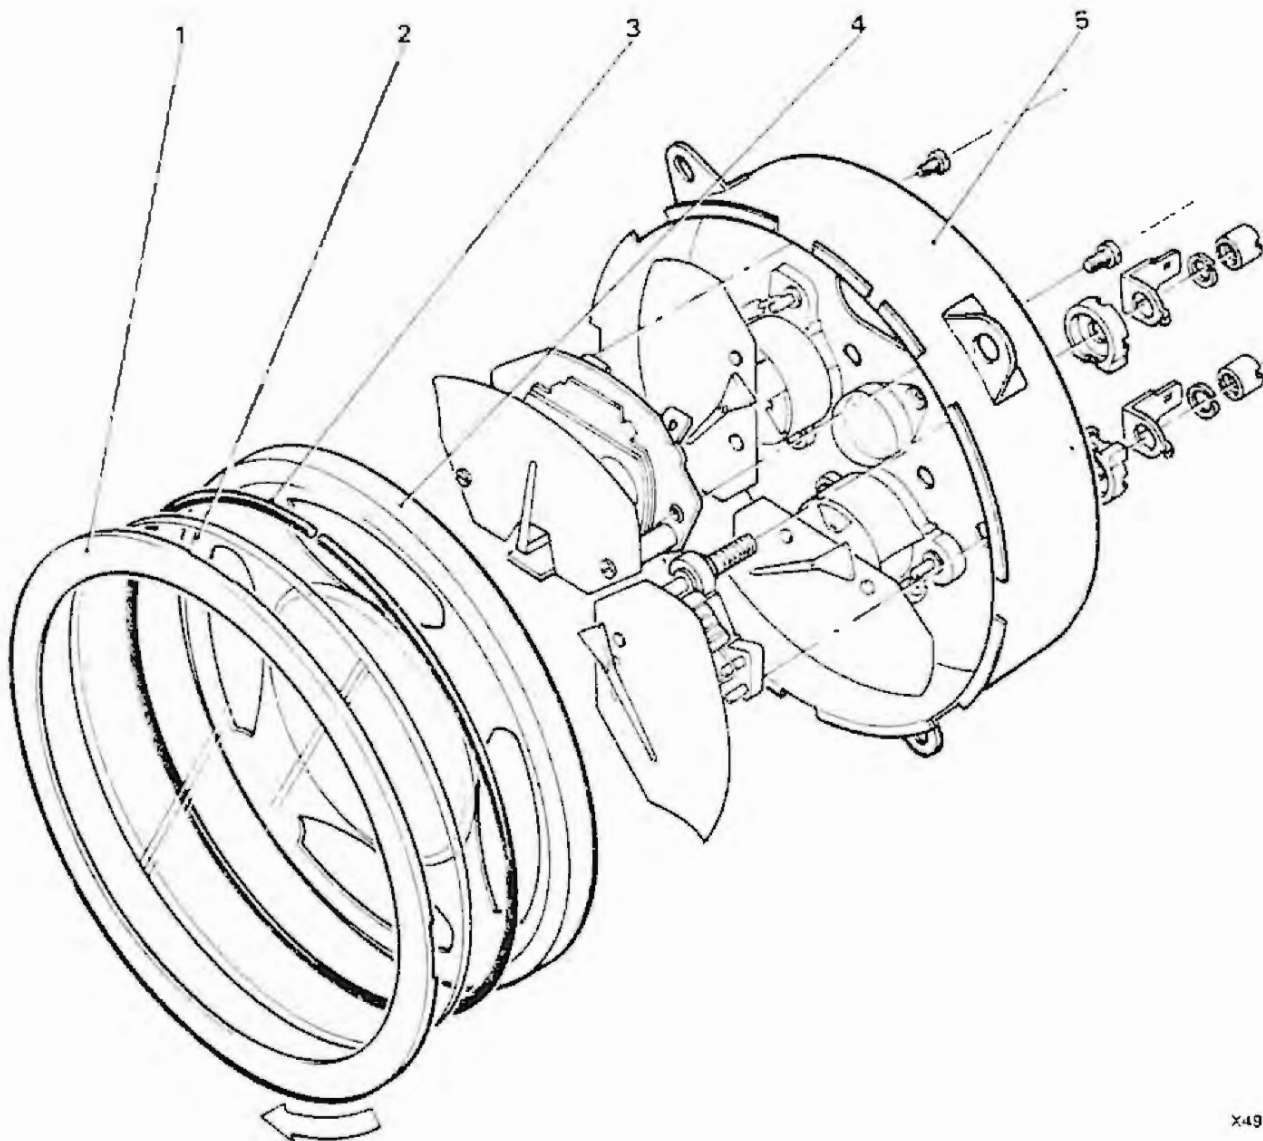
Fig. 1  
1 Bezel  
2 Glass  
3 'O' ring seal  
4 Face plate  
5 4 in 1 instrument case

- 1 Remove the bezel by rotating it clockwise until the metal tongues align with the cut-outs in the case (see fig. 1).
- 2 Remove the glass, 'O' ring seal, and the face plate from the 4 in 1 instrument.
- 3 Remove the appropriate gauge by releasing either screws or nuts from the rear of the 4 in 1 instrument case as shown in figure 1.
- 4 Carefully fit the new gauge.
- 5 Ensure that no dirt or foreign bodies are present in the 4 in 1 instrument case or on the inner face of the glass and the face plate.
- 6 Replace the face plate, 'O' ring seal, glass, and bezel.

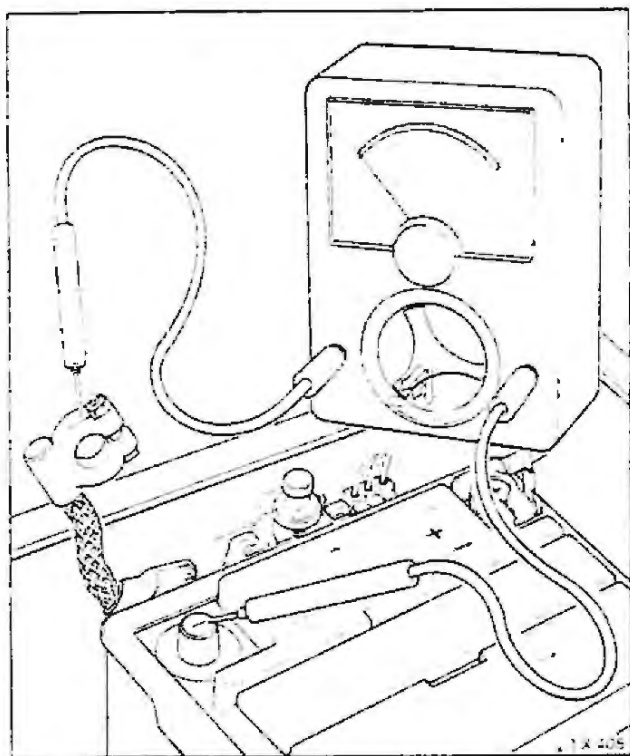
Fig. 1 Measuring battery current drain

6. The current drain with all the electrical systems switched off should be between 30-40 mA.
7. If the current drain is appreciably more than 40 mA the source must be determined and the fault rectified.
8. Disconnect the battery.
9. Remove the right-hand side trim panel from the luggage compartment to provide access to the alternator regulator.
10. Remove the trim panel from the luggage compartment bulkhead.
11. Remove the left-hand side trim panel from the luggage compartment.
12. Remove the rear seat cushion and squab.
13. Remove the left-hand tread plates and body loom covers.
14. Remove the left-hand footwell trim panel.
-

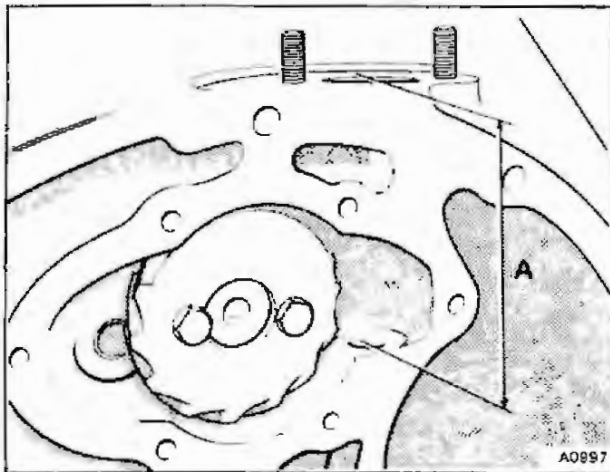
Fig. 1

In order to maintain the correct meshing of the distributor drive gear with the camshaft driving gear, it has been

necessary to increase the dimension on the crankcase taken from the base of the distributor drive bore to the distributor mounting face (see fig. 1).

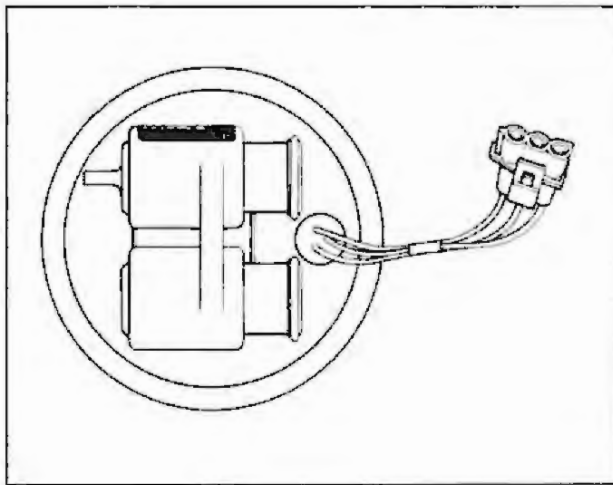
Fig.1 Revised bellows

The new bellows will be supplied for all replacement purposes on cars having a seventeen digit vehicle identification number.

If a new bellows is used to replace the previous type, then it will also be necessary to change the speed control box for the later type. Failure of the early type speed control box may result if it is used in conjunction with the later type of bellows.

When replacing an early bellows with the later type, a fitting kit, RH 9766 will be required to modify the engine loom to a three-pin type socket, using the following procedure. It will also be necessary to replace the earlier type speed control box with a unit of the later design (UD 25279).

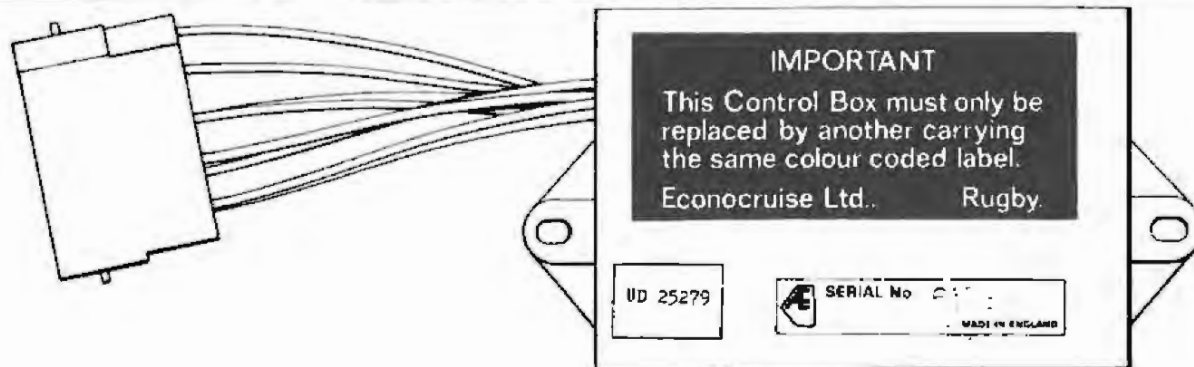
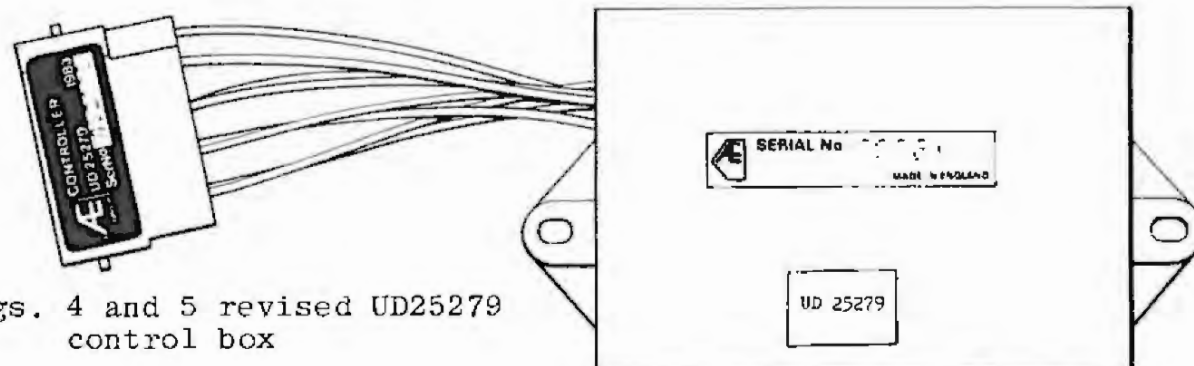
Figs. 4 and 5 revised UD25279 control box

The revised speed control box may be used with either an early or later bellows, and will be supplied for all replacement purposes.

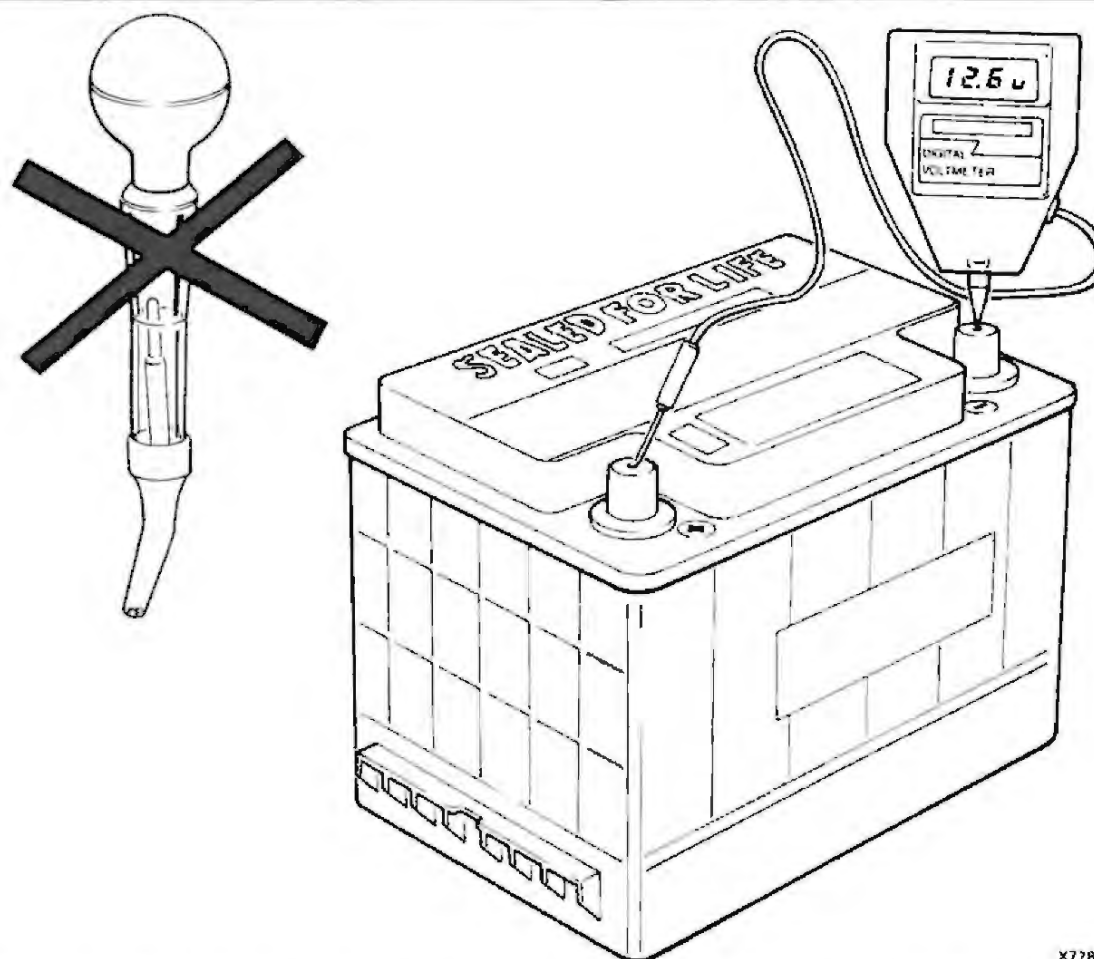
Fig. 1 Digital voltmeter measuring battery terminal voltage

BEFORE TAKING BATTERY VOLTAGE READINGS, IT SHOULD BE NOTED THAT A BATTERY WHICH HAS BEEN RECENTLY CHARGED MAY POSSESS A SURFACE CHARGE ON THE BATTERY PLATES. THIS SURFACE CHARGE MUST BE REMOVED TO AVOID MISLEADINGLY HIGH VOLTAGE READINGS BEING RECORDED.

It will be necessary to use a digital voltmeter or multi-meter (accurate to within 0.1 volts) to measure the voltage at the battery terminals.

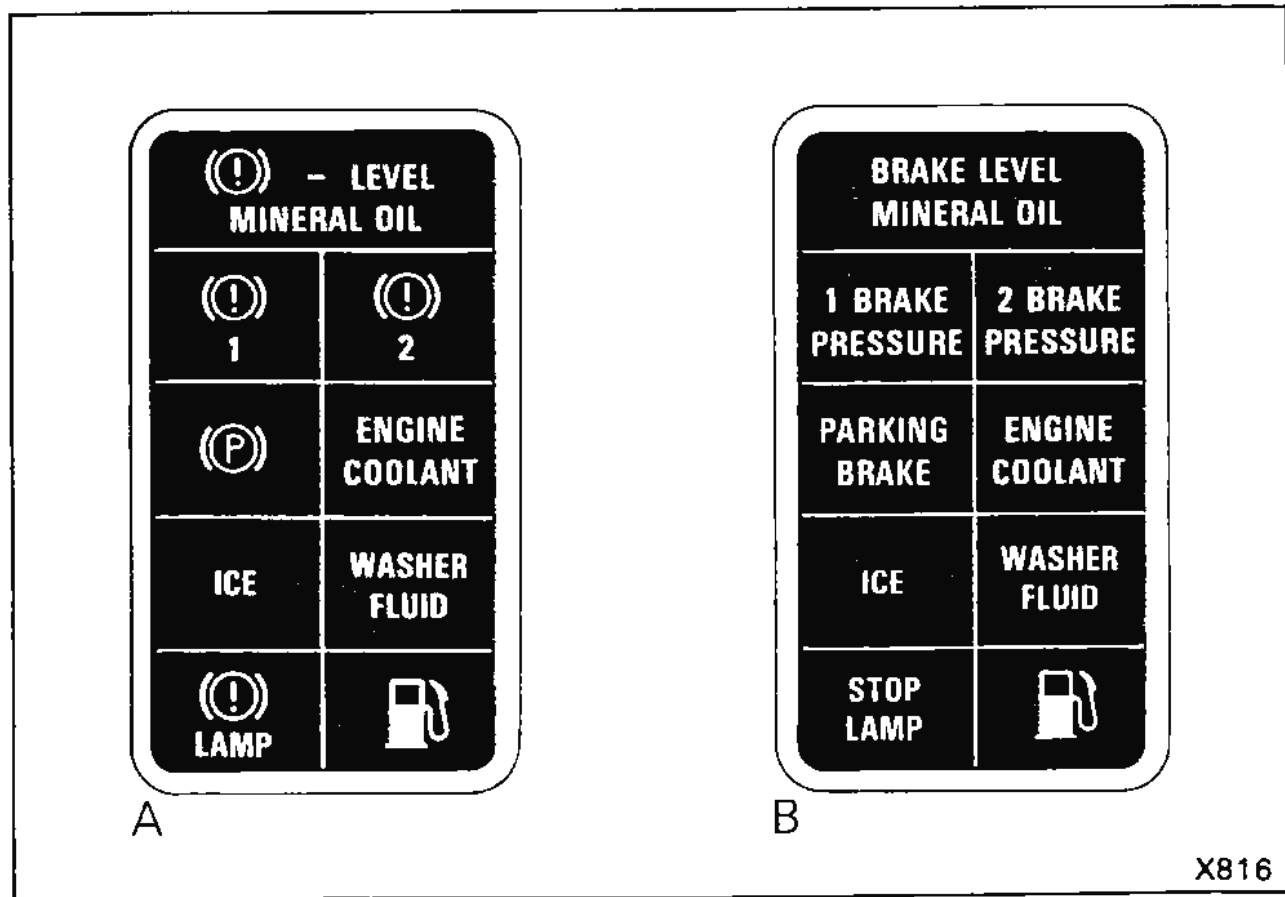
Fig. 1 Warning Panels

Wiring changes have been introduced to the dashboard warning lamp circuits. To coincide with these changes, the layout of the warning lamp cluster has also been altered (see fig. 1, items A and B).

- A Cars other than those conforming to an Australian and North American specification.
- B Cars conforming to an Australian and North American specification.

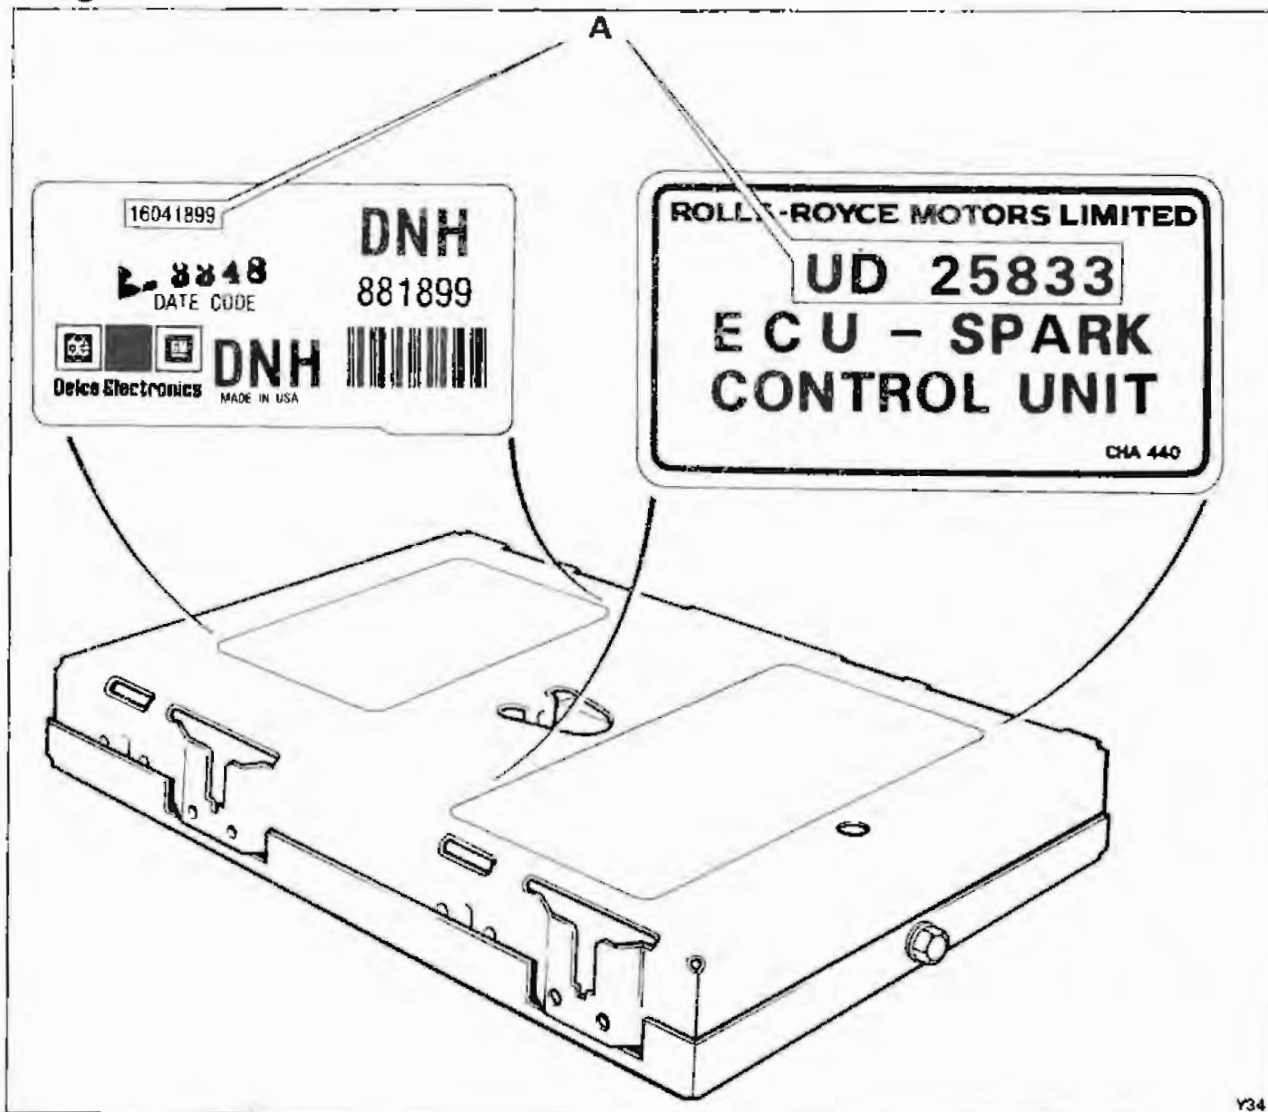
Fig. 2 A = Part Numbers

The early type electronic control unit (ECU) will carry a Delco Electronics label bearing the part number 16006764. The latest type ECU will also carry a Delco Electronics label, but bearing the part number 16041899 (see fig. 2,A).

As further identification, the majority of the later units will also carry a Rolls-Royce label, bearing the part number UD 25833 (see fig. 2).

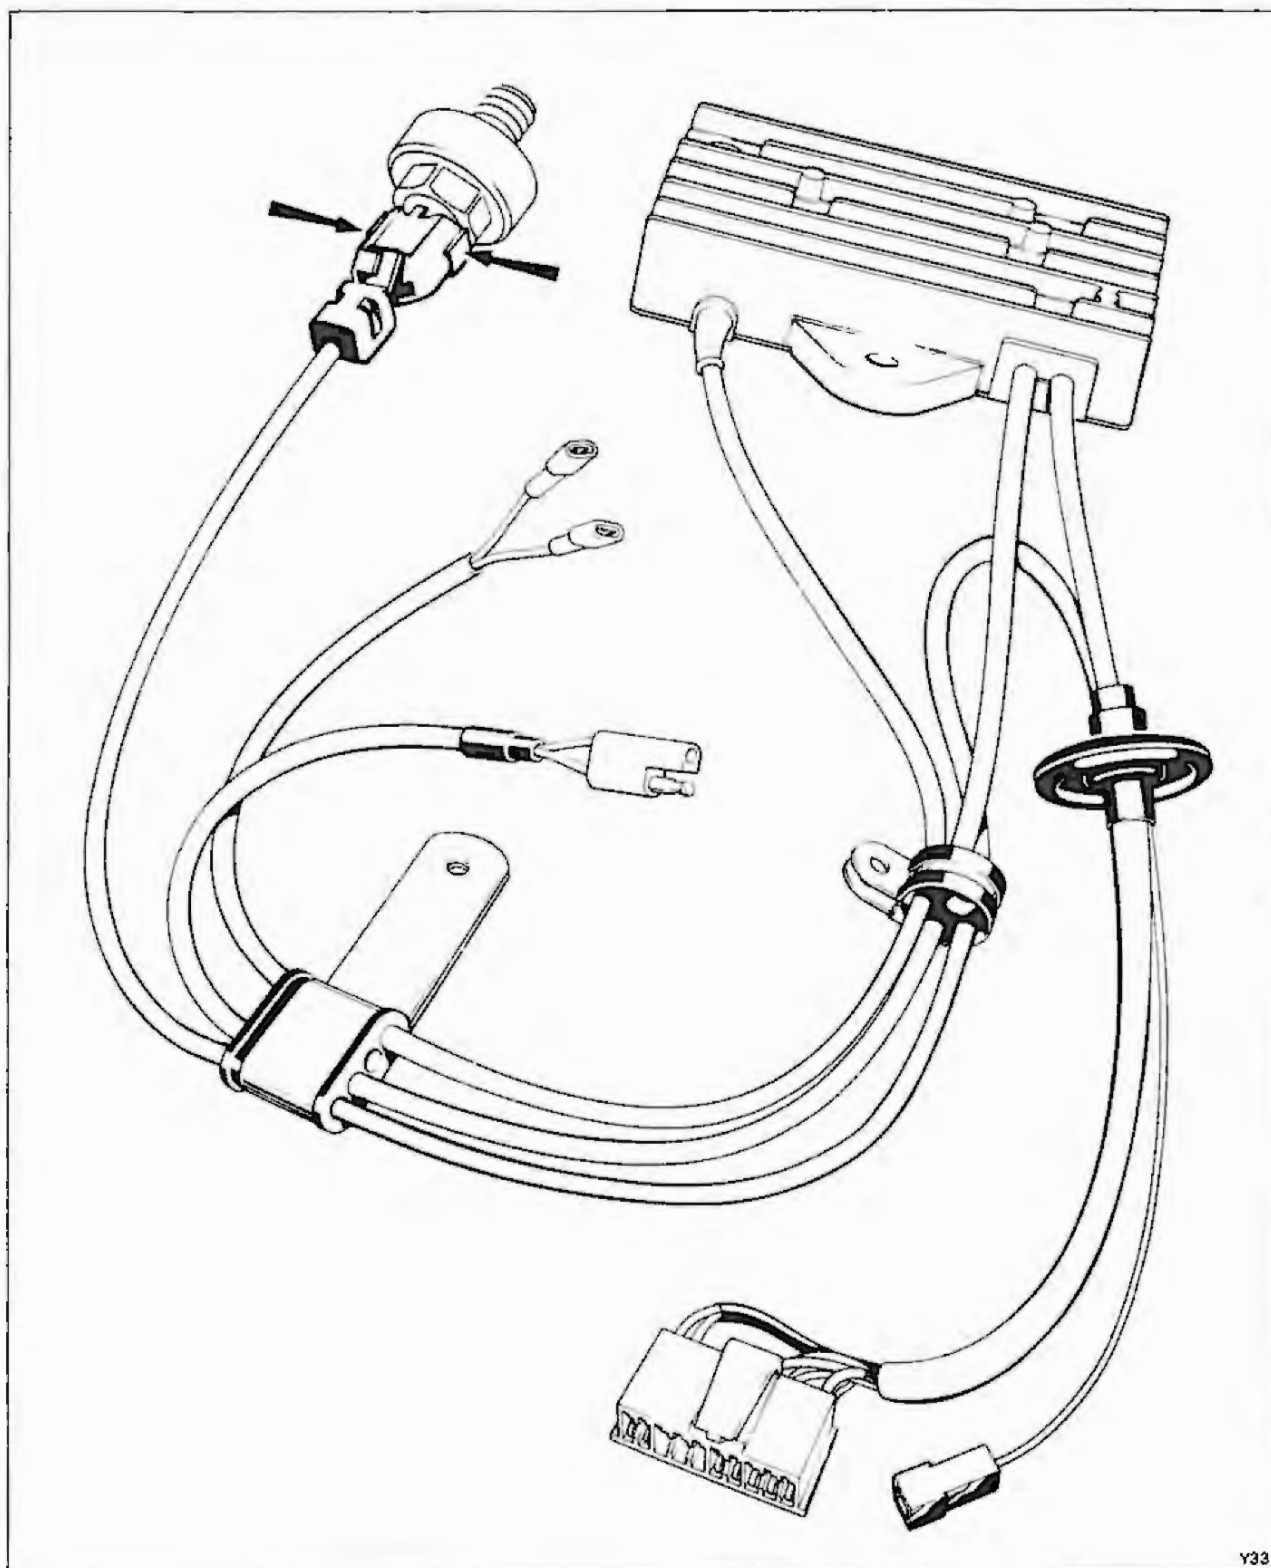
Fig. 3

- 3 Ignition Amplifier Assembly - Recognized by the special connector which will only fit the new type Knock Sensor (see fig. 3, Arrows).

UNDER NO CIRCUMSTANCES MUST DISPLACED PARTS AND NEW PARTS BE FITTED TOGETHER ON THE SAME CAR. FAILURE TO OBSERVE THIS INSTRUCTION CAN RESULT IN ENGINE DAMAGE.

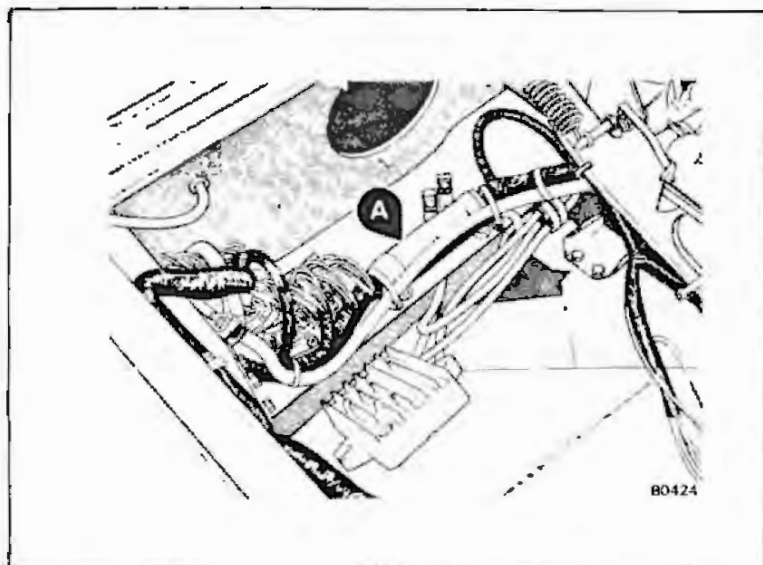
Fig. 1A Protection - Engine wiring loom

There have been isolated instances where a heater system coolant leak has indirectly resulted in a gearbox actuator failure. This has been caused by leaking coolant running down the inside of the wiring loom sleeving. The coolant has then drained into the actuator mechanism causing corrosion and eventual failure.

6. Cut rubber tubing to length and position over the loom as shown in fig. 1(A).
7. Fit new clips around rubber tubing and screw into position using the original retaining holes.
8. Reverse procedures 1 to 4.
9. Check the washer pump and blower motor operation.

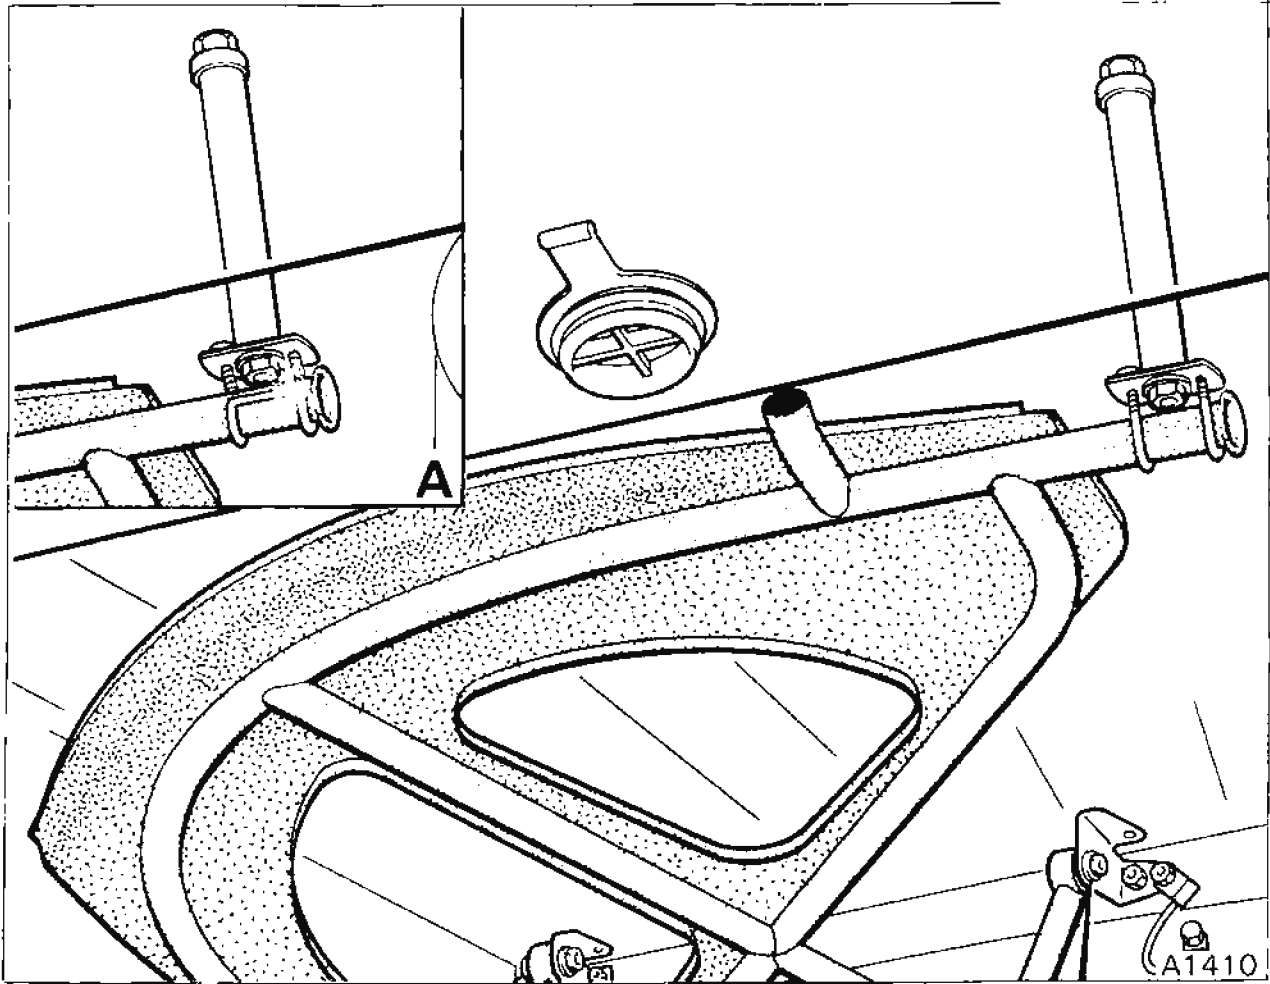
Fig. 1 Spare wheel carrier

A Correct position of lowering screw hook assembly

To alleviate this possibility, the hook is now fitted to the carrier pan with the 'open' side facing REARWARDS (see fig. 1, inset A). This is achieved by simply rotating the lowering screw and hook assembly 180° before attaching it to the pan.

Will Service Personnel please check that all Turbo 'R' motor cars that enter their workshops have the lowering screw hook attached to the pan in this manner.

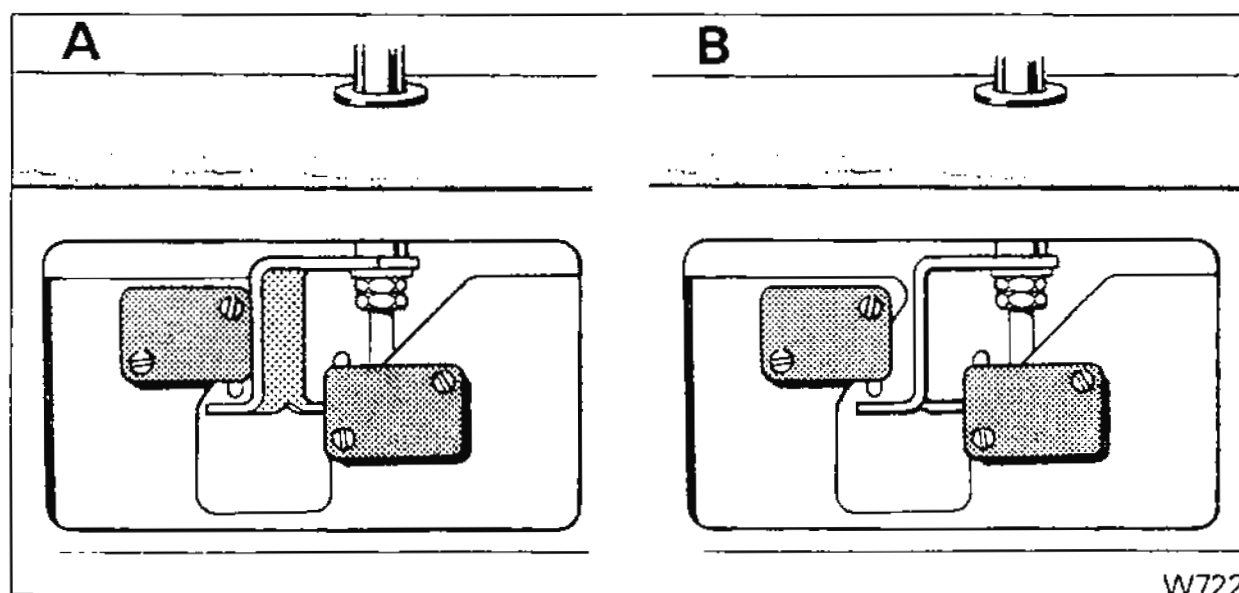
Fig. 2

The centralized door locking flag bracket can vibrate against the micro-switches and rattle on the centralized door locking rod. (see fig. 2).

A - Incorrect fitting

Release the two 3BA nuts securing the flag bracket and centralize the flag bracket between the two micro-switches. Make sure that when the two 3BA nuts are secure, the flag bracket operates the micro-switches correctly (see fig. 2). Apply a small amount of bonding agent such as Seelastik or Loctite around the guide hole in the flag bracket and centralized door locking rod (see fig. 3).

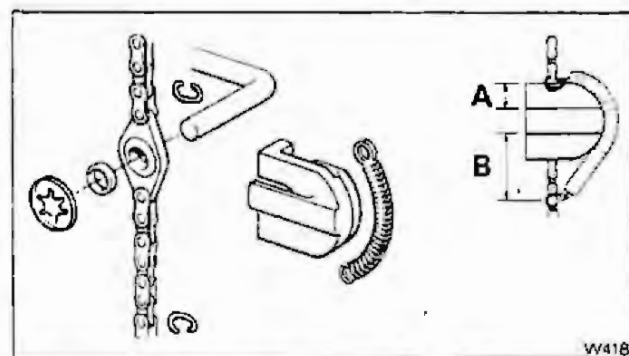
Fig. 7 A Approximately 12,50 mm (0.50 in)  
B Approximately 34,0 mm (1.30 in)

Remove the 7/16 AF nut and washer (see fig. 6, item 1) securing the guide plate and slide the plate to one side; bow the guide plate slightly along its length and refit (see fig. 6). At the same time make sure that the chain tension spring is fitted correctly (see fig. 7).

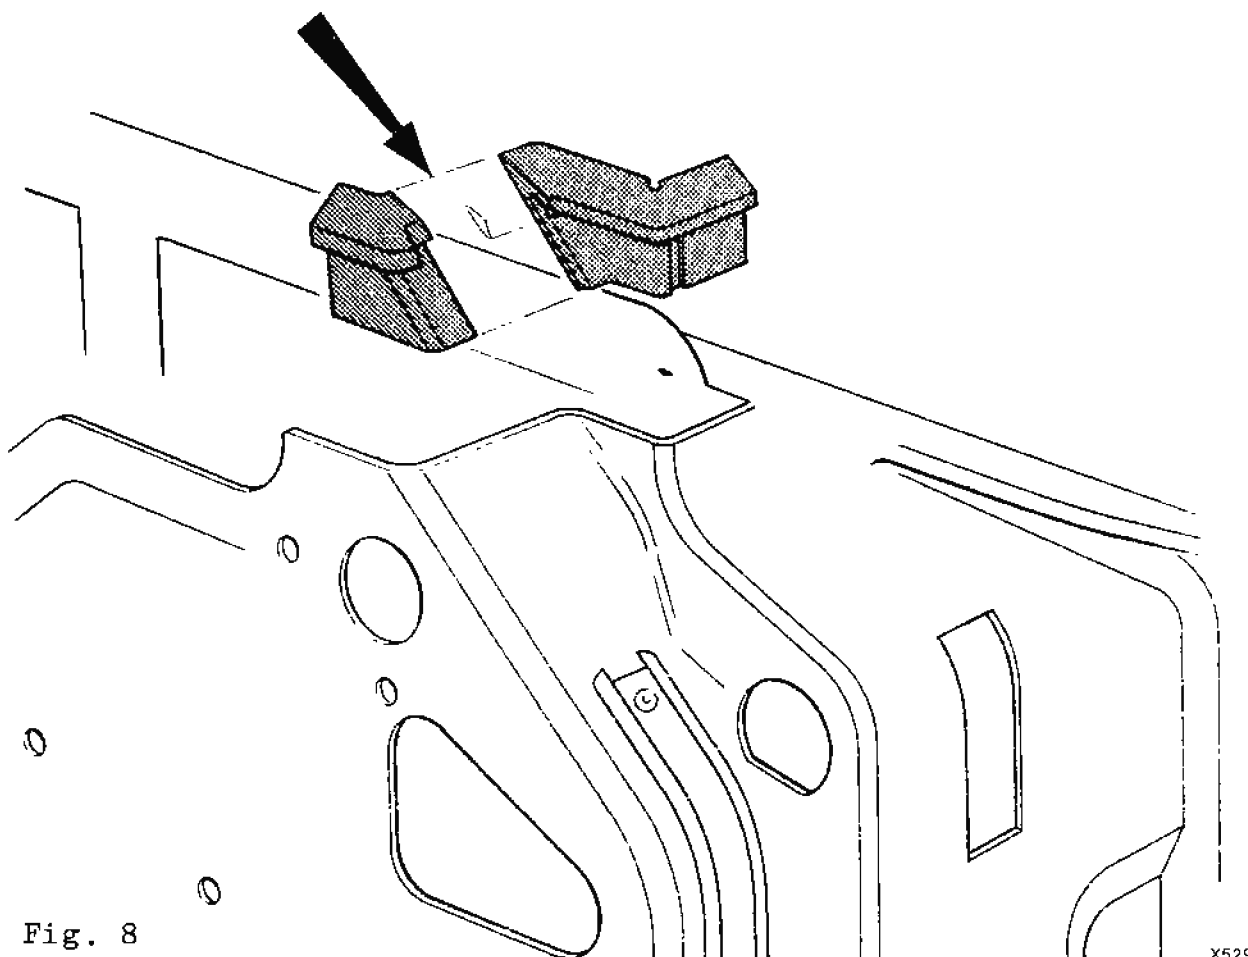
Fig. 8

18. Refit the window frame leg seal and position the frame in the door. Check the window frame front leg fits flush on the door panel, if not, this is due to the frame front seal fouling and it may be necessary to remove a portion of this seal (see fig. 8).
