## **Service Information**

**Rolls-Royce & Bentley  
motor cars**

TSD 4446

## SERVICE INFORMATION SHEETS INDEX FOR TSD 4446

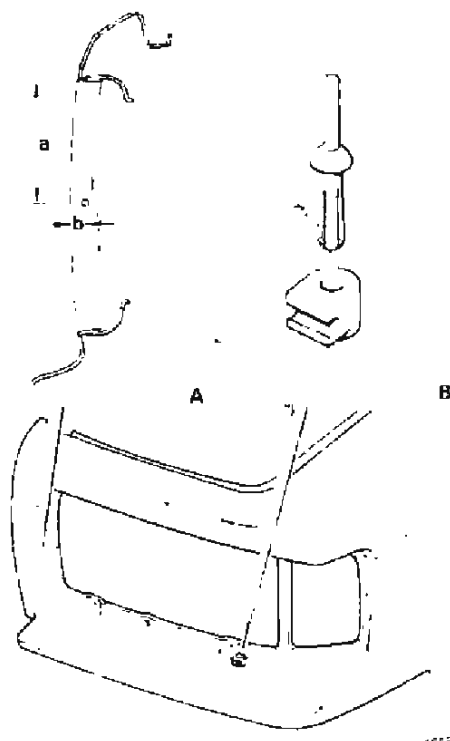
Fig. 1

A number of complaints have been received concerning the failure of the headlamp finisher clips to retain the finisher adequately on early cars. As a result, new clips, finishers, and seals have been designed and are being fitted to all motor cars from the above vehicle identification number (VIN). The purpose of this service information sheet is to explain how earlier motor cars can be modified to accept the new parts.

- 1 Disconnect the battery.
- 2 Remove both headlamp units.
- 3 Remove the old finishers, seals, and clips.
- 4 Using a rule, measure 110,5 mm (4.354in) from the flat of the headlamp aperture (see fig. 1, inset A measurement a) and 13 mm (0.512in) in from the inboard edge of the headlamp aperture (see fig. 1, inset A measurement b). Lightly centrepunch the position and drill a 4,5 mm (0.177in) diameter hole.
- 5 Treat any exposed bare metal with "acidetch" and a suitable paint, to prevent corrosion.
- 6 Fit the new clips to the headlamp aperture as shown in figure 1, inset B. The retaining pegs should be tapped firmly home to avoid a foul with the headlamp unit.
- 7 Fit the new seals.

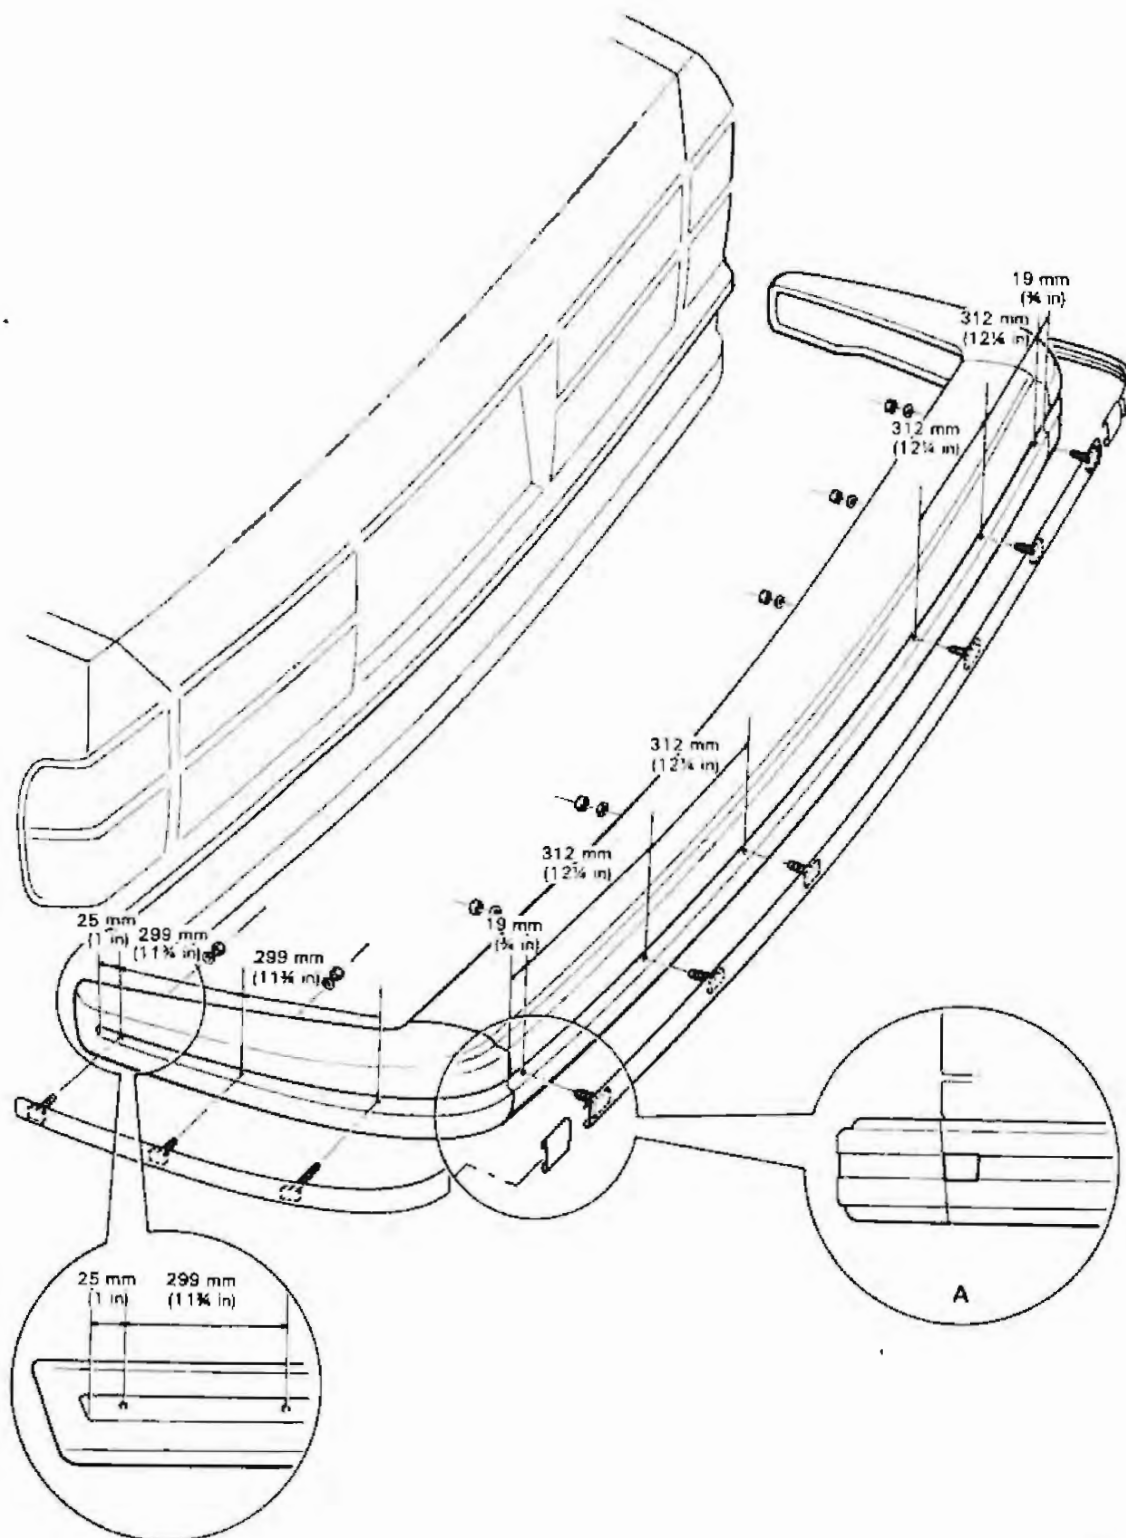
Fig. 3

If the new finisher sits proud of the recess on the corner of the bumper, it will be necessary to remove the corner finisher strip and cut off a sufficient amount from each end, which will allow the finisher strip to sit flush into the recess in the corner moulding.

- j Position the finisher strip trims in line with the rear to corner mould joint seams (see fig. 3, Inset A).
  - k Tighten all the retaining clip nuts, ensuring that these are NOT overtightened, which will cause indentations in the finisher strips.
  - l Refit the bumper to the car.
-

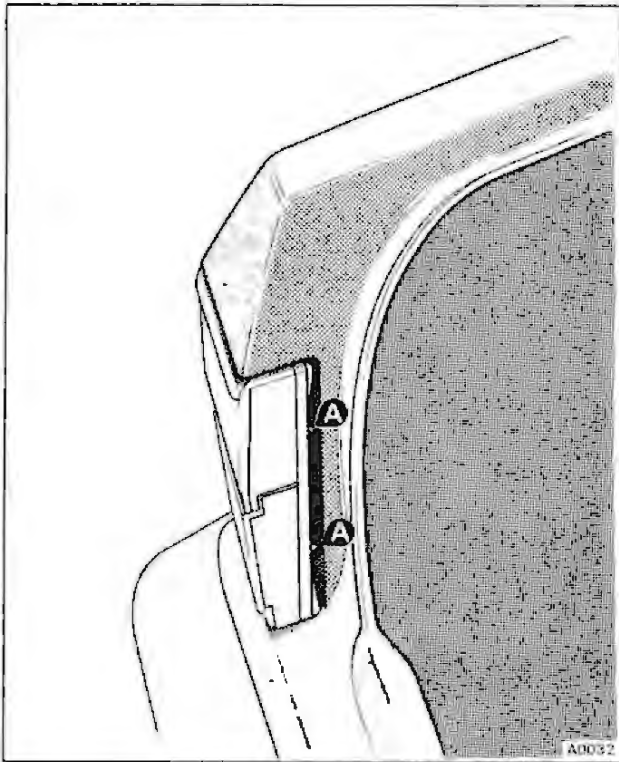
Fig. 1

The latest units can be quickly recognized by two cross-headed screws fitted through the inner ends of the assembly (see fig. 1,A).

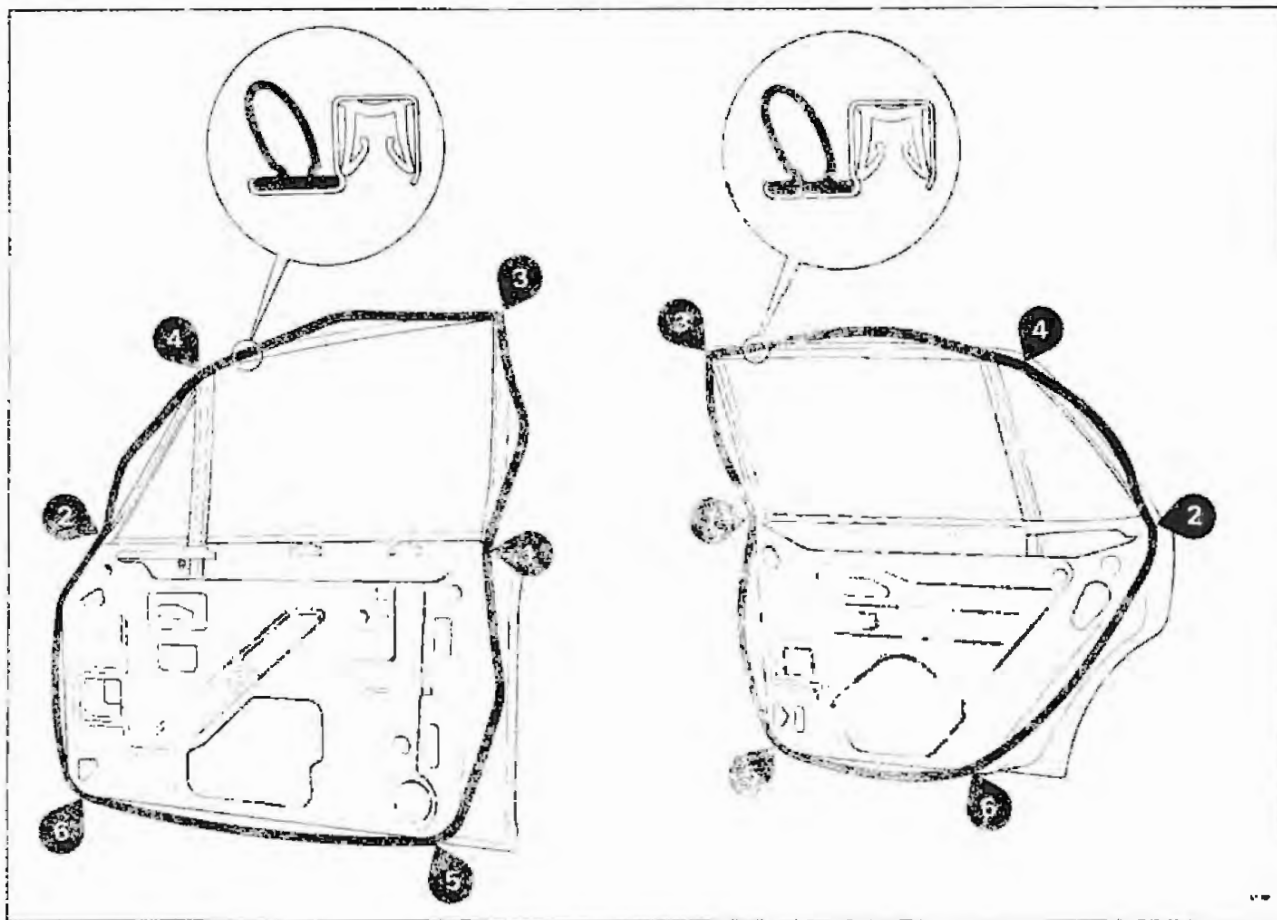
Fig. 1 Door seal location points

4. Locate the door seal at the points shown in figure 1.

5. At points 1 and 2 (see fig. 1) incisions must be made on the inside of the flanges (see fig. 3). This is to allow the flange of the new seal to fit over the retention plate on the frame.
6. The remainder of the seal is then fitted by placing the narrow section into the retainer, then locating the back of the seal in to position with the aid of a perspex or wooden spatula.

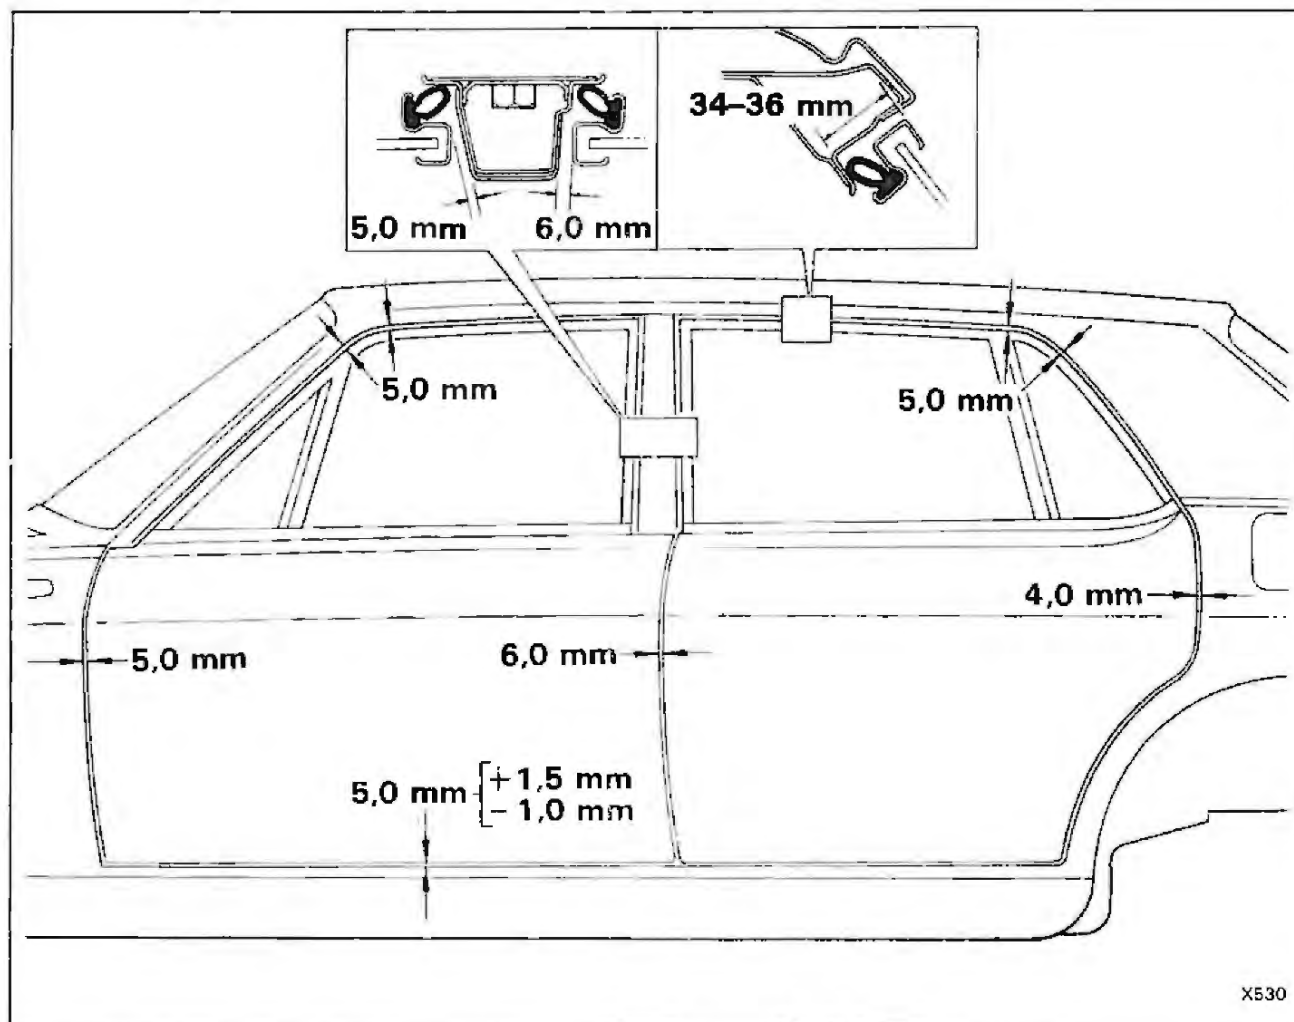
Fig. 2 Position of the door and frame in the body aperture.

It is essential that the door frames are set as shown in figure 2. If the frame to seal landing face is less than 34 mm, then the seal is likely to fold over on closing the door.

It is essential for correct operation of the new door seals that the door frame to seal landing face dimension (34 - 36mm) is correctly set. A lesser figure will damage the door seal whilst a greater figure may cause wind noise.

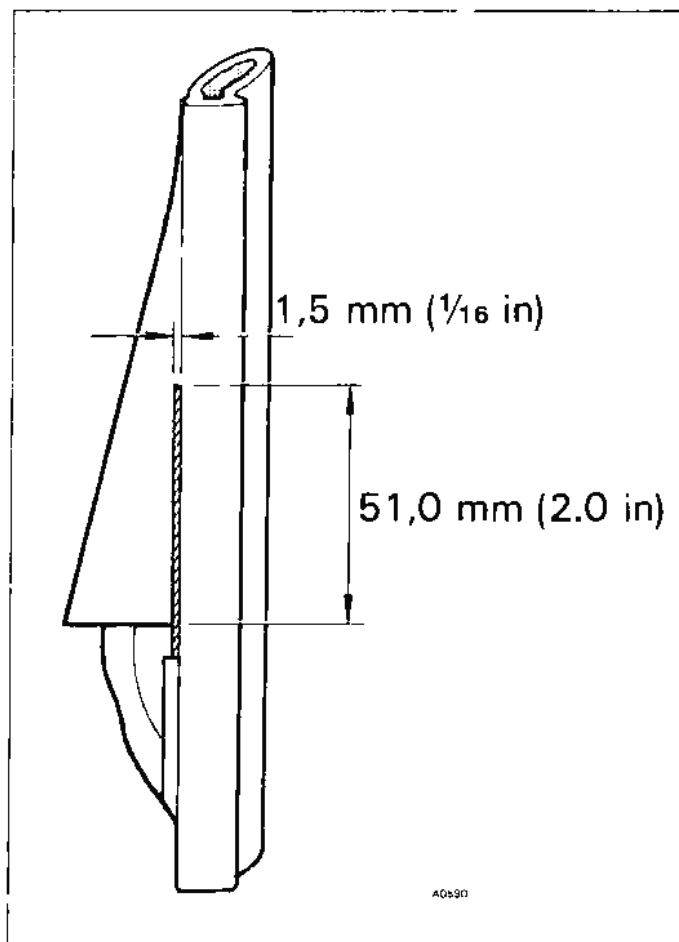
Fig. 3 Cutting incisions on the inside of the flanges.

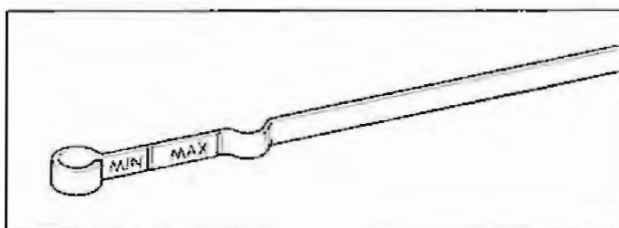
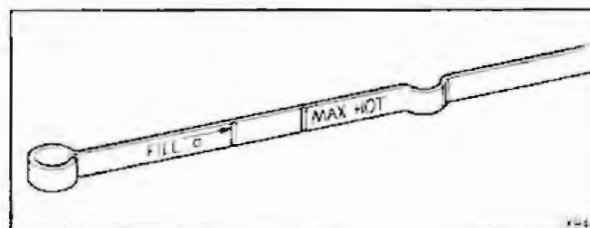
The revised dipstick has three marks stamped on the lower end (see fig. 2) as opposed to two on the previous dipstick (see fig. 1). The three marks are:

Fig. 1  
Early type dipstick

Fig. 2  
Revised dipstick

- 1 An indentation dot (centre punch mark). This is the level at which the fluid should be when the car is first started, with the fluid at room temperature of approximately  $21^{\circ}\text{C}$  ( $70^{\circ}\text{F}$ ).
- 2 A FILL mark. This mark indicates the minimum fluid level when the transmission fluid reaches normal operating temperature.
- 3 A MAXIMUM HOT mark. This mark indicates the maximum fluid level at normal operating temperature i.e.  $77^{\circ}\text{C}$  ( $170^{\circ}\text{F}$ ).

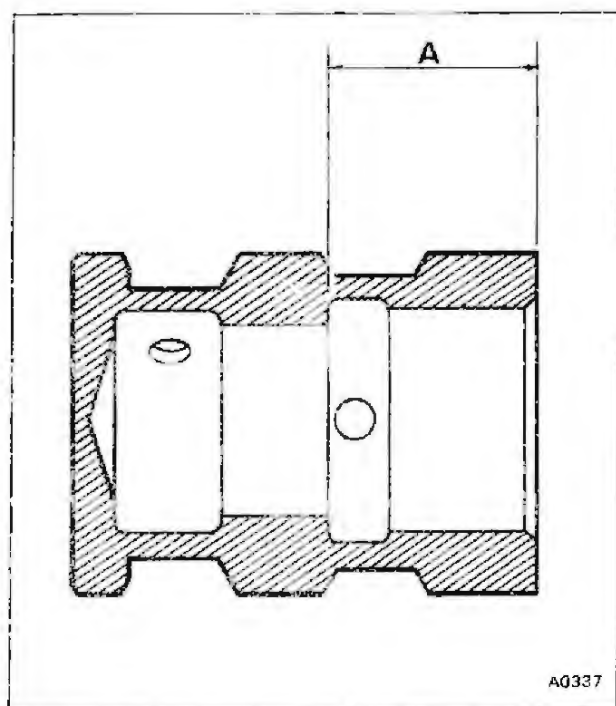
Fig. 1 Reverse boost valve bushing

A = must not exceed 15,875 mm (0.625 in)

- 1 Remove the oil pump as described in Chapter T of the relevant Workshop Manual.
- 2 Remove the reverse boost bushing and valve.
- 3 Measure the depth of the inside diameter of the reverse boost valve bushing, from the open end of the bushing, to the first internal land (see fig. 1).
- 4 If dimension A exceeds 15,875 mm (0.625 in) then the reverse boost valve and bushing should be renewed.
