**DTC****B2797****Communication Malfunction No. 1****DESCRIPTION**

This DTC is output when a communication error occurs between the transponder key amplifier and transponder key ECU assembly. Some possible reasons for the communication error are: 1) 2 or more ignition keys are positioned too close to each other, or 2) noise is occurring in the communication line.

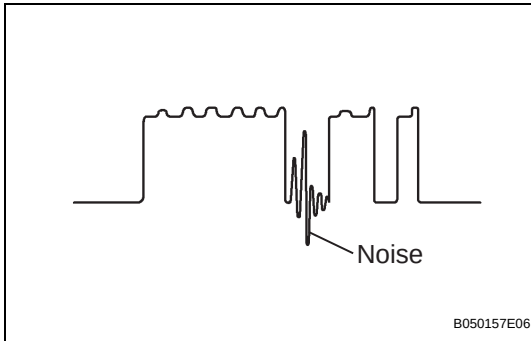
**OK****END****NG****3****CHECK TRANSPONDER KEY ECU ASSEMBLY**

- (a) Using an oscilloscope or the intelligent tester, check the waveform between the terminals of the T9 amplifier connector and T10 ECU connector. The waveform should be similar to the illustration on the left.

| Tester Connection | Specified Condition |
| T10-15 (CODE) - T9-4 (CODE) | No noise is present |

| Tool Setting | 10 V/DIV., 20 ms/DIV. |
| Condition | Ignition switch OFF → ON |

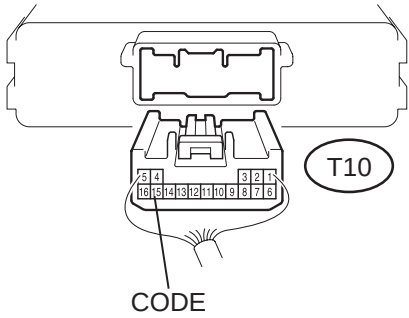
Transponder Key ECU Assembly:

CHECK HARNESS AND CONNECTOR

Wire Harness Rear View:
