# PGM-FI System

## Throttle Position (TP) Sensor

**P0122** The scan tool indicates Diagnostic Trouble Code (DTC) P0122: A low voltage problem in the Throttle Position (TP) sensor circuit.

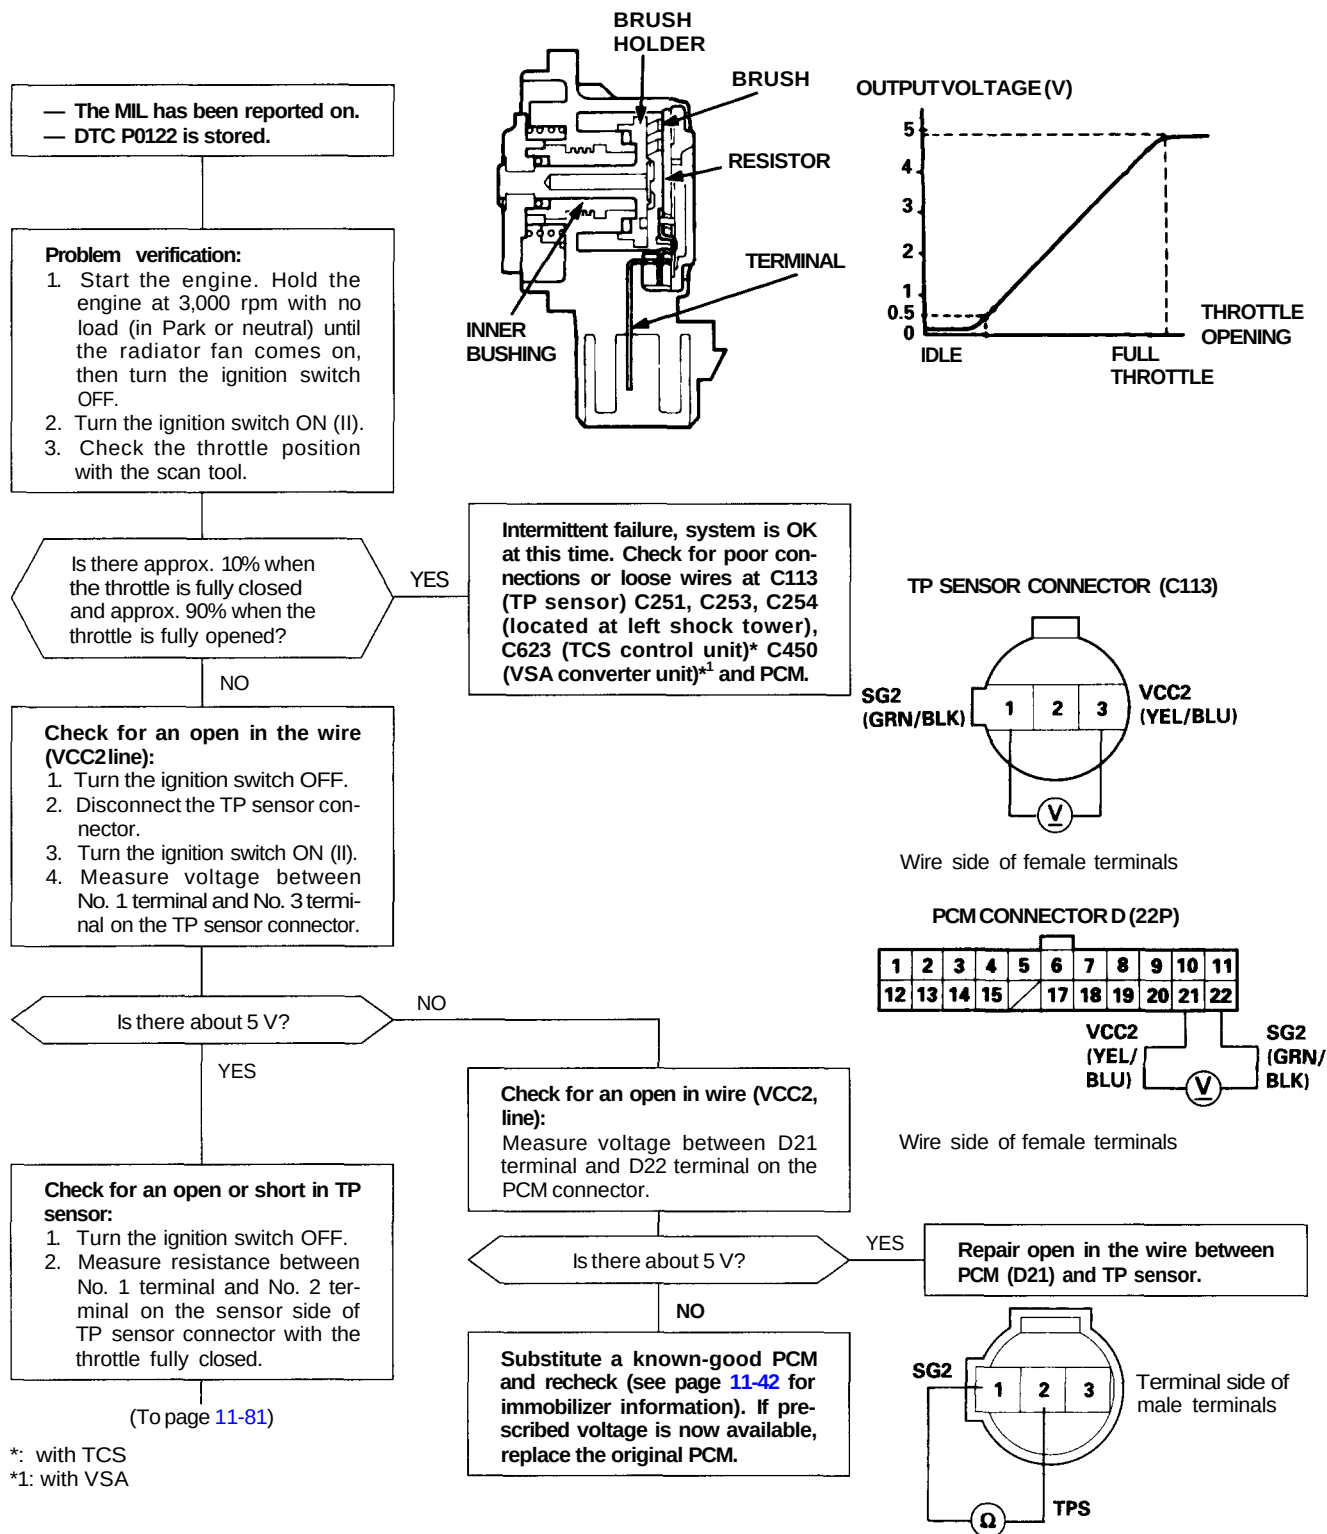
The TP Sensor is a potentiometer. It is connected to the throttle valve shaft. As the throttle position changes, the throttle position sensor varies the voltage signal to the PCM.

\*: with TCS  
\*1: with VSA

Measure resistance between No. 2 terminal and No. 3 terminal with the throttle fully closed.

1. Reconnect the TP sensor connector.
2. Turn the ignition switch ON (II).
3. Measure voltage between D6 terminal and D22 terminal on the PCM connector.
