## Knock Sensor

### P0325

The scan tool indicates Diagnostic Trouble Code (DTC) P0325: A problem in the Right Knock Sensor (Bank 1) circuit.

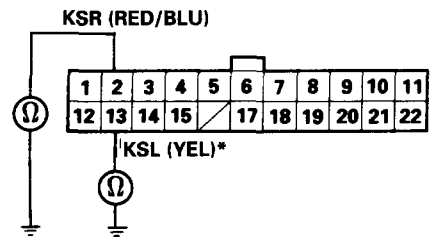
PCM CONNECTOR D (22P)

1. Turn the ignition switch OFF.
2. Disconnect the knock sensor sub-harness connector.
3. Check for continuity between PCM connector terminals D2 or D13\* and body ground.

Wire side of female terminals

Check for continuity between PCM connector terminal D2 or D13\* and knock sensor connector terminal No. 1 or No. 3\*.

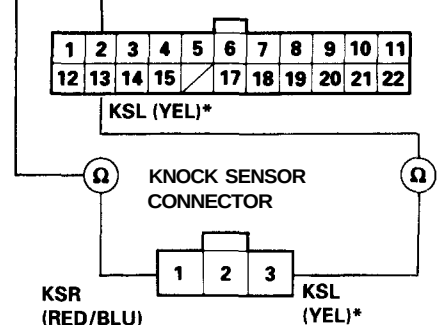
KSR (RED/BLU)

Wire side of female terminals

\*: P0330
