## Troubleshooting

## DTC 95: Precharge Pump Motor

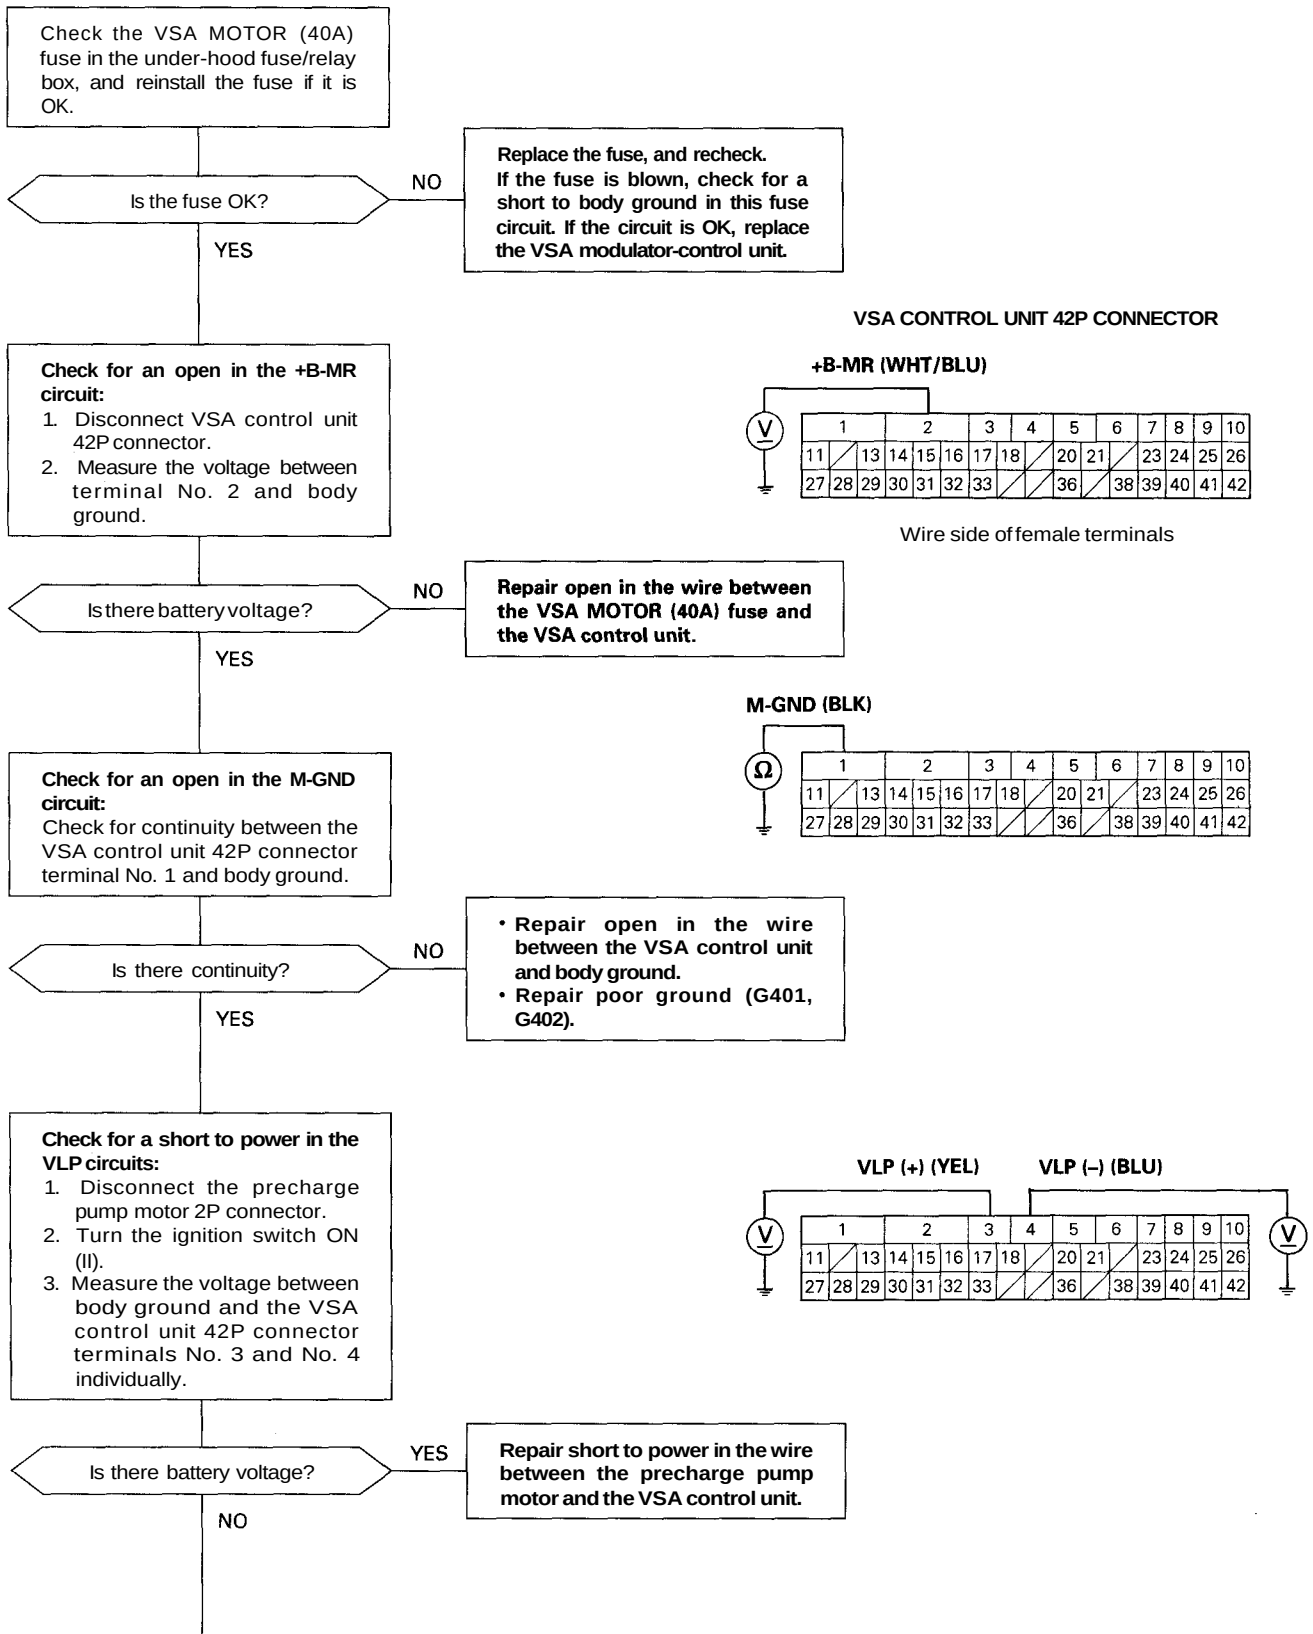
**VSA CONTROL UNIT 42P CONNECTOR**

1. Check for continuity between the VSA control unit 42P connector terminal No. 3 and the precharge pump motor 2P connector terminal No. 2.
2. Check for continuity between the VSA control unit 42P connector terminal No. 4 and the precharge pump motor 2P connector terminal No. 1.

Wire side of female terminals

VLP (+) (YEL)

PRECHARGE PUMP MOTOR  
2P CONNECTOR

1. Turn the ignition switch OFF.
2. Check for continuity between body ground and the VSA control unit 42P connector terminals No. 3 and No. 4 individually.
