## DTC 98: Different Model

## DTC 98: Different Model (cont'd)

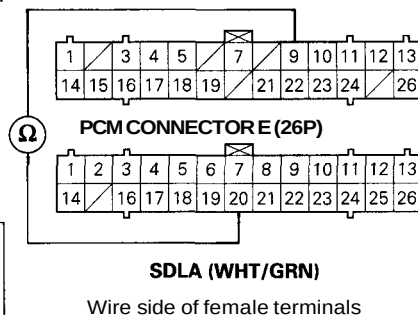
VSA CONVERTER UNIT 26P CONNECTOR

SDLA (WHT/GRN)
