# Troubleshooting - '96 - '98 Models

## DTC 2-3

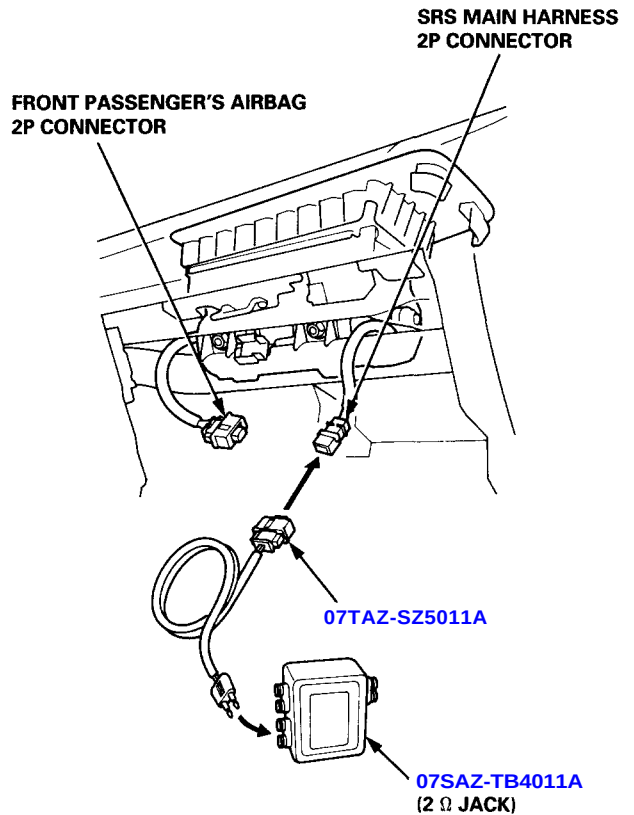
### Check for a short to another wire or decreased resistance in the passenger's airbag inflator:

1. Turn the ignition switch OFF.
2. Disconnect the battery negative cable, then disconnect the positive cable, and wait for 3 minutes.
3. Disconnect the front passenger's airbag 2P connector from the SRS main harness (see page 24-33).
4. Connect the special tool (2  $\Omega$ ) to the SRS main harness 2P connector.  
**CAUTION: Do not disconnect the driver's airbag connector.**
5. Reconnect the battery positive cable, then reconnect the negative cable.
6. Erase the DTC memory (see page 24-37).
7. Read the DTC (see page 24-35).

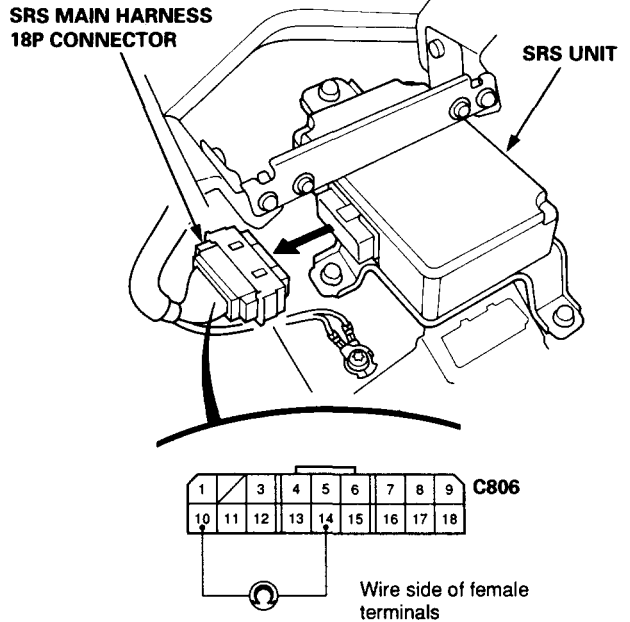
**Check for a short to another wire or decreased resistance in the SRS main harness:**

1. Disconnect the battery negative cable, then disconnect the positive cable, and wait for 3 minutes.
2. Disconnect the driver's airbag connector, then disconnect the driver's and front passenger's seat belt tensioner connectors (see page [24-33](#)).
3. Disconnect the SRS main harness 18P connector from the SRS unit. Do not disconnect the special tool (2 Ω) from the SRS main harness 2P connector.
4. Check resistance between the No. 10 terminal and No. 14 terminal of the SRS main harness 18P connector. There should be approx. 2.0 - 3.0 Ω.
