**72 11 071****Removing and installing/replacing front lower strap fitting (belt tensioner), front passenger seat**

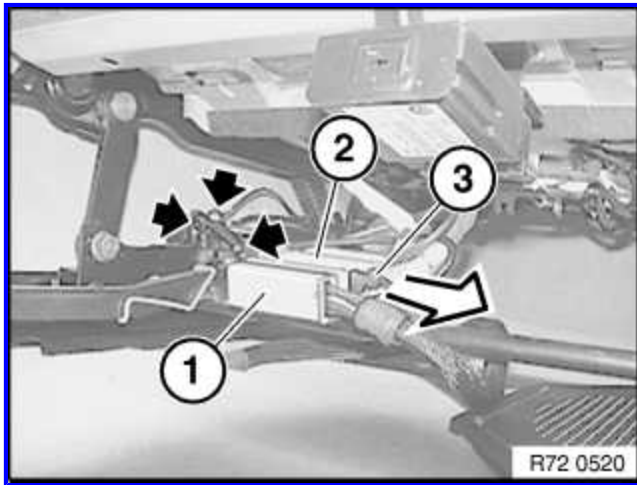
Unfasten plug connection (1) and disconnect.
