COMPONENTS  
ILLUSTRATION

### Horn System

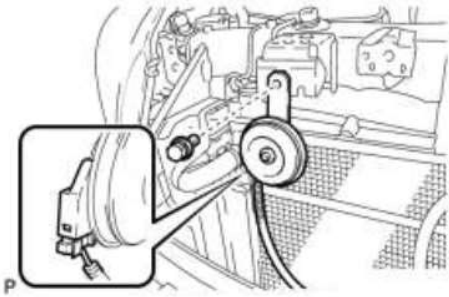
3. REMOVE HIGH PITCHED HORN ASSEMBLY

(a) Disconnect the connector.

(b) Remove the bolt and high pitched horn assembly.

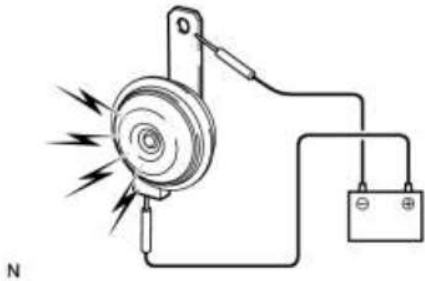
## 1. INSPECT HIGH PITCHED HORN ASSEMBLY

(a) Apply battery voltage and check the operation of the horn according to the table below.

| Measurement Condition | Specified Condition |
| Battery positive (+) → Terminal 1 | Horn sounds |
| Battery negative (-) → Body ground | |

If the result is not as specified, replace the high pitched horn assembly.

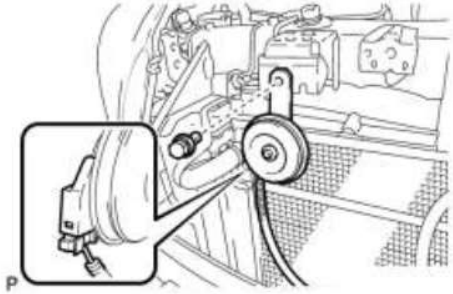
## 1. INSTALL HIGH PITCHED HORN ASSEMBLY

(a) Install the high pitched horn assembly with the bolt.

Torque: **20 N·m (204 kgf·cm, 15ft·lbf)**

(b) Connect the connector.

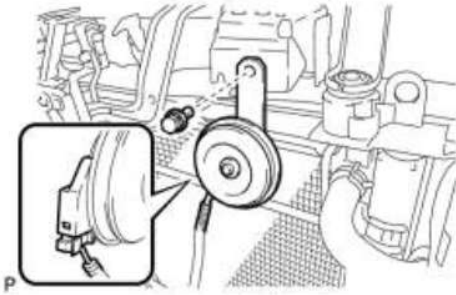
3. REMOVE LOW PITCHED HORN ASSEMBLY

(a) Disconnect the connector.

(b) Remove the bolt and low pitched horn assembly.

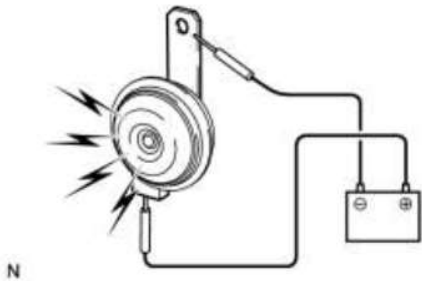
## 1. INSPECT LOW PITCHED HORN ASSEMBLY

(a) Apply battery voltage and check the operation of the horn according to the table below.

| Measurement Condition | Specified Condition |
| Battery positive (+) → Terminal 1 | Horn sounds |
| Battery negative (-) → Body ground | |

If the result is not as specified, replace the low pitched horn assembly.

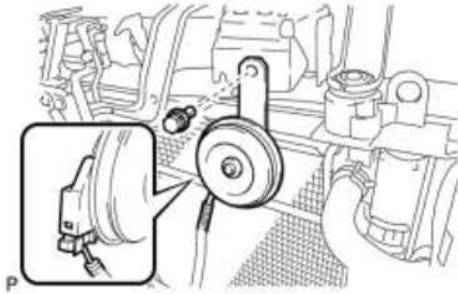
## 1. INSTALL LOW PITCHED HORN ASSEMBLY

(a) Install the low pitched horn assembly with the bolt.

Torque: **20 N·m (204 kgf·cm, 15ft·lbf)**

(b) Connect the connector.
