| <b>Model Year:</b> 2008 | <b>Model:</b> LX570 | <b>Doc ID:</b> RM000000O9L02EX |
| <b>Title:</b> AB60F AUTOMATIC TRANSMISSION / TRANSAXLE: VALVE BODY ASSEMBLY: DISASSEMBLY (2008 LX570) | | |

## **DISASSEMBLY**

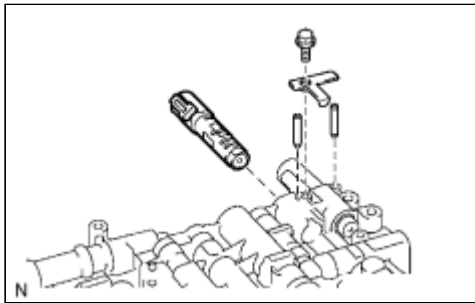
### **1. REMOVE SHIFT SOLENOID VALVE SL2**

(a) Remove the bolt, lock plate and 2 straight pins.

(b) Remove the shift solenoid valve.

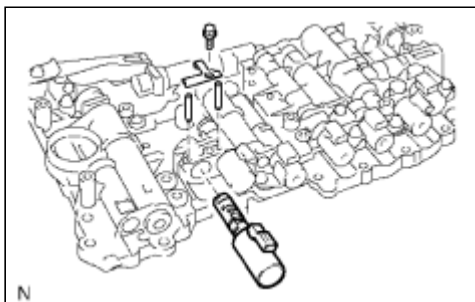
### **3. REMOVE SHIFT SOLENOID VALVE SLT**

(a) Remove the bolt, lock plate and 2 straight pins.

(b) Remove the shift solenoid valve.

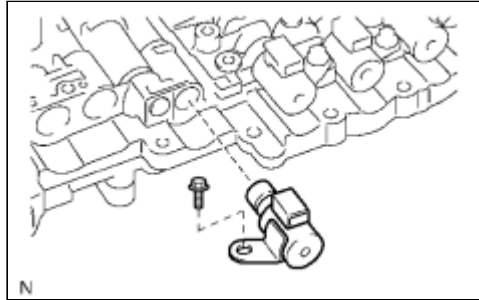
#### 5. REMOVE SHIFT SOLENOID VALVE SR

(a) Remove the bolt and shift solenoid valve.

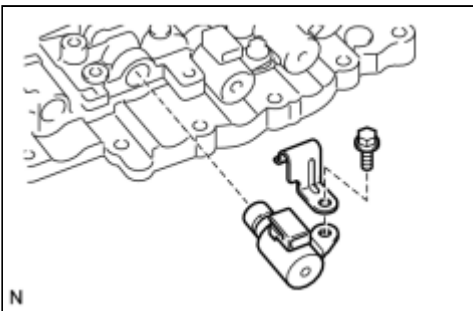
#### 6. REMOVE SHIFT SOLENOID VALVE S1

(a) Remove the bolt, valve body wire harness clamp and shift solenoid valve.

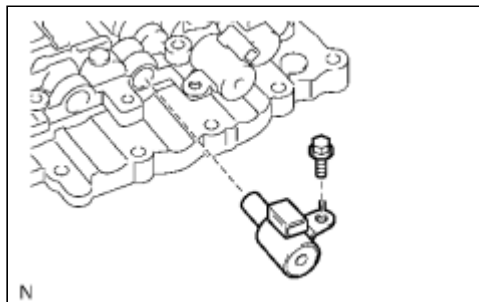
#### 7. REMOVE SHIFT SOLENOID VALVE S4

(a) Remove the bolt and shift solenoid valve.

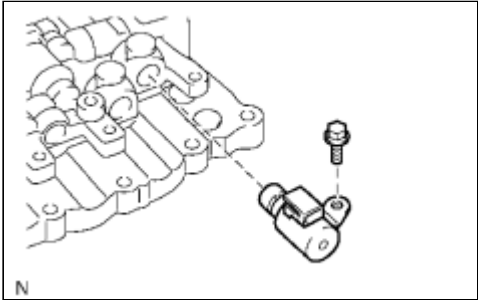
9. REMOVE SHIFT SOLENOID VALVE S3

(a) Remove the bolt and shift solenoid valve.
