## [Engine Compartment]

[Engine Room R/B No.1 and Engine Room J/B No.1 Inner Circuit]

# [Instrument Panel J/B Assembly Inner Circuit]

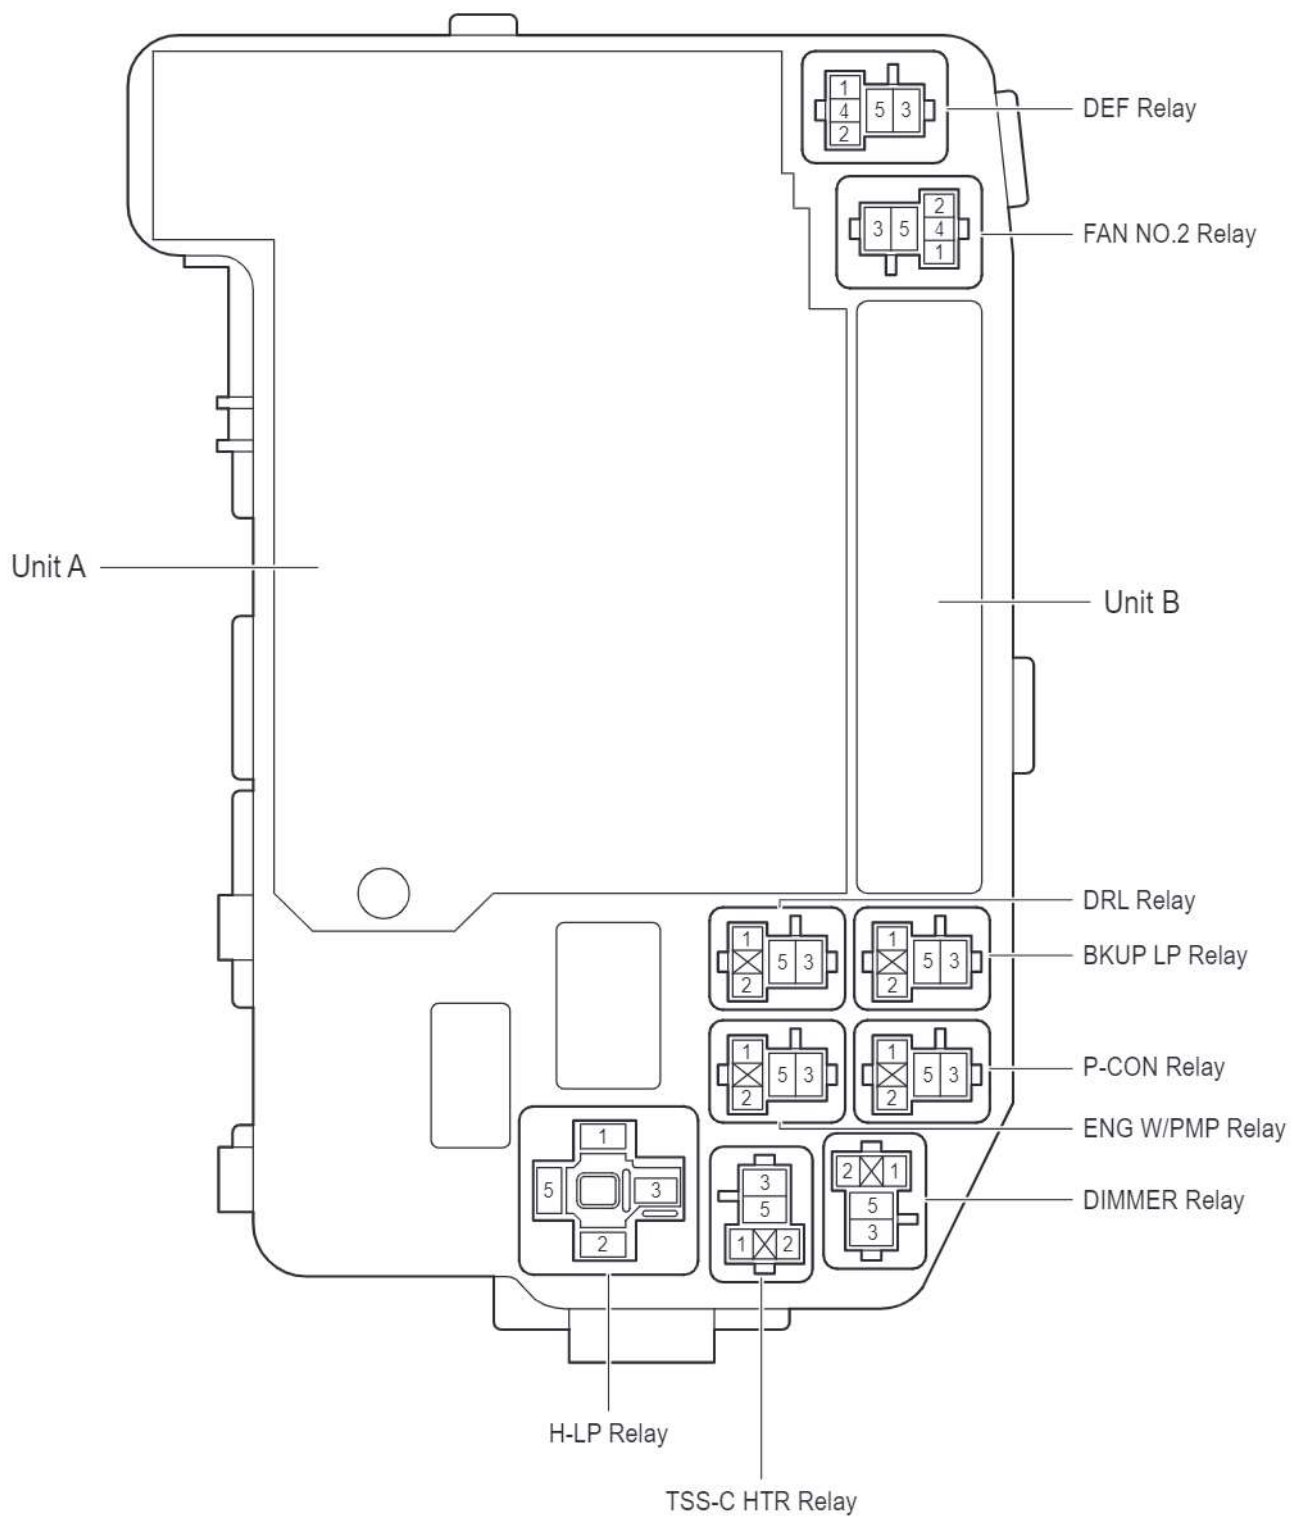
| ○ 1 : Engine Room R/B No. 1 | Left Engine Compartment |
| ● : Engine Room J/B No. 1 | |

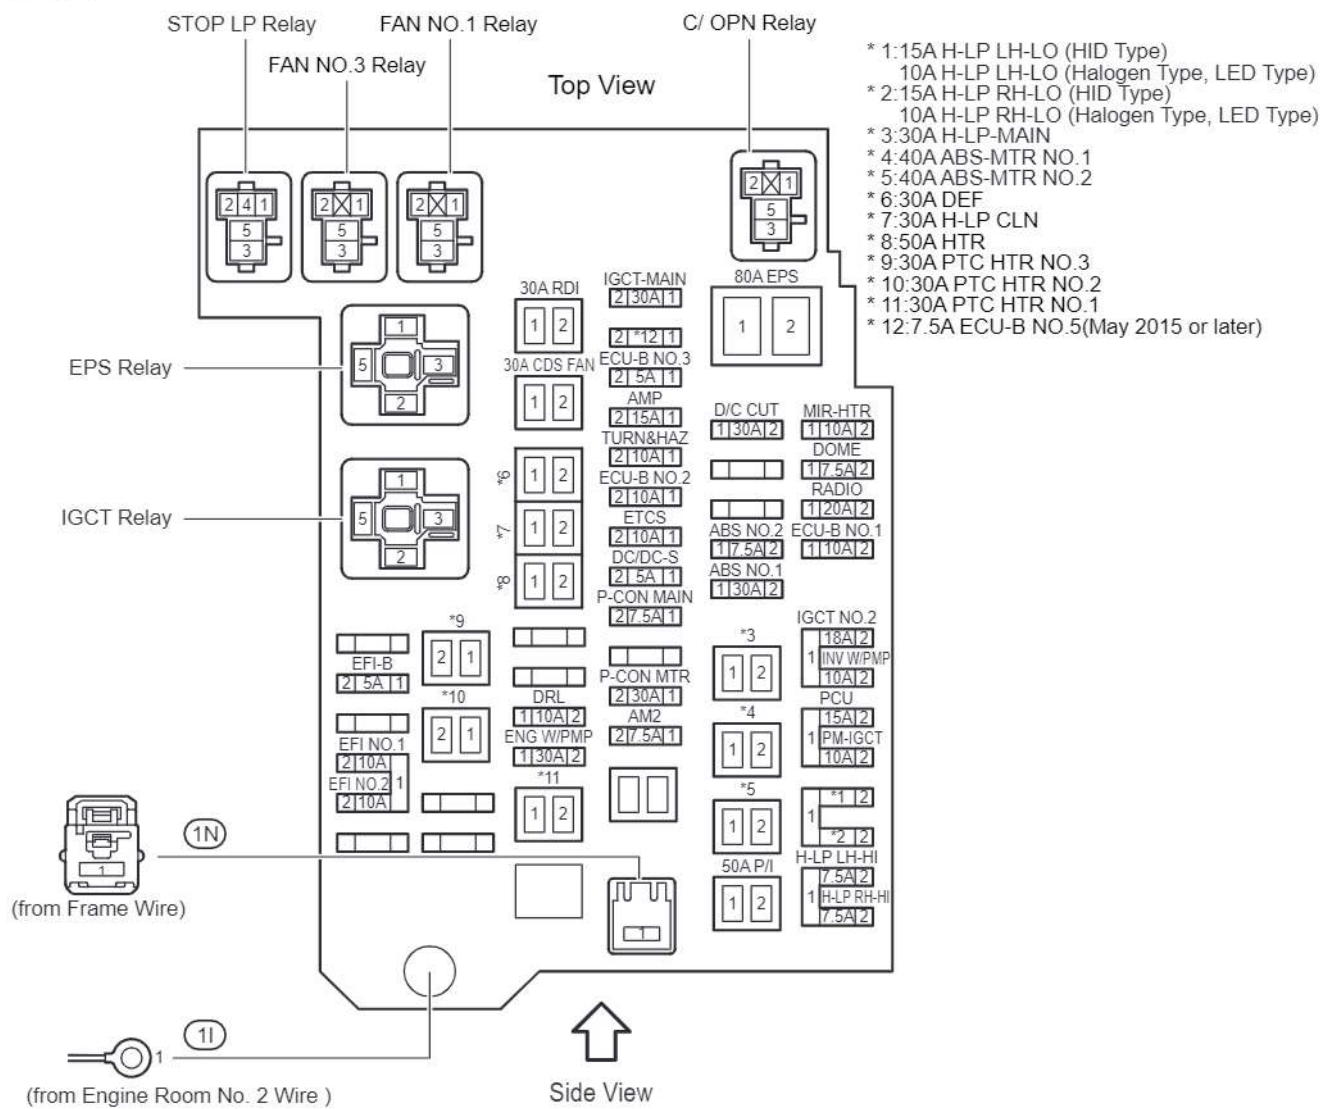
Unit A

| ① : Engine Room R/B No. 1 | Left Engine Compartment |
| ② : Engine Room J/B No. 1 | |

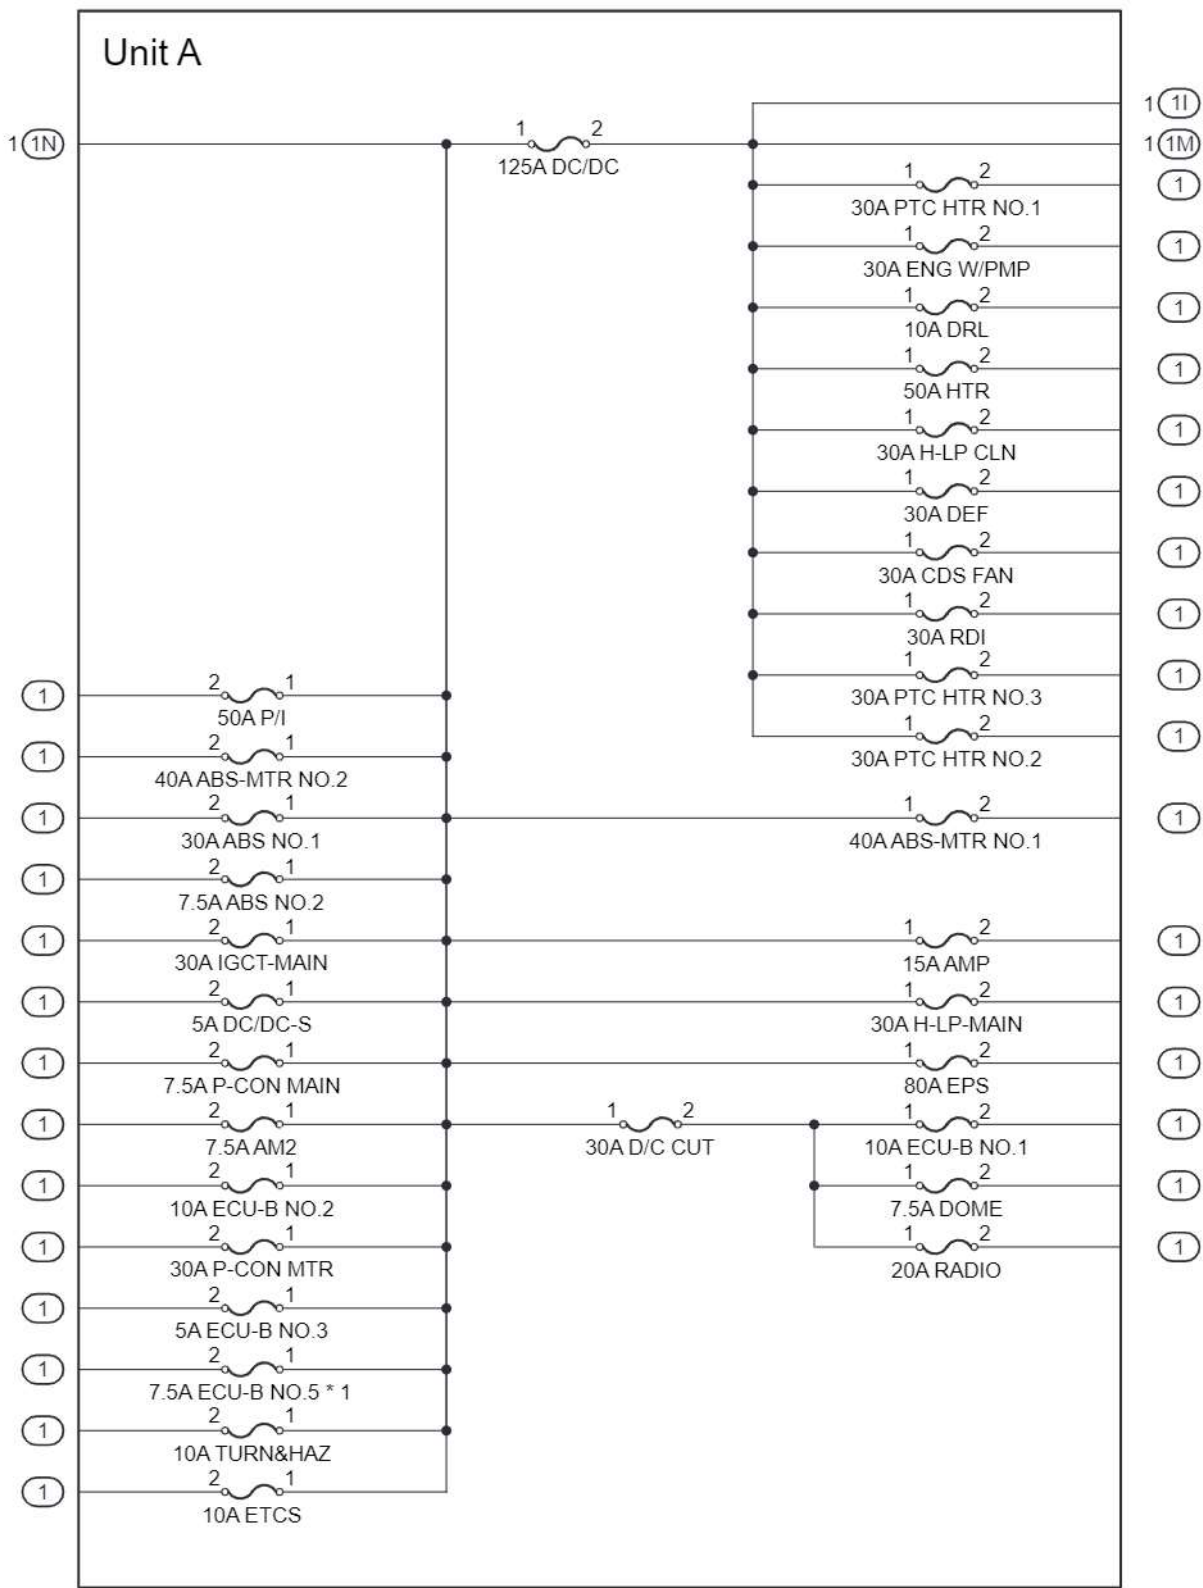
\* 1:May 2015 or later

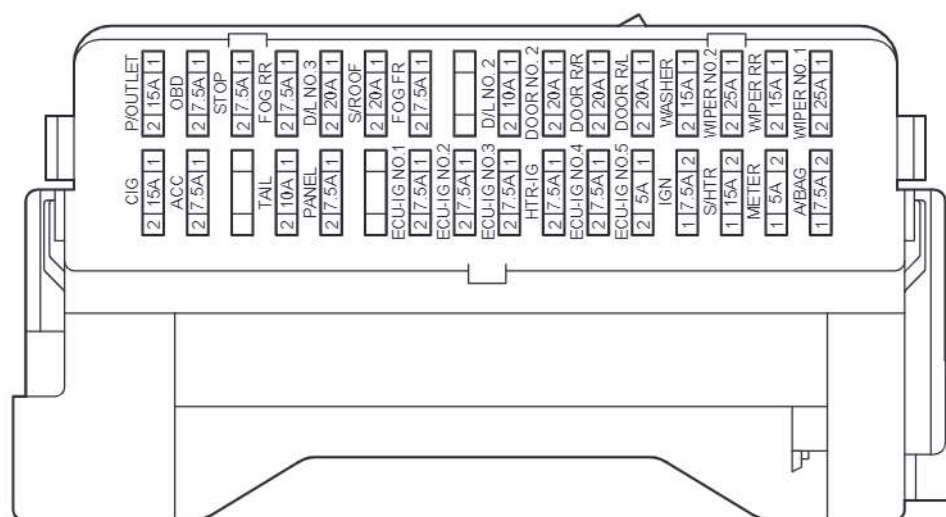
## Instrument Panel Reinforcement

: Instrument Panel J/B Assembly

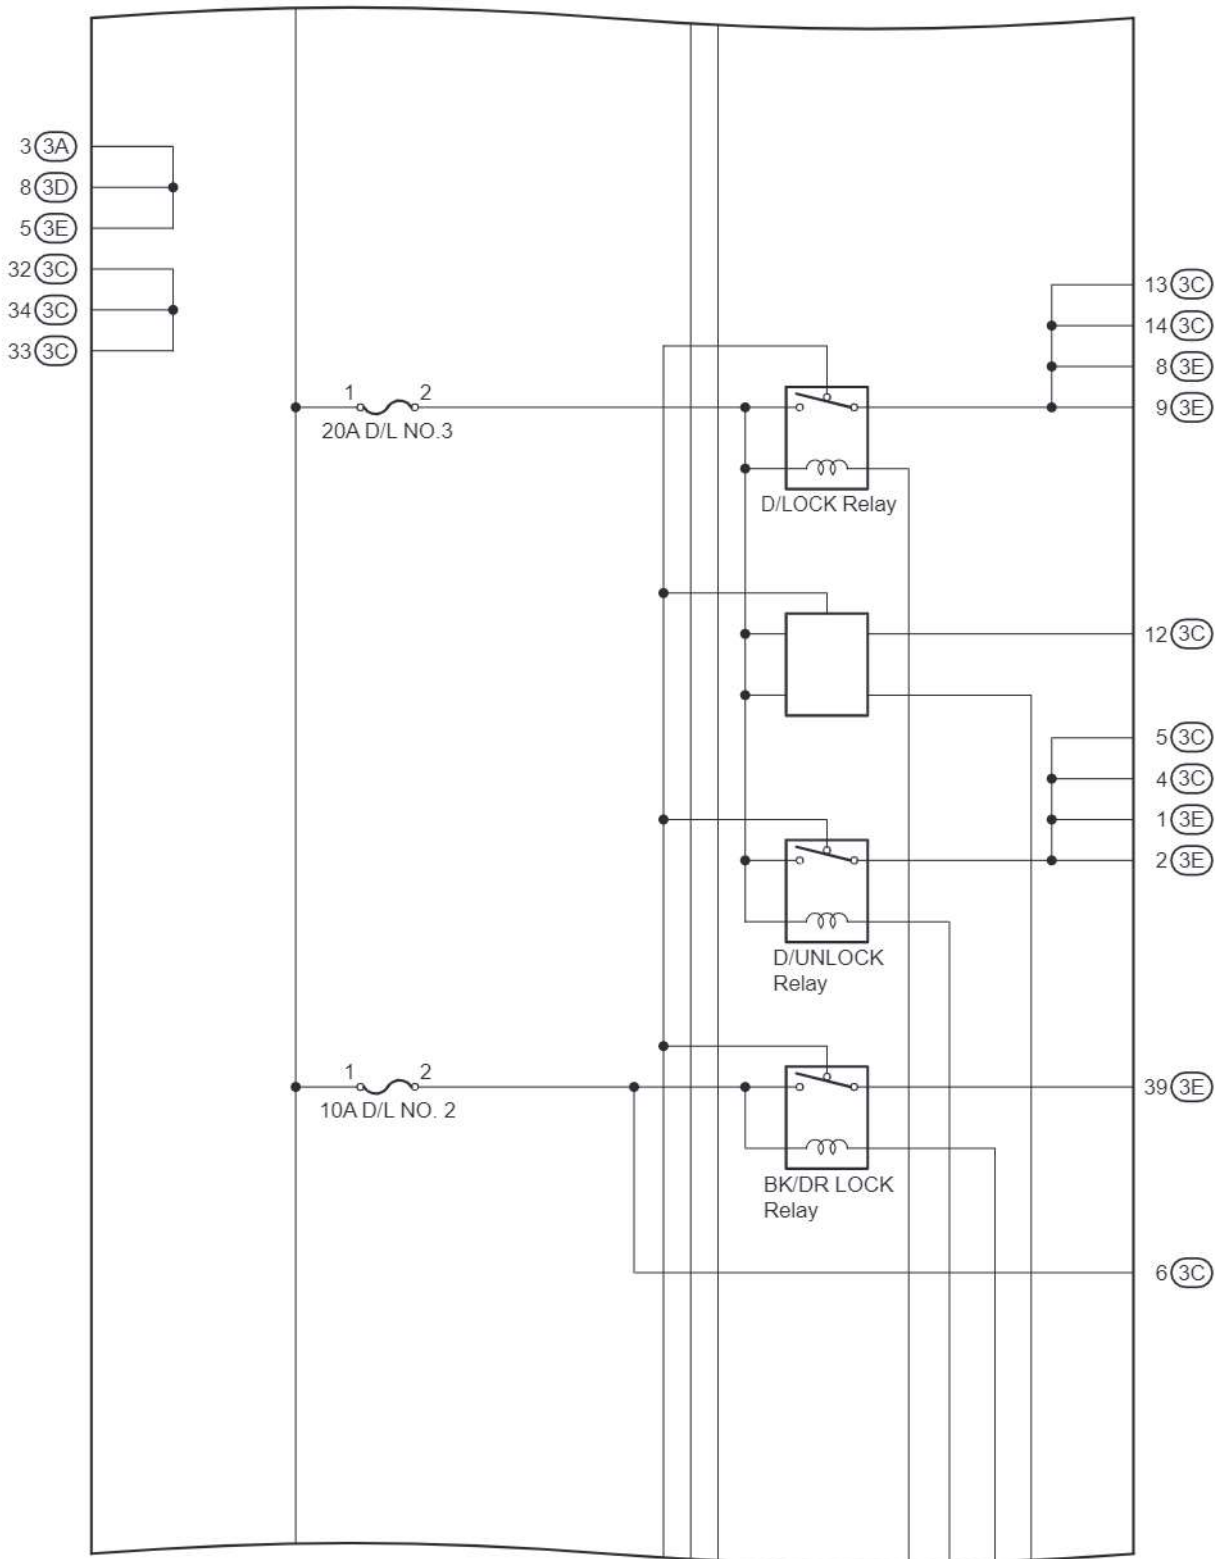
[Instrument Panel J/B Assembly Inner Circuit]

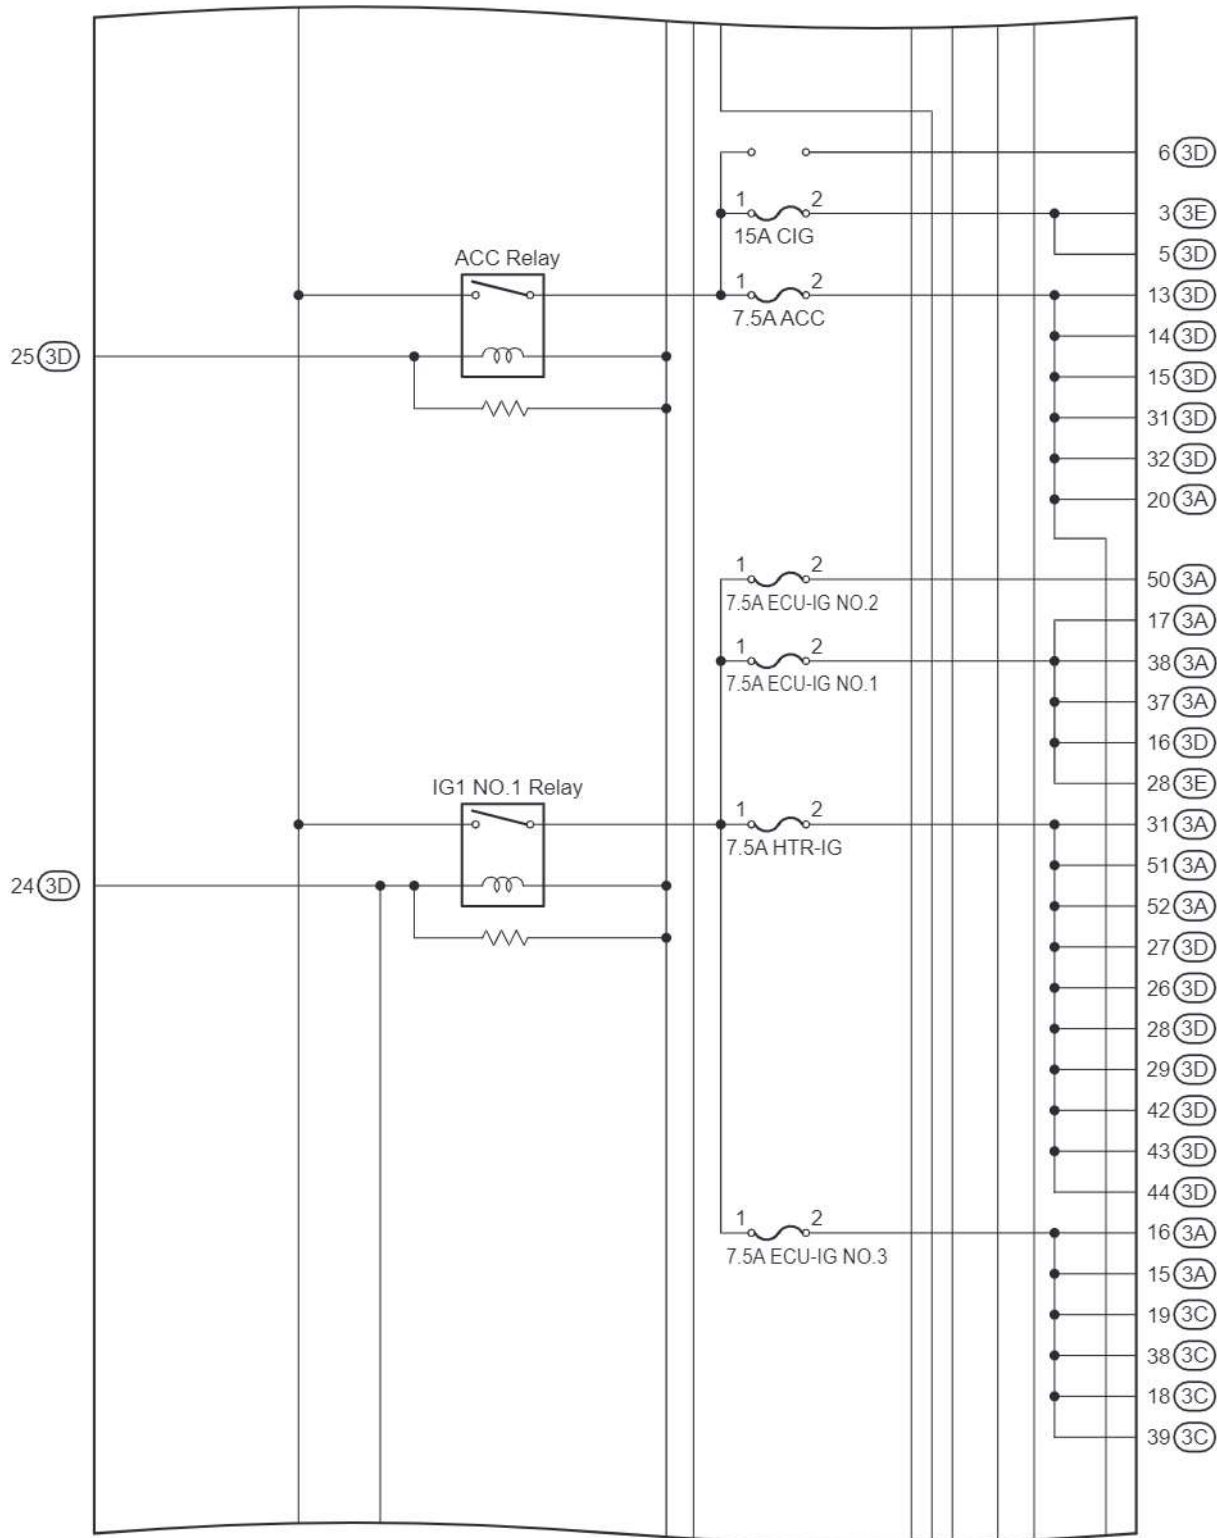
[Instrument Panel J/B Assembly Inner Circuit]

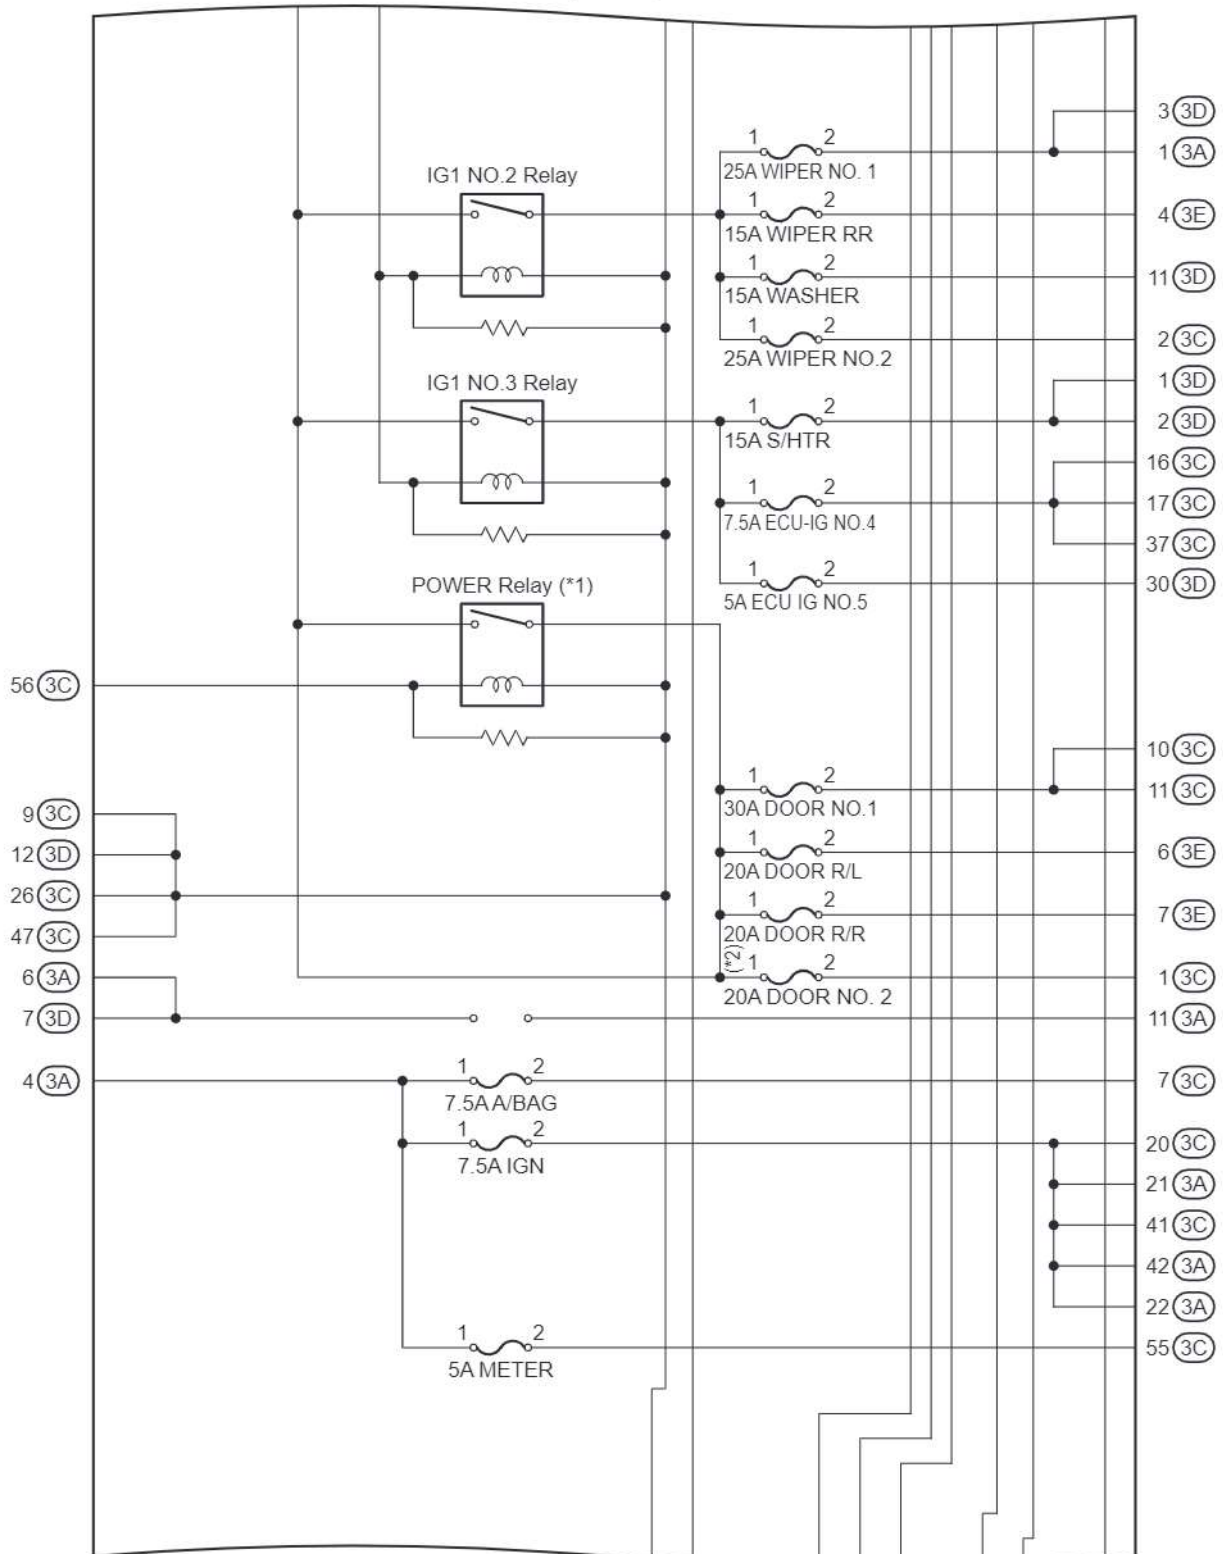
# [Instrument Panel J/B Assembly Inner Circuit]

\* 1:Driver's Door Only Jam Protection  
 \* 2:4-Door Jam Protection

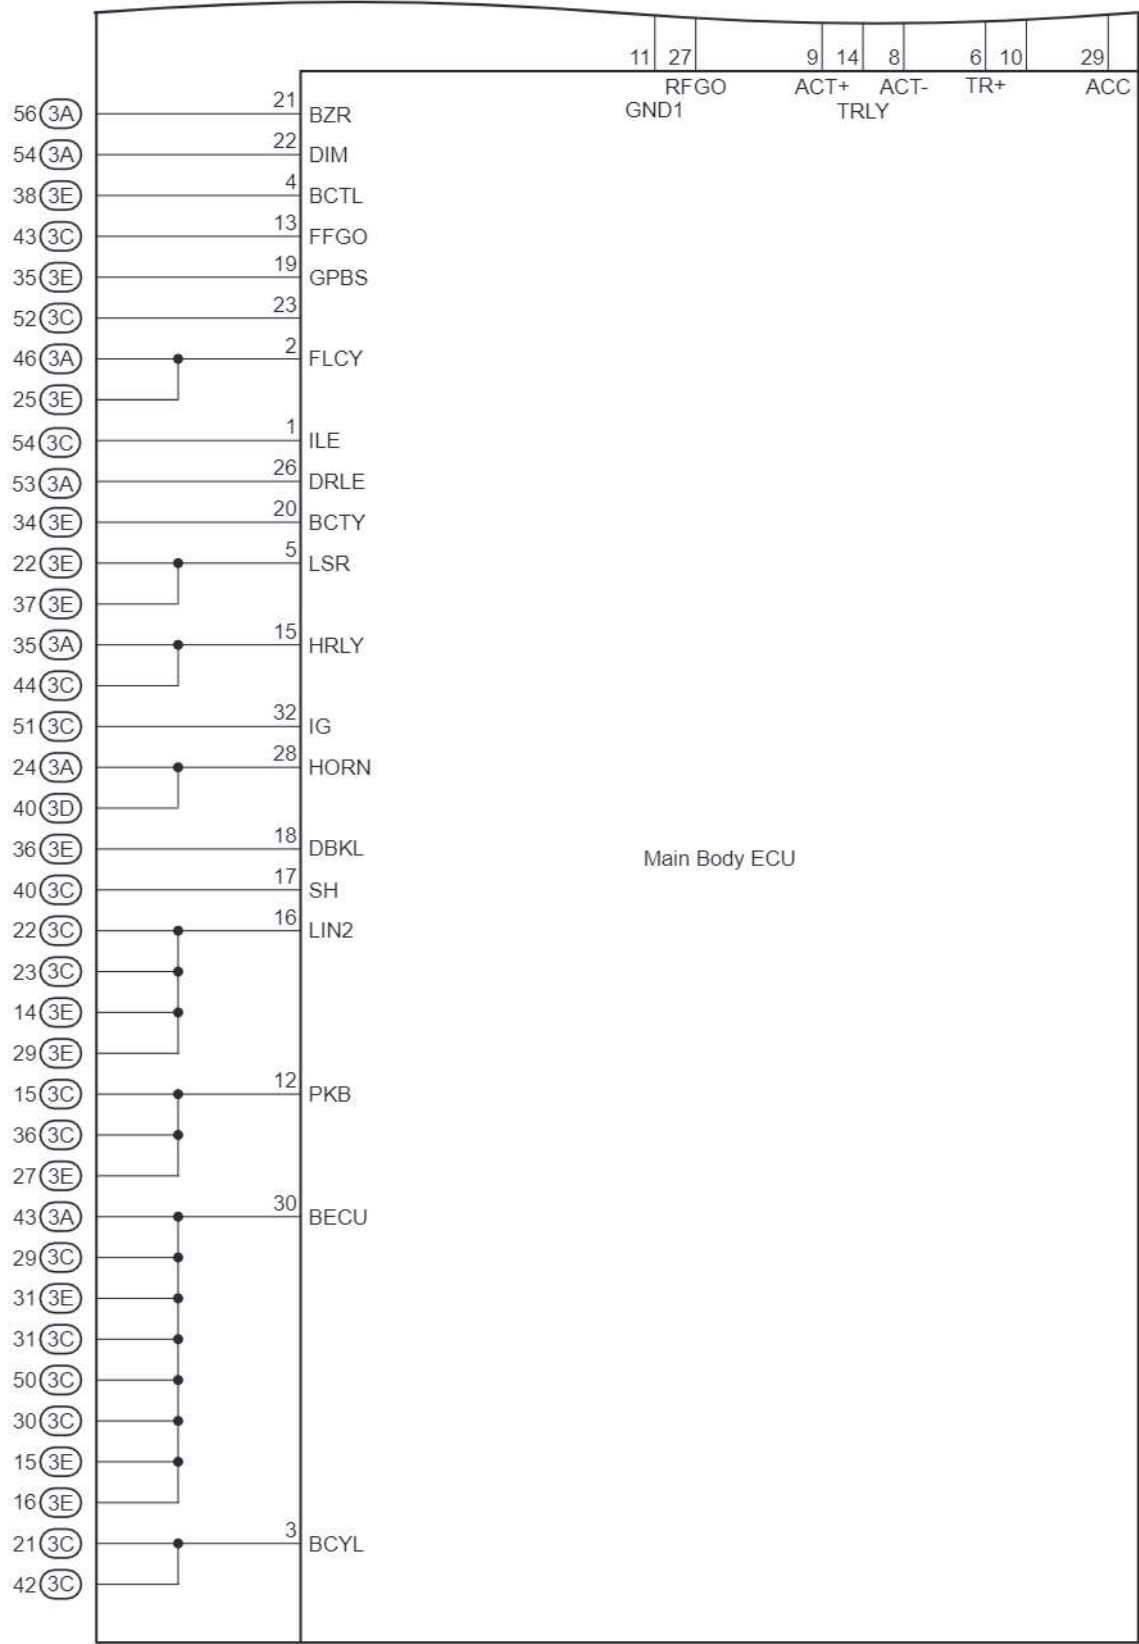
[Instrument Panel J/B Assembly Inner Circuit]
