| <b>DTC</b> | <b>B0135/73</b> | <b>Short in P/T Squib (LH) Circuit</b> |

## CIRCUIT DESCRIPTION

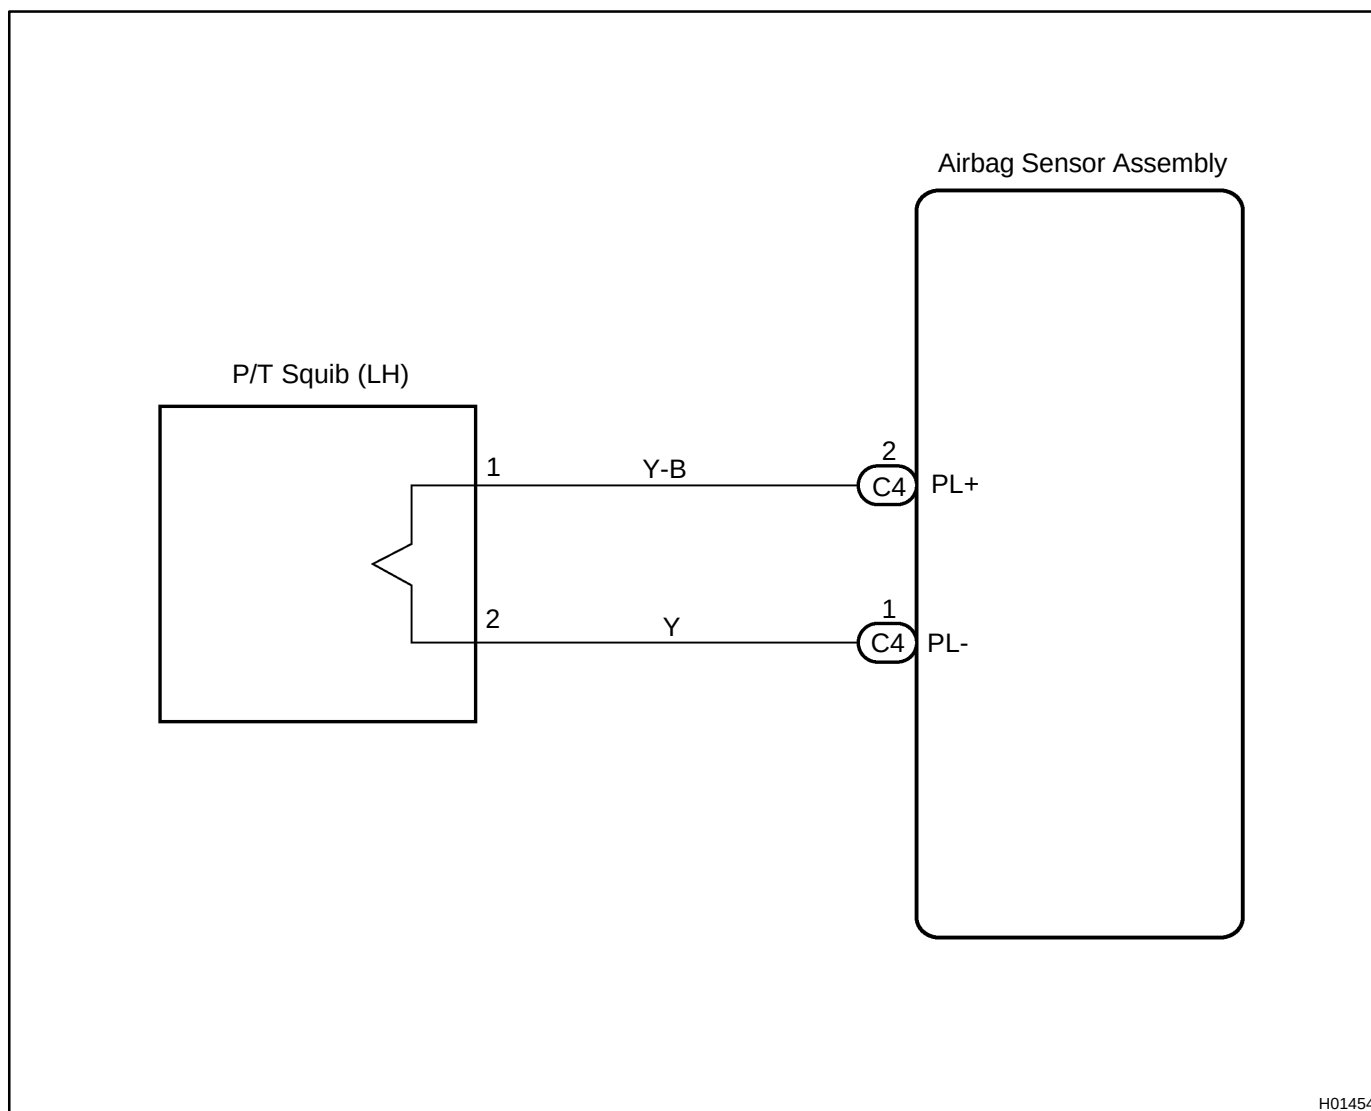
## WIRING DIAGRAM

The P/T squib (LH) circuit consists of the airbag sensor assembly and seat belt pretensioner (LH). It causes the SRS to deploy when the SRS deployment conditions are satisfied. For details of the function of each component, see OPERATION on page [RS-2](#). DTC B0135/73 is recorded when a short is detected in the P/T squib (LH) circuit.

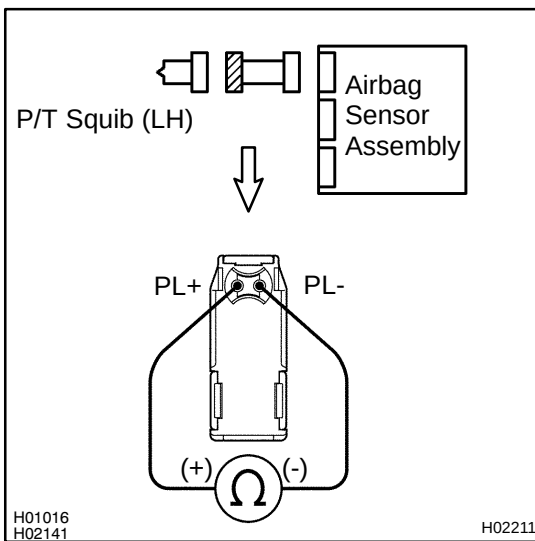
- 2 Check P/T squib (LH) circuit.

Release the airbag activation prevention mechanism of the connector (on the airbag sensor assembly side) between the airbag sensor assembly and the seat belt pretensioner (LH) (See page [DI-358](#) ).

For the connector (on the seat belt pretensioner side) between the seat belt pretensioner (LH) and the airbag sensor assembly, measure the resistance between PL+ and PL-.

**Resistance: 1 MΩ or Higher**

**Repair or replace harness or connector between seat belt pretensioner (LH) and airbag sensor assembly.**

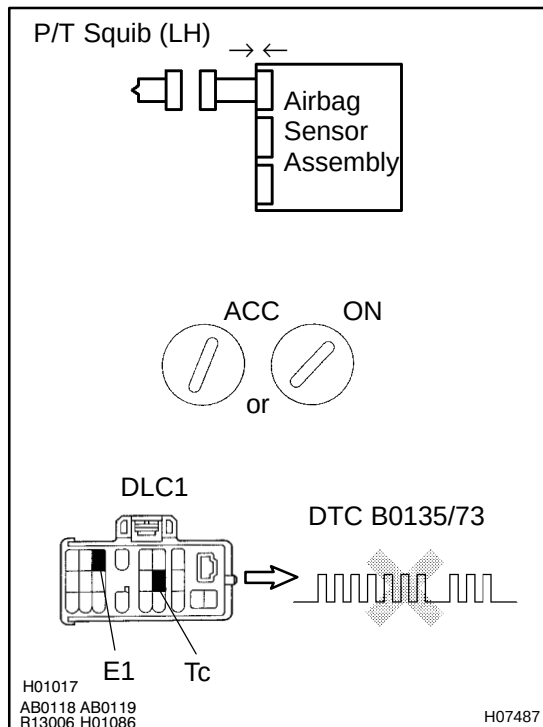
### 3 Check airbag sensor assembly.

- Connect the connector to the airbag sensor assembly.
- Connect negative (-) terminal cable to the battery, and wait at least for 2 seconds.

- Turn the ignition switch to ACC or ON and wait at least for 20 seconds.
- Clear the DTC stored in memory (See page [DI-358](#)).
- Turn the ignition switch to LOCK, and wait at least for 20 seconds.
- Turn the ignition switch to ACC or ON, and wait at least for 20 seconds.
- Check the DTC (See page [DI-358](#)).

**DTC B0135/73 is not output.**

**Replace airbag sensor assembly.**

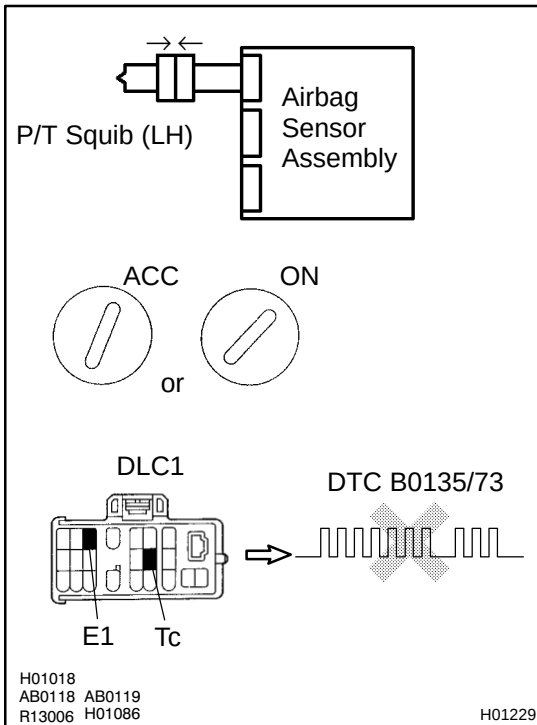
#### 4 Check P/T squib (LH).

- Turn the ignition switch to LOCK.
- Disconnect negative (-) terminal cable from the battery, and wait at least for 90 seconds.
- Connect the seat belt pretensioner (LH) connector.
- Connect negative (-) terminal cable to the battery, and wait at least for 2 seconds.

- Turn the ignition switch to LOCK, and wait at least for 20 seconds.
- Turn the ignition switch to ACC or ON, and wait at least for 20 seconds.
- Clear the DTC stored in memory (See page [DI-358](#)).
- Turn the ignition switch to LOCK, and wait at least for 20 seconds.
- Turn the ignition switch to ACC or ON, and wait at least for 20 seconds.
- Check the DTC (See page [DI-358](#)).

**DTC B0135/73 is not output.**

**Replace seat belt pretensioner (LH).**
