## ON-VEHICLE INSPECTION

### 1. INSPECT REFRIGERANT VOLUME

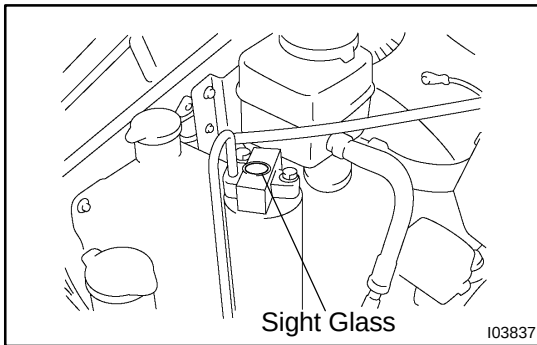
Observe the sight glass on the liquid tube.

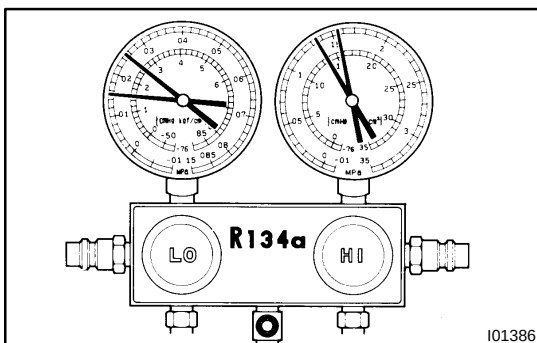
(1) Normally functioning refrigeration system

**Gauge reading:**

**Low pressure side: 0.15 - 0.25 MPa (1.5 - 2.5 kgf/cm<sup>2</sup>)**

**High pressure side: 1.37 - 1.57 MPa (14 - 16 kgf/cm<sup>2</sup>)**

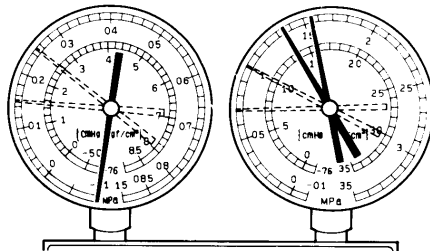
I01387

## (2) Moisture present in refrigeration system.

Condition : Periodically cools and then fails to cool

| Symptom seen in refrigeration system | Probable cause | Diagnosis | Remedy |
|---|---|---|---|
| During operation, pressure on low pressure side sometimes become a vacuum and sometime normal | Moisture entered in refrigeration system freezes at expansion valve orifice and temporarily stops cycle, but normal state is restored after a time when the ice melts | <ul style="list-style-type: none"> <li>• Drier in oversaturated state</li> <li>• Moisture in refrigeration system freezes at expansion valve orifice and blocks circulation of refrigerant</li> </ul> | (1) Replace receiver<br>(2) Remove moisture in cycle through repeatedly evacuating air<br>(3) Charge proper amount of new refrigerant |

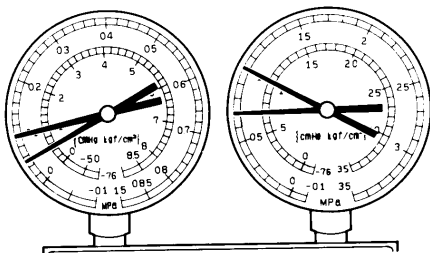
I01388

## (3) Insufficient cooling

Condition: Insufficient cooling

| Symptom seen in refrigeration system | Probable cause | Diagnosis | Remedy |
|---|---|---|---|
| <ul style="list-style-type: none"> <li>• Pressure low on both low and high pressure sides</li> <li>• Bubbles seen in sight glass continuously</li> <li>• Insufficient cooling performance</li> </ul> | Gas leakage at some place in refrigeration system | <ul style="list-style-type: none"> <li>• Insufficient refrigerant in system</li> <li>• Refrigerant leaking</li> </ul> | (1) Check for gas leakage with gas leak detector and repair if necessary<br>(2) Charge proper amount of refrigerant<br>(3) If indicated pressure value is near 0 when connected to gauge, create the vacuum after inspecting and repairing the location of the leak |

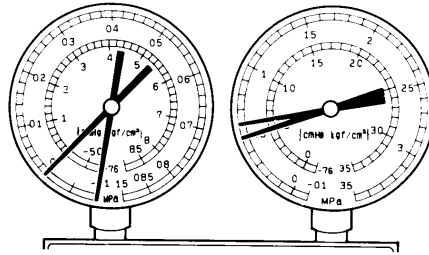
I01389

(4) Poor circulation of refrigerant

Condition: Insufficient cooling

| Symptom seen in refrigeration system | Probable cause | Diagnosis | Remedy |
|---|---|---|---|
| <ul style="list-style-type: none"> <li>Pressure low in both low and high pressure sides</li> <li>Frost on tube from receiver to unit</li> </ul> | Refrigerant flow obstructed by dirt in receiver | Receiver clogged | Replace receiver |

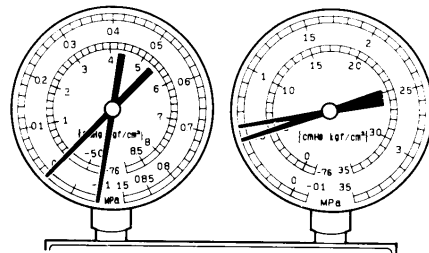
I01449

(5) Refrigerant does not circulate

Condition: Does not cool (Cools from time to time in some cases)

| Symptom seen in refrigeration system | Probable cause | Diagnosis | Remedy |
|---|---|---|---|
| <ul style="list-style-type: none"> <li>Vacuum indicated on low pressure side, very low pressure indicated on high pressure side</li> <li>Frost or dew seen on piping before and after receiver/ drier or expansion valve</li> </ul> | <ul style="list-style-type: none"> <li>Refrigerant flow obstructed by moisture or dirt in refrigeration system</li> <li>Refrigerant flow obstructed by gas leakage from expansion valve</li> </ul> | Refrigerant does not circulate | <ol style="list-style-type: none"> <li>Check expansion valve</li> <li>Clean out dirt in expansion valve by blowing with air</li> <li>Replace receiver</li> <li>Evacuate air and charge new refrigerant to proper amount</li> <li>For gas leakage from expansion valve, replace expansion valve</li> </ol> |

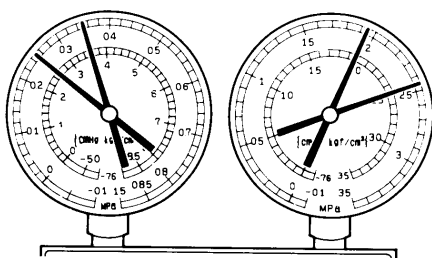
I01390

## (6) Refrigerant overcharged or insufficient cooling of condenser

Condition: Insufficient cooling

| Symptom seen in refrigeration system | Probable cause | Diagnosis | Remedy |
|---|---|---|---|
| <ul style="list-style-type: none"> <li>Pressure too high on both low and high pressure sides</li> <li>No air bubbles seen through the sight glass even when the engine rpm is lowered</li> </ul> | <ul style="list-style-type: none"> <li>Unable to develop sufficient performance due to excessive refrigeration system</li> <li>Insufficient cooling of condenser</li> </ul> | <ul style="list-style-type: none"> <li>Excessive refrigerant in cycle → refrigerant over charged</li> <li>Condenser cooling → condenser fins clogged of condenser fan faulty</li> </ul> | (1) Clean condenser<br>(2) Check condenser fan motor operation<br>(3) If (1) and (2) are in normal state, check amount of refrigerant<br>Charge proper amount of refrigerant |

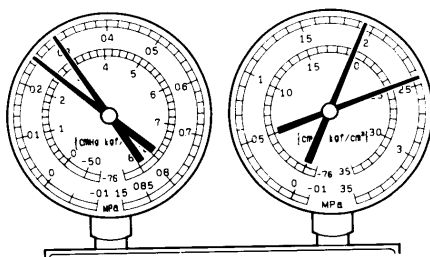
I01392

## (7) Air present in refrigeration system

Condition: Insufficient cooling

NOTE : These gauge indications are shown when the refrigeration system has been opened and the refrigerant charged without vacuum purging.

| Symptom seen in refrigeration system | Probable cause | Diagnosis | Remedy |
|---|---|---|---|
| <ul style="list-style-type: none"> <li>Pressure too high on both low and high pressure sides</li> <li>The low pressure piping hot to touch</li> <li>Bubbles seen in sight glass</li> </ul> | Air entered in refrigeration system | <ul style="list-style-type: none"> <li>Air present in refrigeration system</li> <li>Insufficient vacuum purging</li> </ul> | (1) Check compressor oil to see if it is dirty or insufficient<br>(2) Evacuate air and charge new refrigerant |

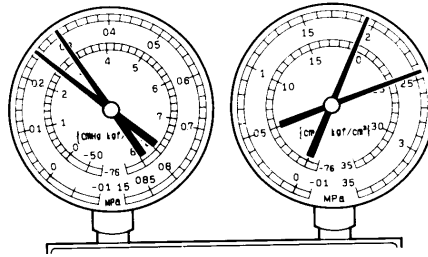
I01450

(8) Expansion valve improperly

Condition: Insufficient cooling

| Symptom seen in refrigeration system | Probable cause | Diagnosis | Remedy |
|---|---|---|---|
| <ul style="list-style-type: none"> <li>Pressure too high on both low and high pressure sides</li> <li>Frost or large amount of dew on piping on low pressure side</li> </ul> | Trouble in expansion valve | <ul style="list-style-type: none"> <li>Excessive refrigerant in low pressure piping</li> <li>Expansion valve opened too wide</li> </ul> | (1) Check expansion valve<br>(2) Check heat sensing tube installed condition<br>Replace if defective |

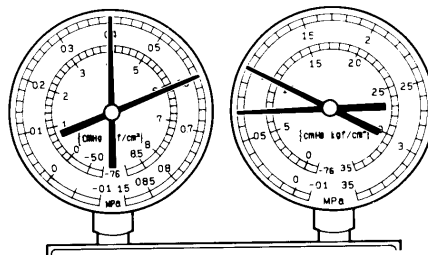
I01393

(9) Defective compression compressor

Condition : Does not cool

| Symptom seen in refrigeration system | Probable cause | Diagnosis | Remedy |
|---|---|---|---|
| <ul style="list-style-type: none"> <li>Pressure too high on low and high pressure sides</li> <li>Pressure too low on high pressure side</li> </ul> | Internal leak in compressor | <ul style="list-style-type: none"> <li>Compression defective</li> <li>Valve leaking or broken sliding parts</li> </ul> | Repair or replace compressor |
