## Idle Air Control (IAC) Valve

### P1508

The scan tool indicates Diagnostic Trouble Code (DTC) P1508: A problem in the Idle Air Control (IAC) valve circuit.

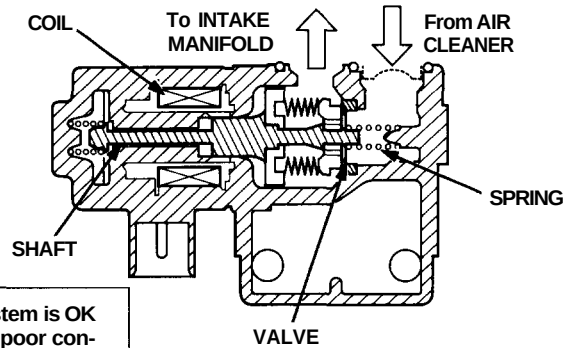
IAC VALVE CONNECTOR (C129)

The IAC Valve changes the amount of air bypassing the throttle body in response to a current signal from the PCM in order to maintain the proper idle speed.

Wire side of female terminals

PCM CONNECTOR A (26P)

IACV (BLK/BLU)
