# Precautions/Procedures

## Spring-loaded Lock Connector with Built-in Short Contact

## Seats with Side Airbags - '99 - 01 Models

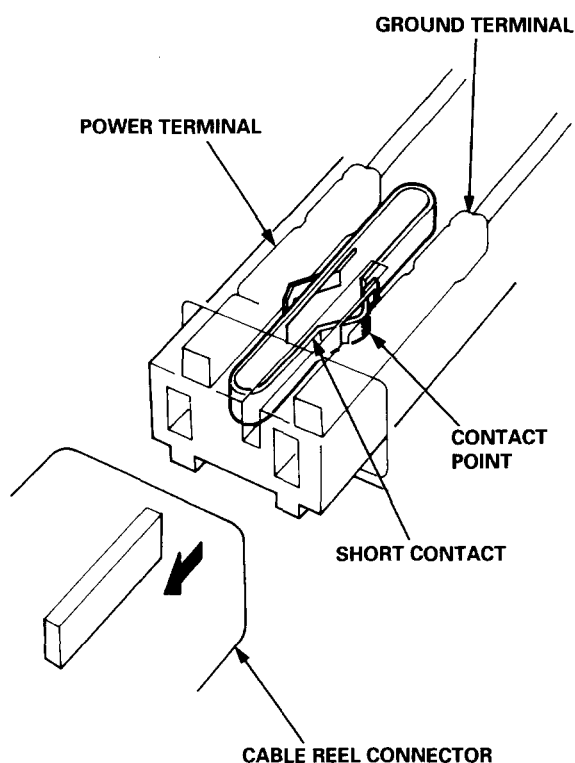
### Connector halves disconnected:

Both frontal airbags, the side airbags (if so equipped), and the seat belt tensioners have a spring-loaded lock connector with a built-in short contact. When this connector is disconnected, the power terminal and the ground terminal in the airbag connector are automatically shorted.

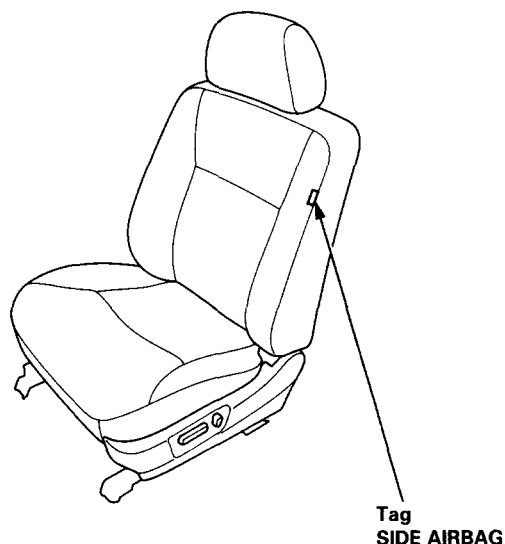
- Seats with side airbags have a tag attached to the seat-back. Because the component parts (seat-back cover, cushion, etc.) of seats with and without airbags are different, make sure you install only the correct replacement parts.

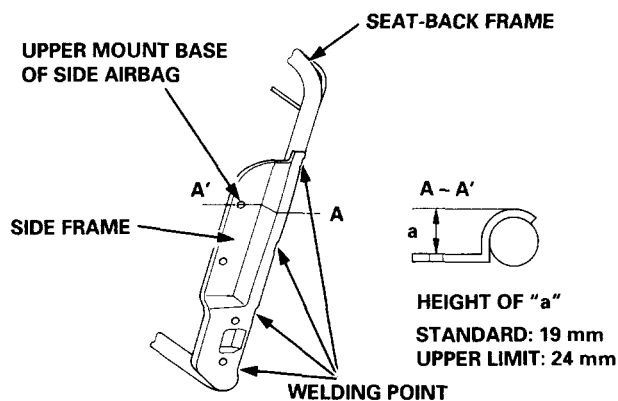
- When cleaning, do not saturate the seat with liquid, and do not spray steam on the seat.
- Do not repair torn or frayed seat-back covers. Replace the seat-back cover.
- After a collision in which the side airbag was deployed, replace the seat-back cover and the side airbag with new parts. If the seat-back cushion is split, it must be replaced. If the seat-back frame is deformed, it must be replaced. If you are not sure if the seat-back frame is deformed, check the side airbag upper mount base as shown below. If the distance "a" is more than 24 mm, replace the seat-back frame.
