# Troubleshooting - '96 - 98 Models

## DTC 3-1 and 3-2

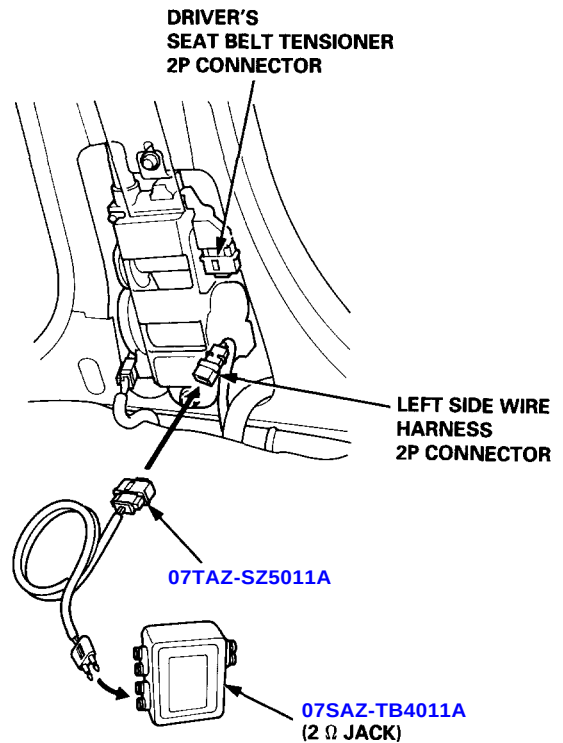
1. Turn the ignition switch OFF. Make sure you have the anti-theft code for the radio, then write down the frequencies for the radio's preset buttons.
2. Disconnect the battery negative cable, then disconnect the positive cable, and wait for 3 minutes.
3. Disconnect the driver's seat belt tensioner 2P connector from the left side wire harness.  
**CAUTION: Do not disconnect the front passenger's seat belt tensioner connector.**
4. Connect the special tool (2  $\Omega$ ) to the left side wire harness 2P connector.
5. Reconnect the battery positive cable, then reconnect the negative cable.
6. Erase the DTC memory (see page 24-37).
7. Read the DTC (see page 24-35).

Open or increased resistance in the driver's seat belt tensioner; replace the driver's seat belt (see page 24-165).

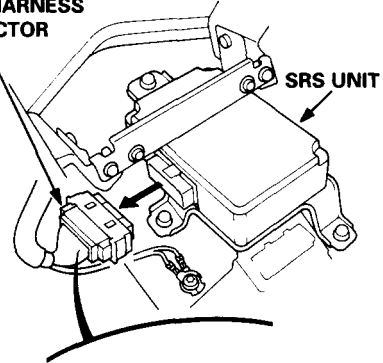
**SRS MAIN HARNESS 18P CONNECTOR**

1. Disconnect the battery negative cable, then disconnect the positive cable, and wait for 3 minutes.
2. Disconnect the driver's and front passenger's airbag connectors, then disconnect the front passenger's seat belt tensioner connector (see page 24-33).
3. Disconnect the SRS main harness 18P connector from the SRS unit. Do not disconnect the special tool (2  $\Omega$ ) from the left side wire harness 2P connector.
4. Check resistance between the No. 4 terminal and No. 11 terminal of SRS main harness 18P connector. There should be approx. 2.0 - 3.0  $\Omega$ .

**Poor contact at the SRS main harness 18P connector; check the connector.**

- If the connector is OK, substitute a known-good SRS unit, and recheck.
- If the problem is still present, replace the SRS main harness.

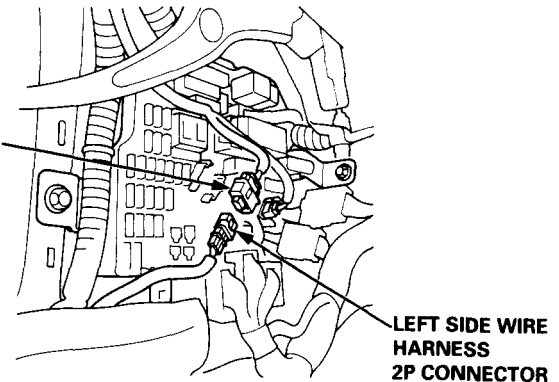
**LEFT SIDE WIRE HARNESS 2P CONNECTOR**

1. Disconnect the SRS main harness 2P connector from the left side wire harness.  
NOTE: Do not disconnect the special tool (2  $\Omega$ ).
2. Check resistance between the No. 1 terminal and No. 2 terminal of the left side wire harness 2P connector. There should be approx. 2.0 - 3.0  $\Omega$ .

**Open or increased resistance in the SRS main harness; replace the SRS main harness.**

**Open or increased resistance in the left side wire harness; repair the left side wire harness.**
