# Troubleshooting - '96 - 98 Models

## DTC 3-3

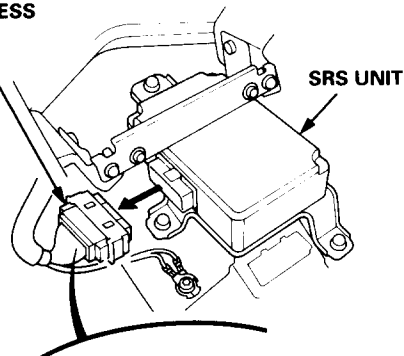
**SRS MAIN HARNESS 18P CONNECTOR**

1. Disconnect the battery negative cable, then disconnect the positive cable, and wait for 3 minutes.
2. Disconnect the driver's and front passenger's airbag connectors, then disconnect the front passenger's seat belt tensioner connector (see page [24-33](#)).
3. Disconnect the SRS main harness 18P connector from the SRS unit.  
NOTE: Do not disconnect the special tool (2  $\Omega$ ) from the left side wire harness 2P connector.
4. Check resistance between the No. 4 terminal and No. 11 terminal of SRS main harness 18P connector. There should be approx. 2.0 - 3.0  $\Omega$ .

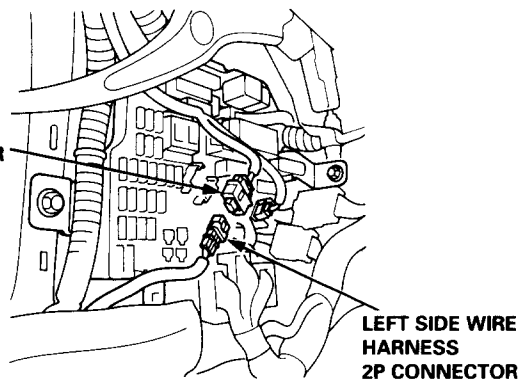
**SRS MAIN HARNESS 2P CONNECTOR**

1. Disconnect the SRS main harness 2P connector from the left side wire harness.  
NOTE: Do not disconnect the special tool (2  $\Omega$ ).
2. Check resistance between the No. 1 terminal and No. 2 terminal of the left side wire harness 2P connector. There should be approx. 2.0 - 3.0  $\Omega$ .

**LEFT SIDE WIRE HARNESS 2P CONNECTOR**
