# Troubleshooting - '99 - 01 Models

## DTC 14-3

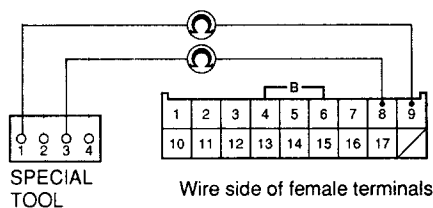
1. Connect the special tool to the SRS floor harness 4P connector (see page 24-97).
2. Check resistance between the No. 9 terminal of the SRS floor harness 18P connector and the No. 1 terminal of the special tool, and between the No. 8 terminal of the SRS floor harness 18P connector and the No. 3 terminal of the special tool. There should be 0 – 1.0 Ω.
