# INSPECTION

# HORN SYSTEM LOCATION

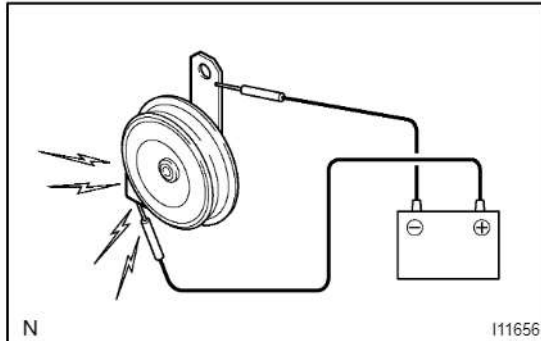
## 1. INSPECT LOW PITCHED HORN ASSY

- Connect the positive (+) lead from the battery to the terminal and the negative (-) lead to the horn body, and check that the horn blows.

If the result is not as specified, replace the horn.

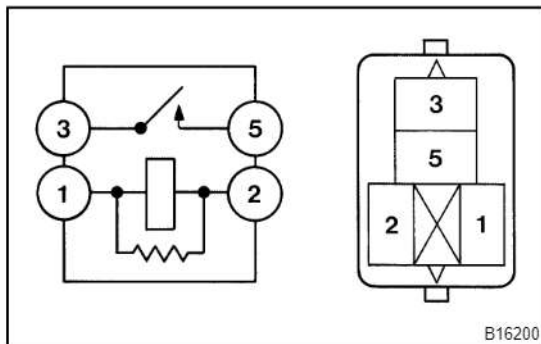
## 2. INSPECT HORN RELAY ASSY (Marking: HORN)

- Remove the horn relay from the engine room J/B.
- Inspect the horn relay continuity.

### Standard:

| Terminal No. | Condition | Specified condition |
| 1 ⇔ 2 | Constant | Continuity |
| 3 ⇔ 5 | Apply B+ between terminals 1 and 2 | |

If the result is not as specified, replace the relay.
