**2007 BMW X3**

## GENERAL INFORMATION Diagnostic Connector (DLC) Locations

## COMPONENT LOCATION GRAPHICS

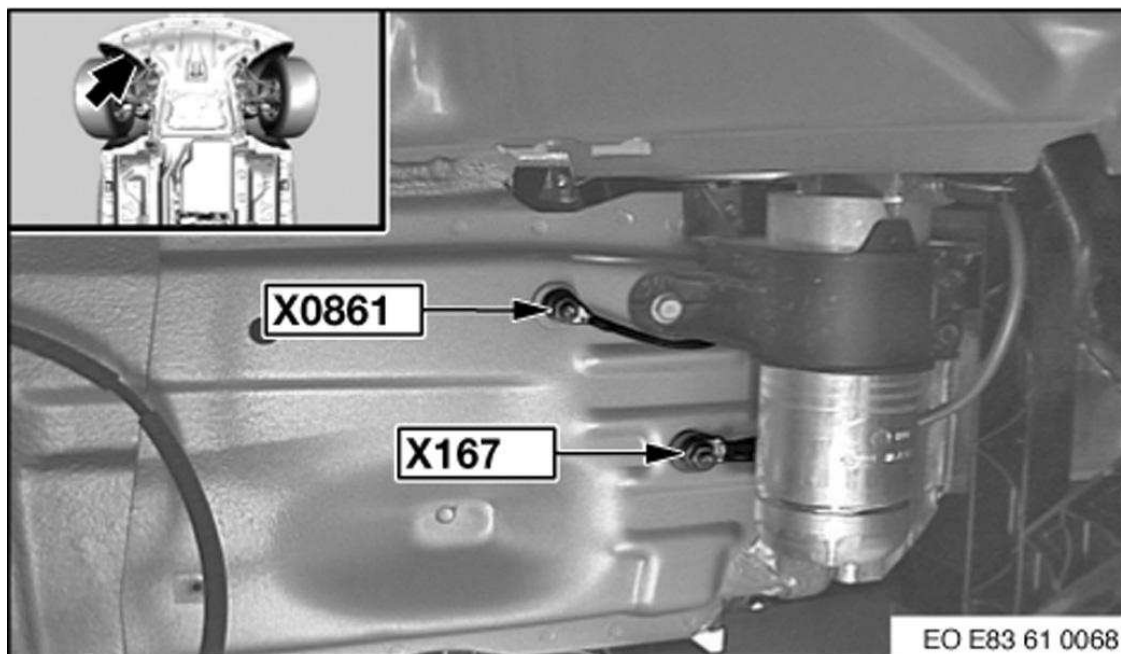
G00365149

**Fig. 1: Right Front Wheelwell**  
Courtesy of BMW OF NORTH AMERICA, INC.

| Component | Location |
|---|---|
| X167 | Right front wheelwell. See <a href="#">Fig. 1</a> . |
| X0861 | Right front wheelwell. See <a href="#">Fig. 1</a> . |

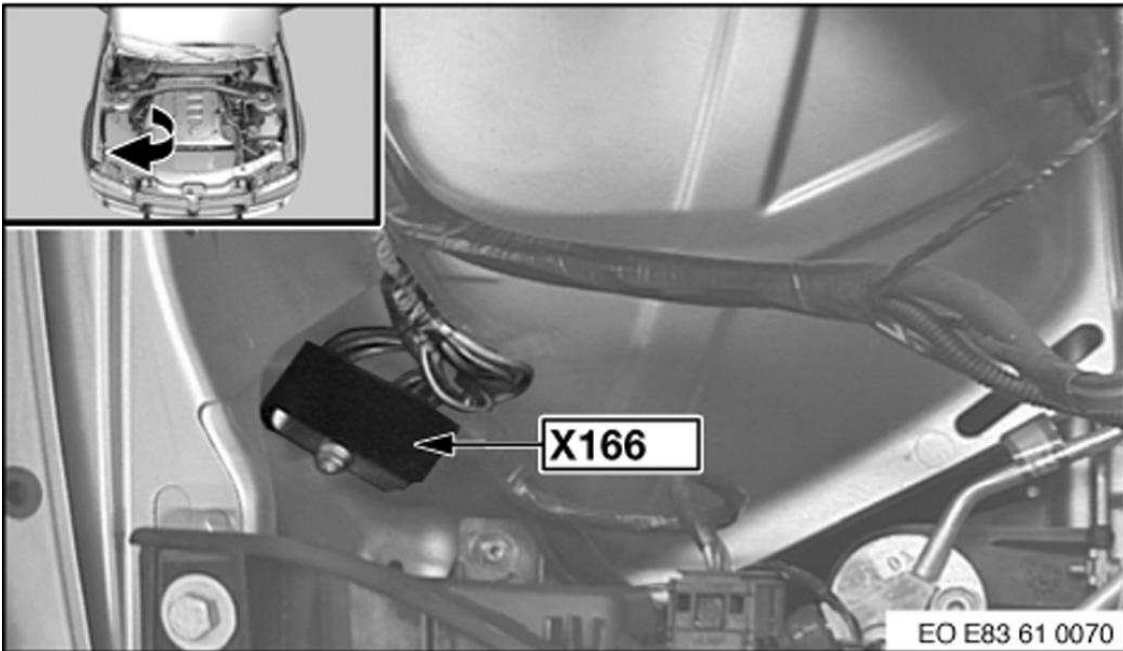
G00365150

**Fig. 2: Right Front Of Engine Compartment**  
Courtesy of BMW OF NORTH AMERICA, INC.

| Component | Location |
|---|---|
| X166 | Right front engine compartment. See <a href="#">Fig. 2</a> . |

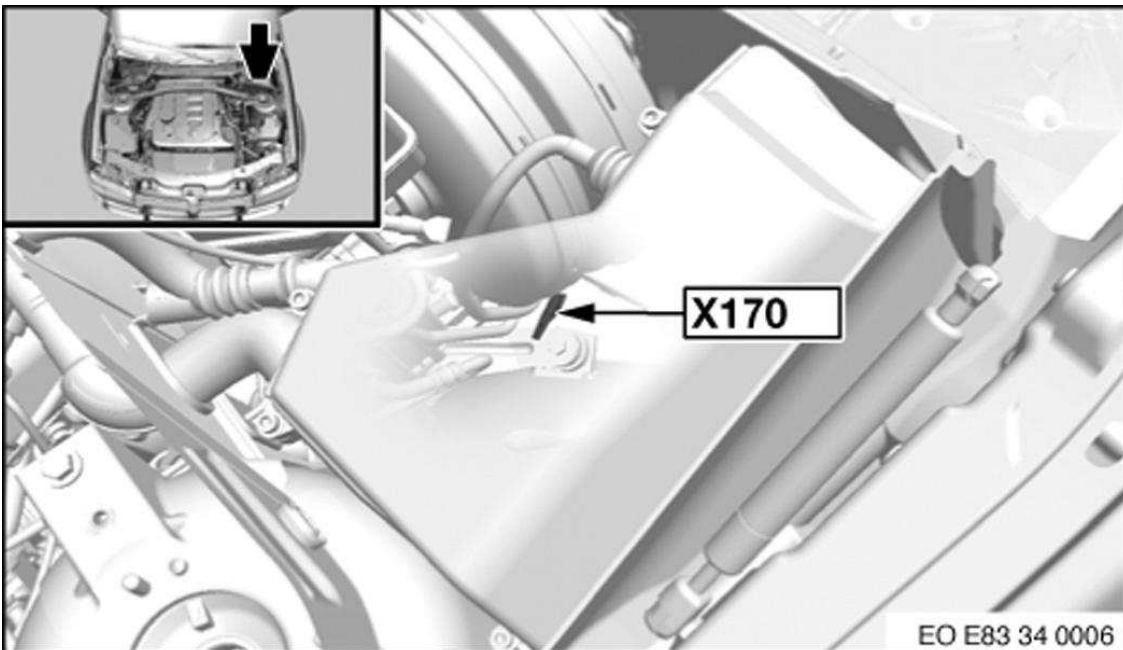
G00420837

**Fig. 3: Left Rear Of Engine Compartment**  
Courtesy of BMW OF NORTH AMERICA, INC.

| Component | Location |
|---|---|
| X170 | Left rear engine compartment. See <a href="#">Fig. 3</a> . |

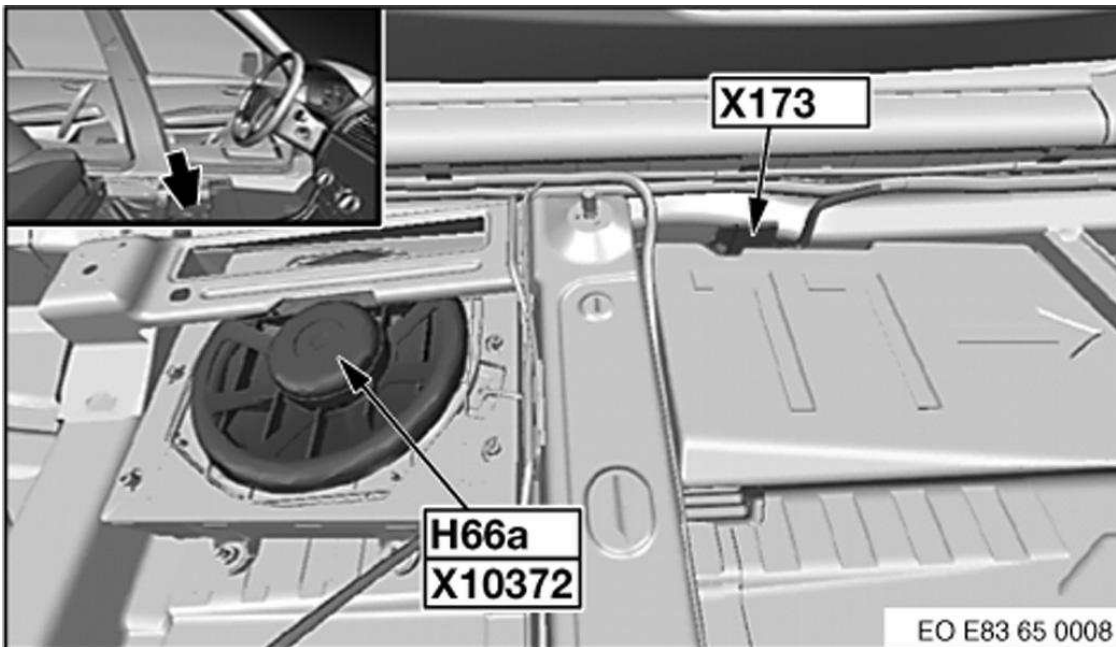
G00365152

**Fig. 4: Below Driver's Seat**

| Component | Location |
|---|---|
| X173 | Below driver's seat. See <a href="#">Fig. 4</a> . |

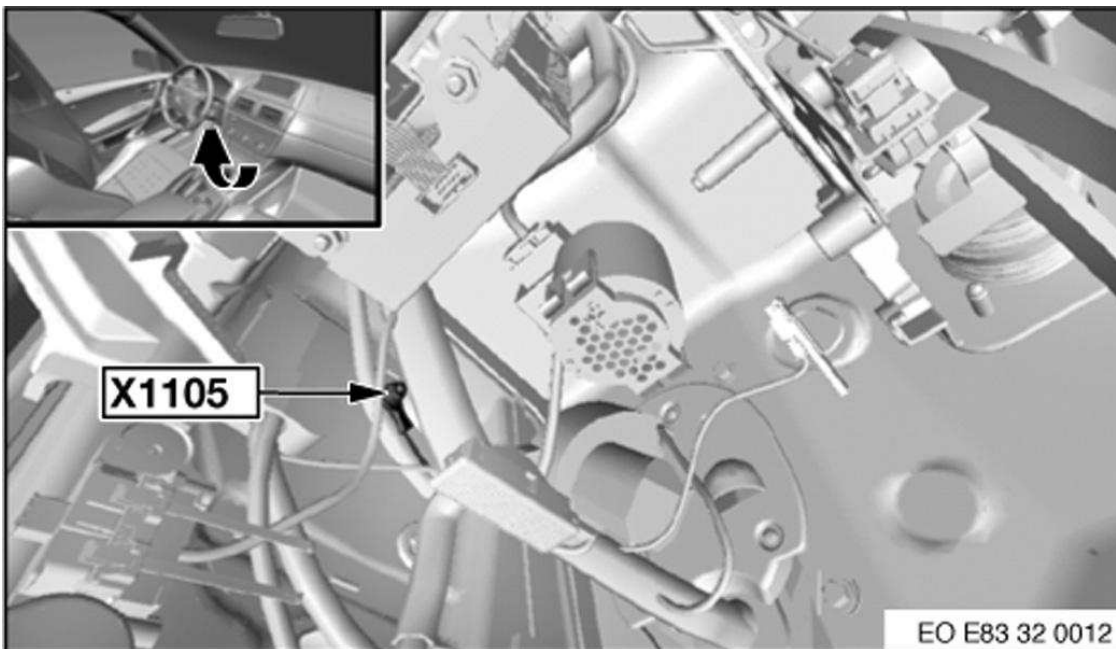
G00365154

**Fig. 5: Left Side Of Dash**

| Component | Location |
|---|---|
| X1105 | Left side of dash. See <a href="#">Fig. 5</a> . |

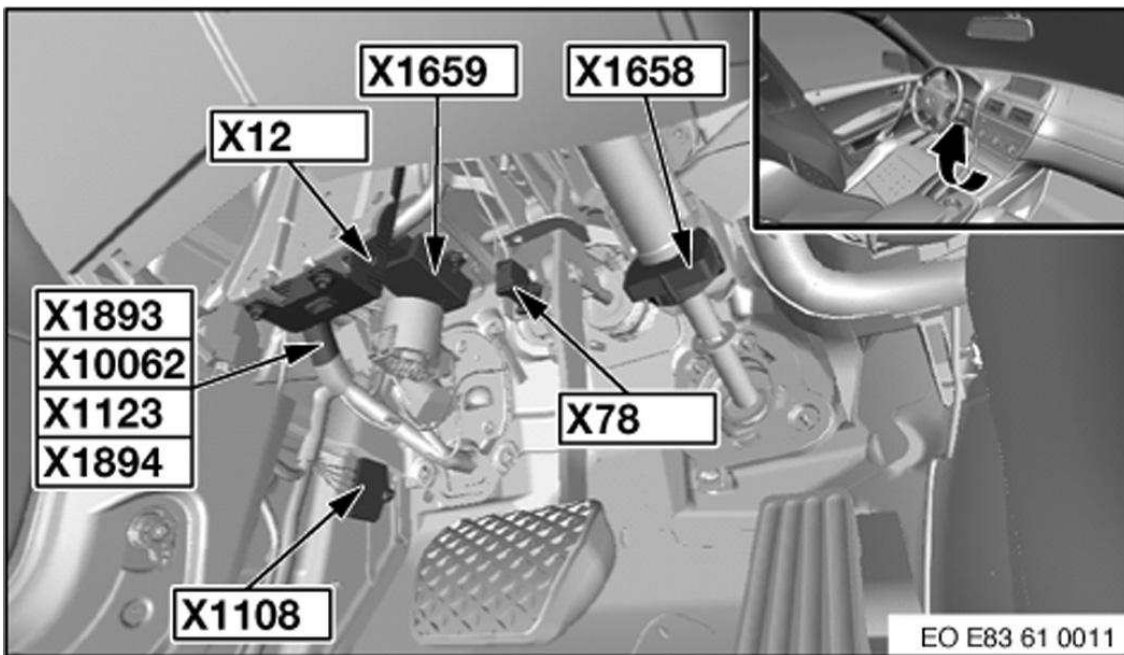
G00365155

**Fig. 6: Left Kick Panel**

| Component | Location |
|---|---|
| X1108 | Left kick panel. See <a href="#">Fig. 6</a> . |

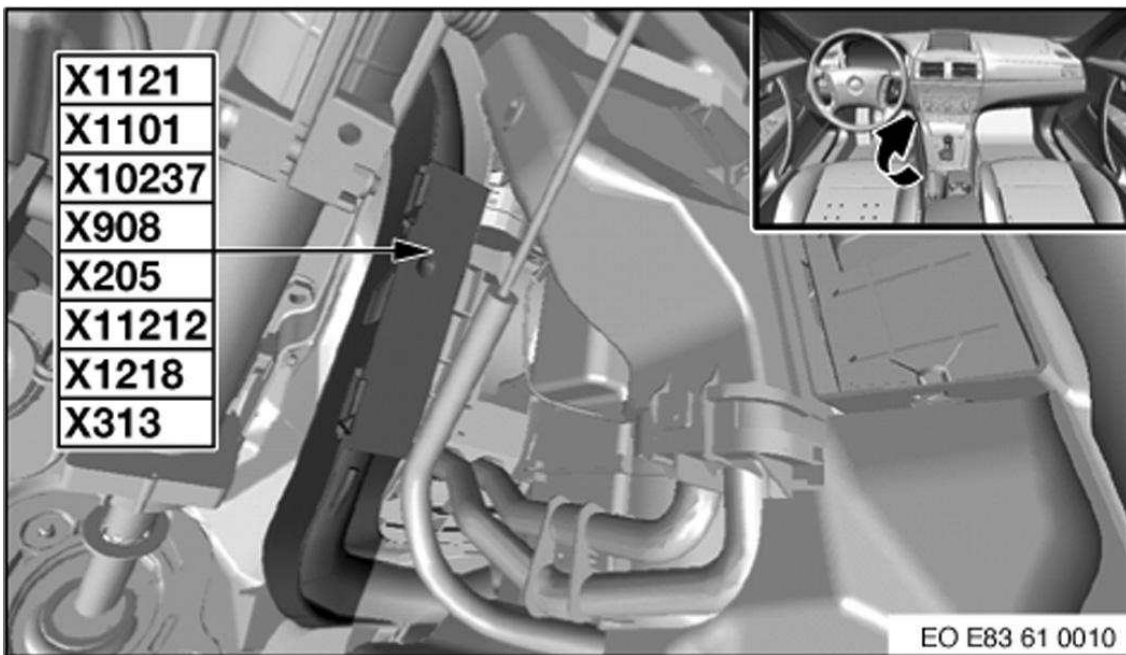
G00365157

**Fig. 8: Center Of Dash**

| X10237 | Center of dash. See <a href="#">Fig. 8.</a> |

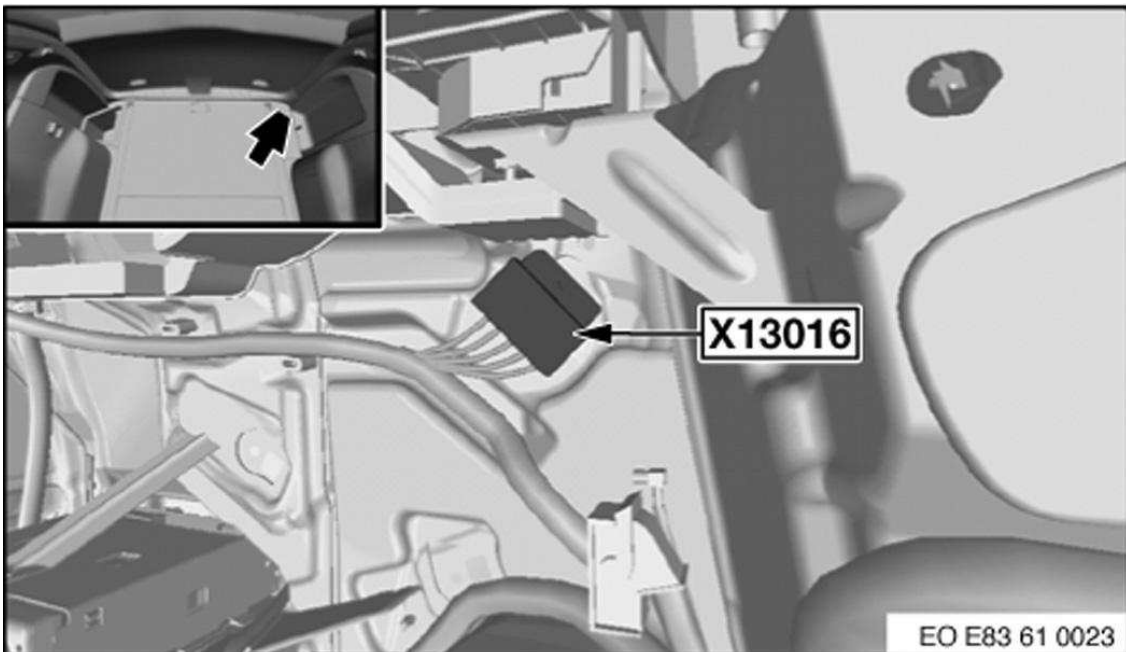
G00365158

**Fig. 9: Right Side Of Luggage Compartment**

| Component | Location |
|---|---|
| X13016 | Right side of luggage compartment. See <a href="#">Fig. 9</a> . |

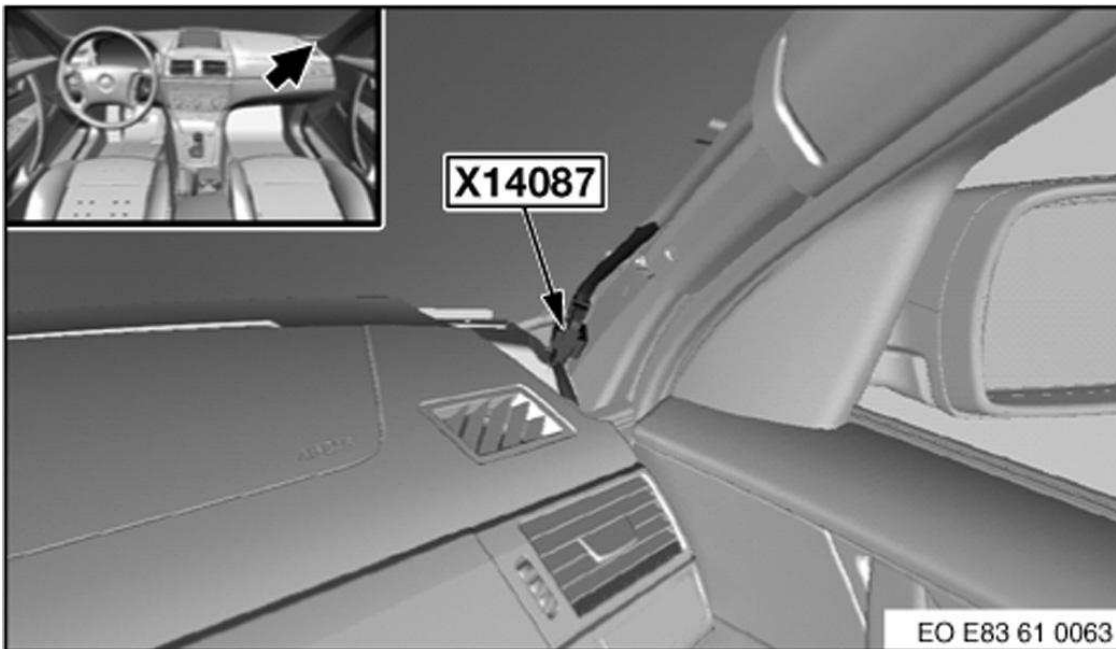
G00365159

**Fig. 10: Right "A" Pillar**

| Component | Location |
|---|---|
| X14087 (26 Pin) | Right "A" pillar. See <a href="#">Fig. 10</a> . |

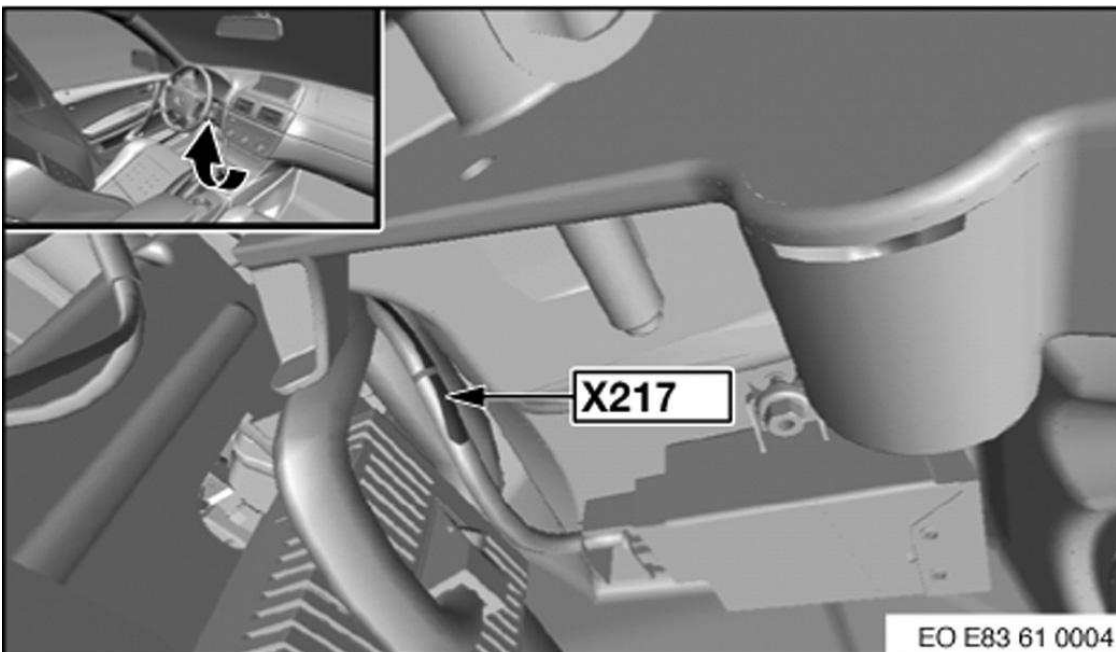
G00365160

**Fig. 11: Left Side Of Dash**

| X217 | Left side of dash. See <a href="#">Fig. 11.</a> |

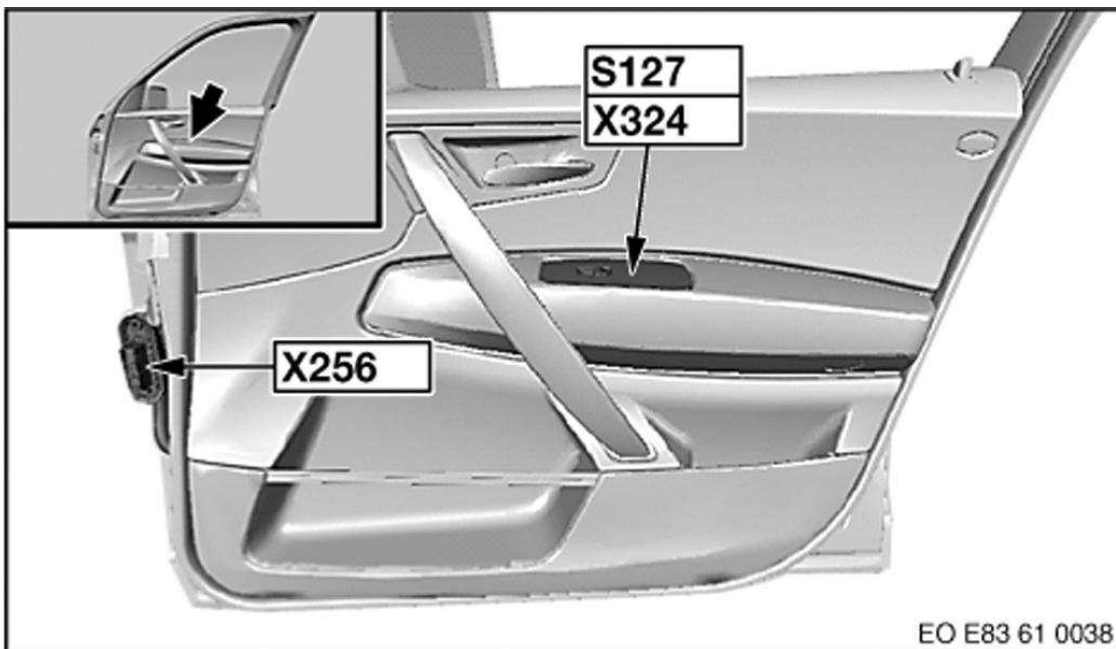
G00365161

**Fig. 12: Right Front Door**

| Component | Location |
|---|---|
| X256 (37 Pin) | Right front door. See <a href="#">Fig. 12</a> . |

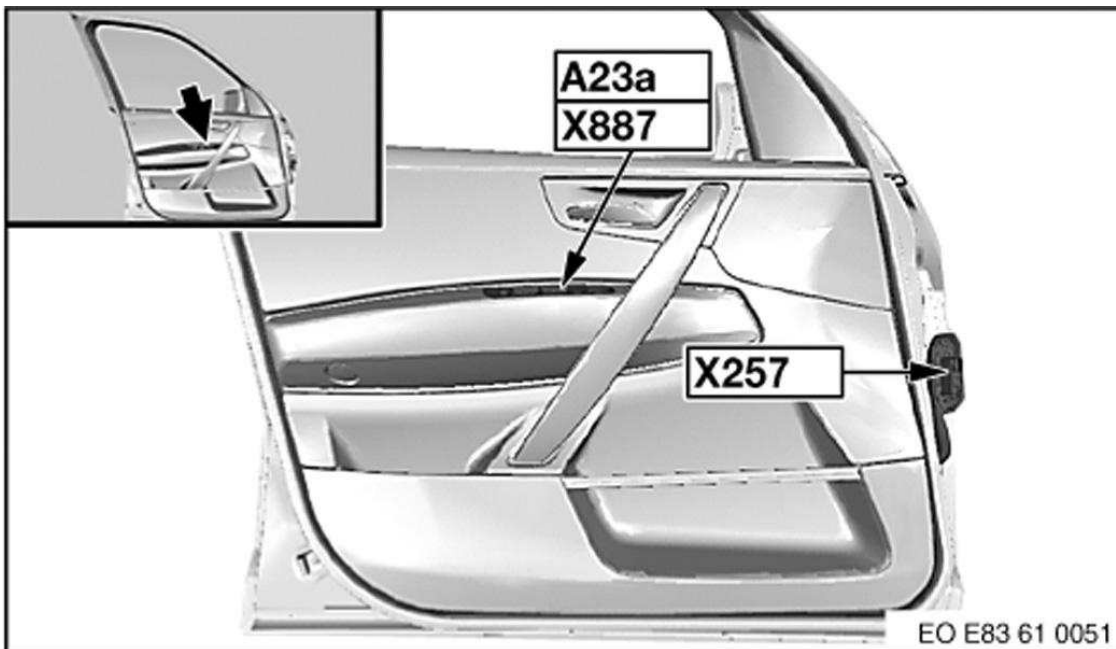
G00365162

**Fig. 13: Left Front Door**

| Component | Location |
|---|---|
| X257 (37 Pin) | Left front door. See <a href="#">Fig. 13</a> . |

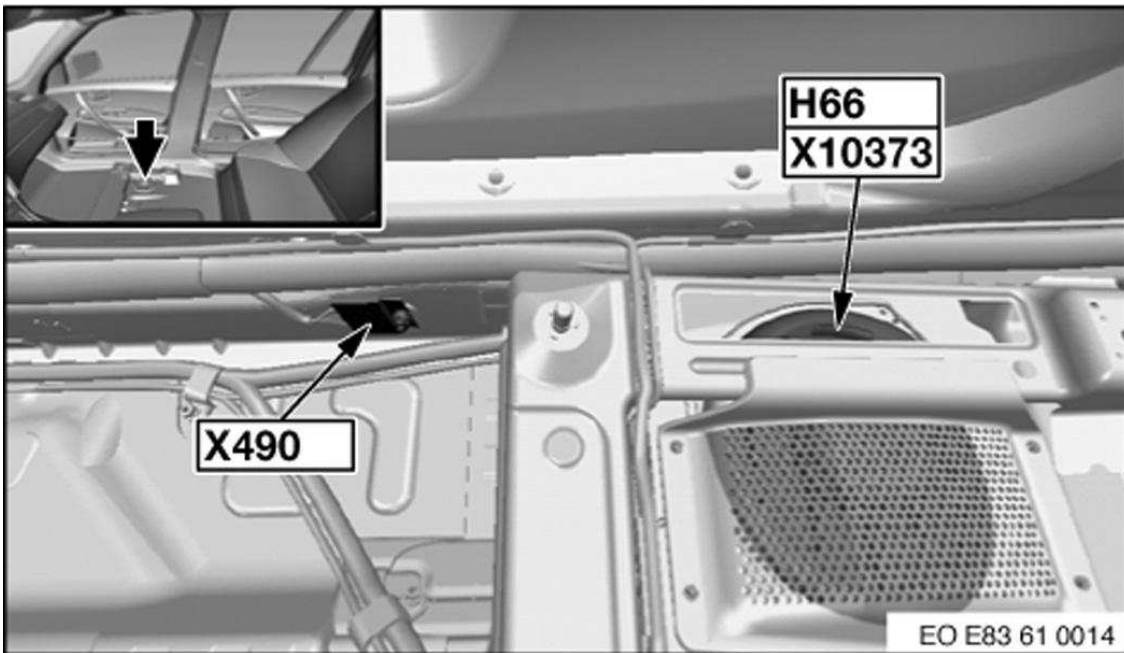
G00365164

**Fig. 14: Right Door Sill**

| Component | Location |
|---|---|
| X490 | Right door sill. See <a href="#">Fig. 14</a> . |

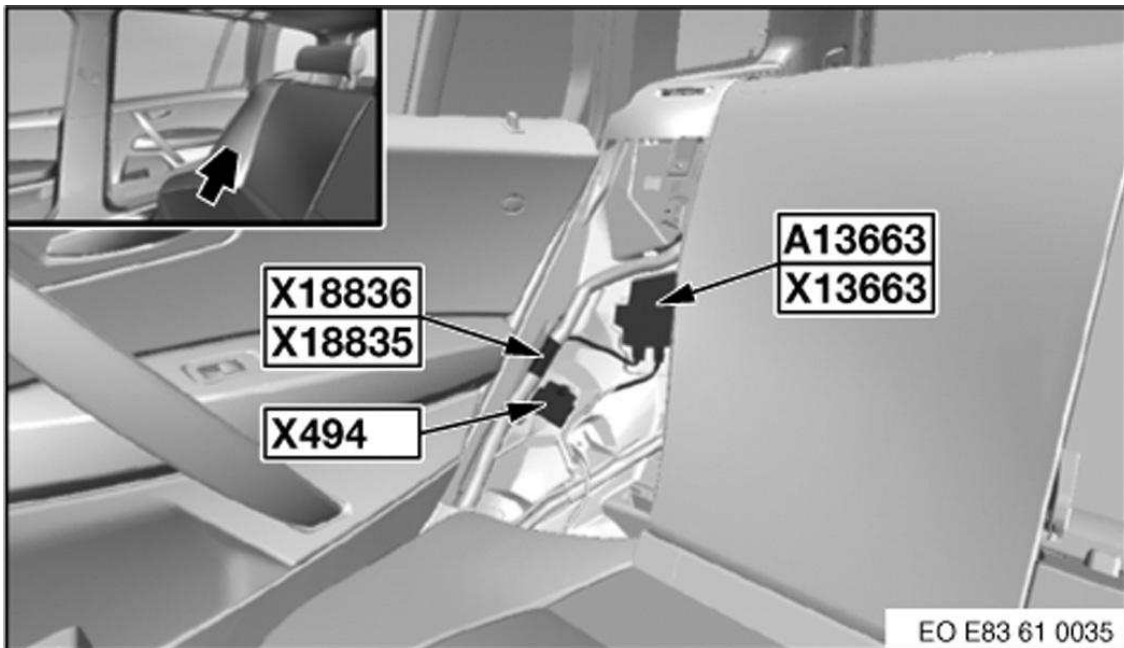
G00365165

**Fig. 15: Right Side Of Rear Seat**

| Component | Location |
|---|---|
| X494 | Right side of rear seat. See <a href="#">Fig. 15</a> . |

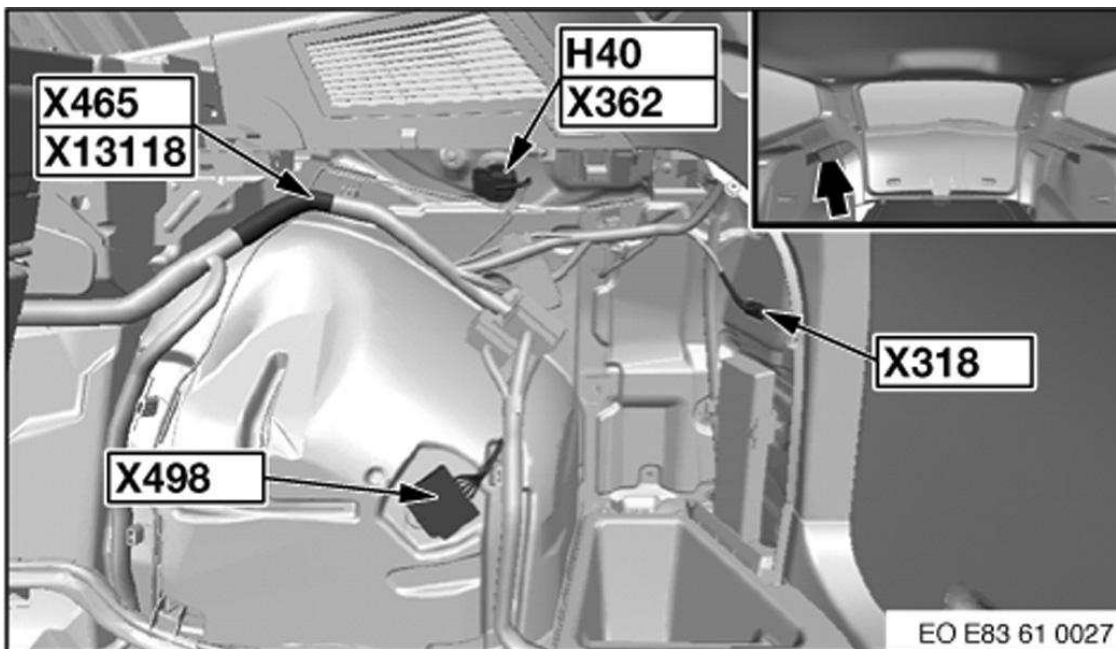
G00365166

**Fig. 16: Right Side Of Luggage Compartment**  
Courtesy of BMW OF NORTH AMERICA, INC.

| Component | Location |
|---|---|
| X498 | Right side of luggage compartment. See <a href="#">Fig. 16</a> . |

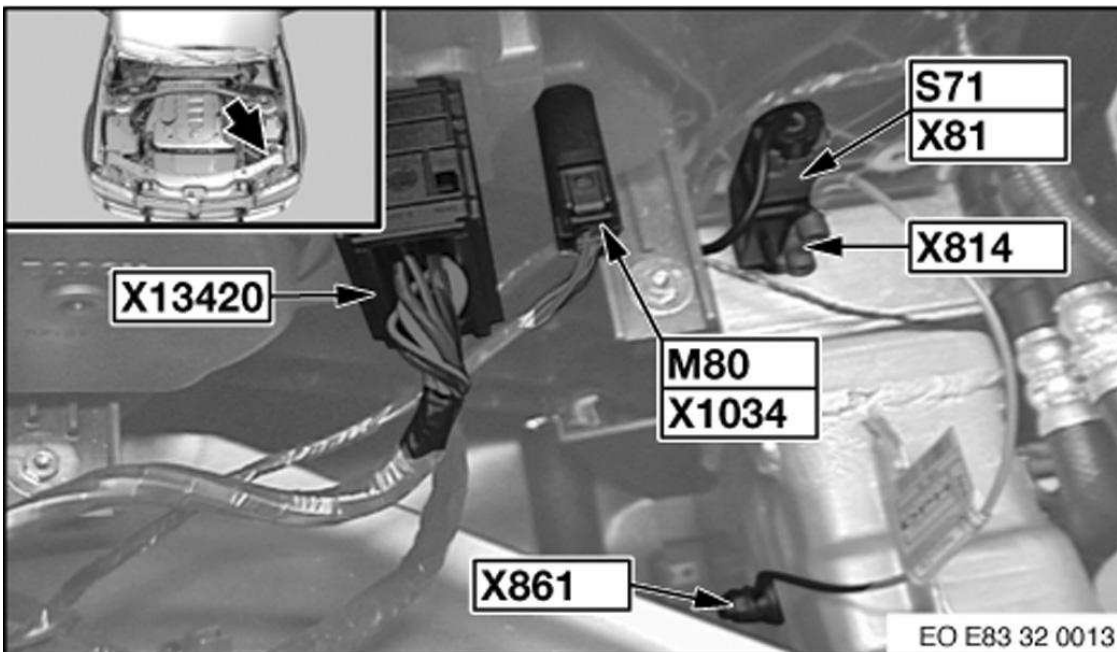
G00365168

**Fig. 17: Left Front Of Engine Compartment**  
Courtesy of BMW OF NORTH AMERICA, INC.

| <b>Component</b> | <b>Location</b> |
|---|---|
| Left Headlight Beam Height Control Stepper Motor (M80) | Left front of engine compartment. See <b>Fig. 17.</b> |

| <b>Component</b> | <b>Location</b> |
|---|---|
| Left Front Airbag Sensor (S71) | Left front of engine compartment. See <b>Fig. 17.</b> |

| Component | Location |
|---|---|
| X861 | Left front of engine compartment. See <a href="#">Fig. 17</a> . |

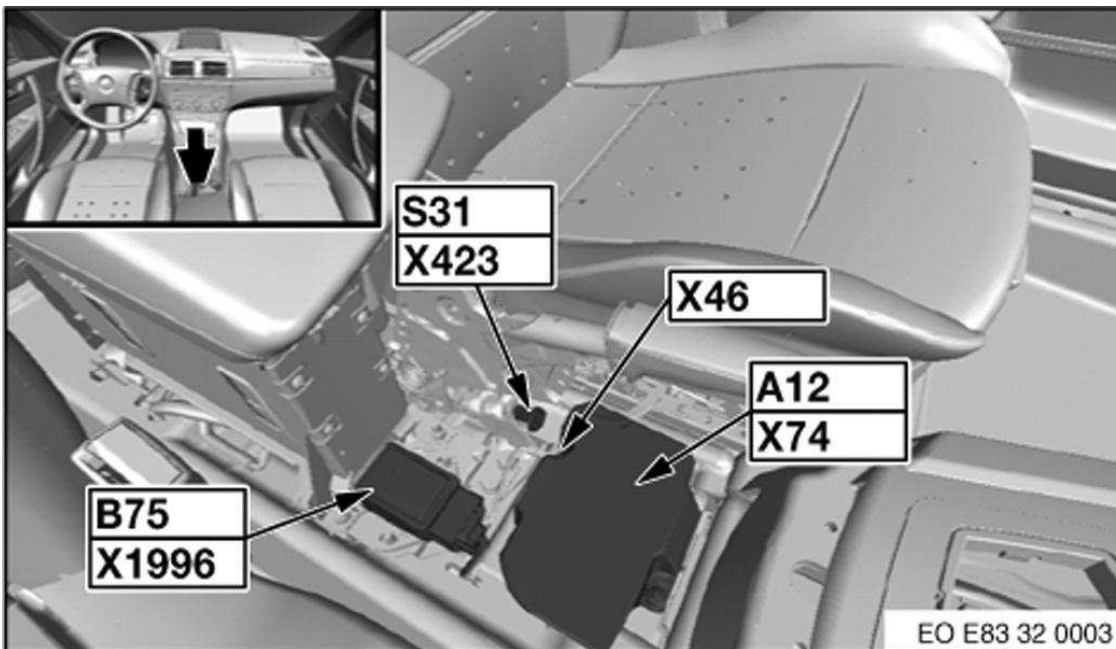
G00365170

**Fig. 19: Center Console**

| <b>Component</b> | <b>Location</b> |
|---|---|
| Multiple Restraint System Control Module (A12) | In center console. See <a href="#">Fig. 19.</a> |

| <b>Component</b> | <b>Location</b> |
|---|---|
| DSC Sensor (B75) | Center console. See <b>Fig. 19.</b> |

| Component | Location |
|---|---|
| Park Brake Switch (S31) | Rear center console. See <a href="#">Fig. 19.</a> |

| Component | Location |
|---|---|
| X46 | Center console. See <a href="#">Fig. 19</a> . |

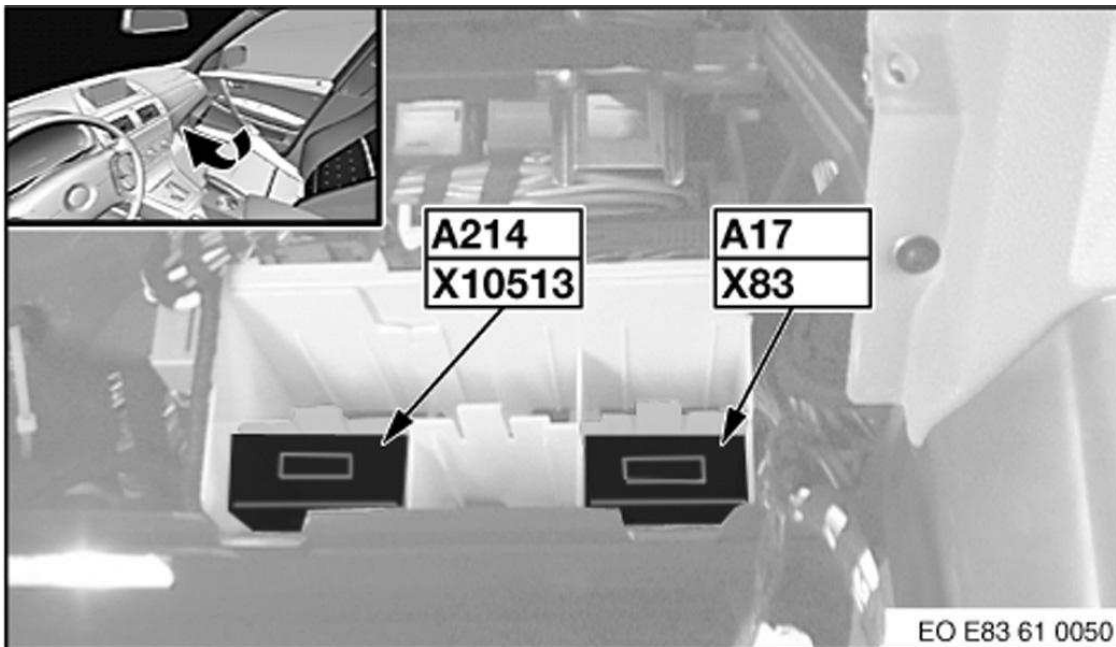
G00365171

**Fig. 20: Right Side Of Dash**

| Servotronic (A17) | Right side of dash. See <b>Fig. 20.</b> |

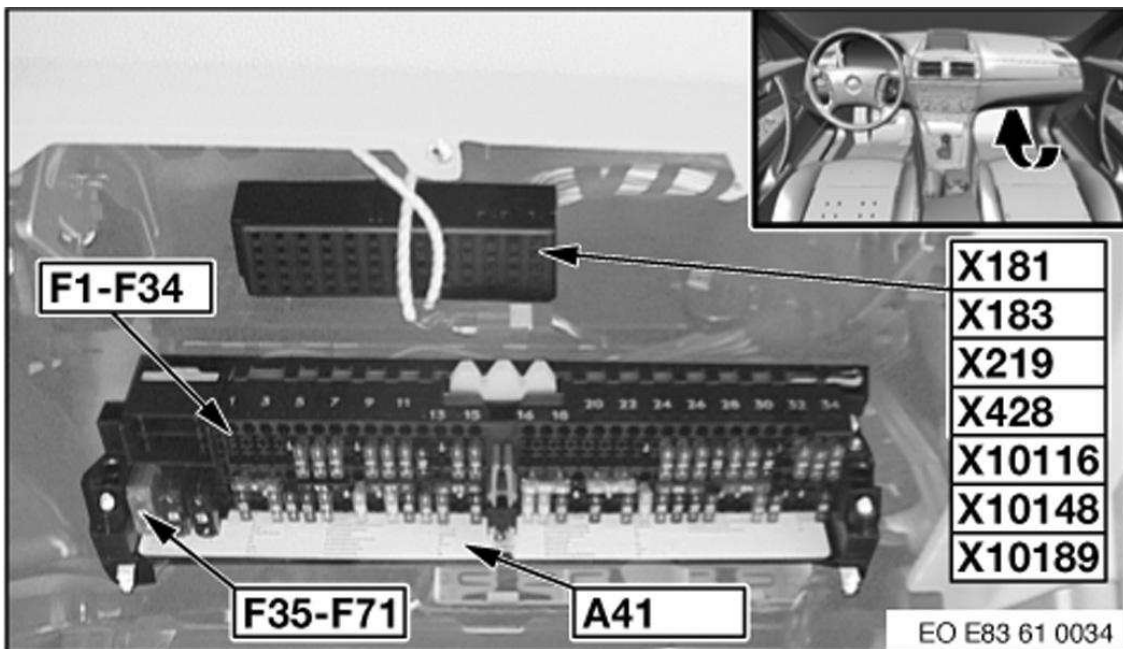
G00365173

**Fig. 22: Right Side Of Dash**

| X181 | Right side of dash. See <a href="#">Fig. 22.</a> |
| X183 | Right side of dash. See <a href="#">Fig. 22.</a> |
| X219 | Right side of dash. See <a href="#">Fig. 22.</a> |
| X428 | Right side of dash. See <a href="#">Fig. 22.</a> |
| X10116 | Right side of dash. See <a href="#">Fig. 22.</a> |
| X10189 | Right side of dash. See <a href="#">Fig. 22.</a> |

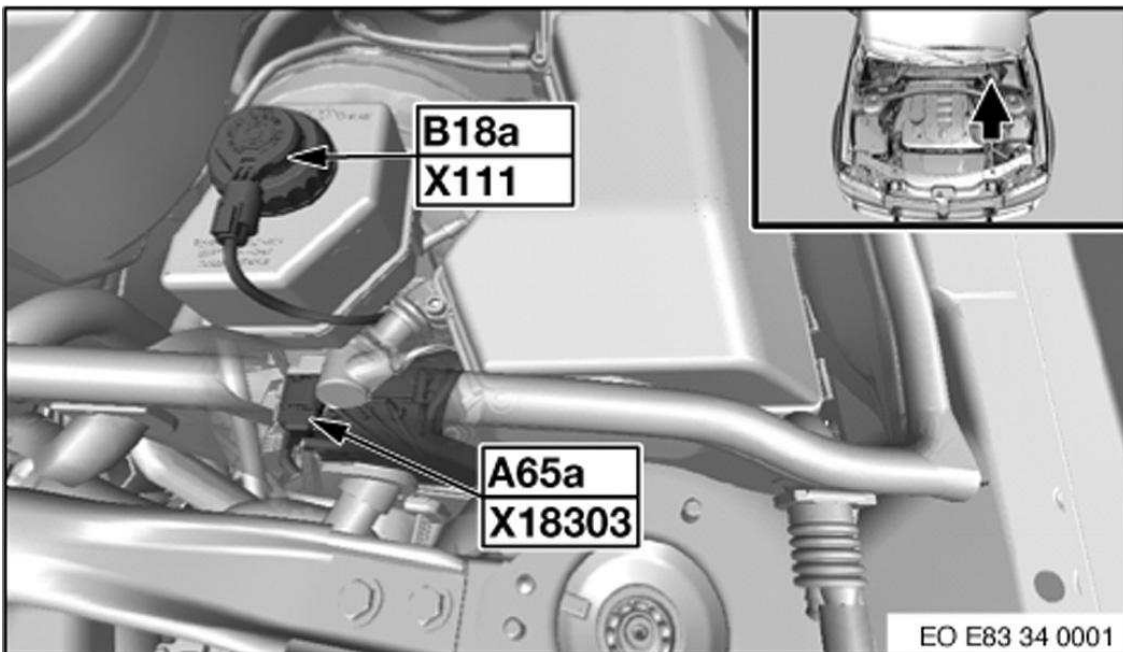
G00365174

**Fig. 23: Left Rear Of Engine Compartment**

| Component | Location |
|---|---|
| Brake Fluid Level Switch (B18a) | Left rear engine compartment. See <a href="#">Fig. 23.</a> |

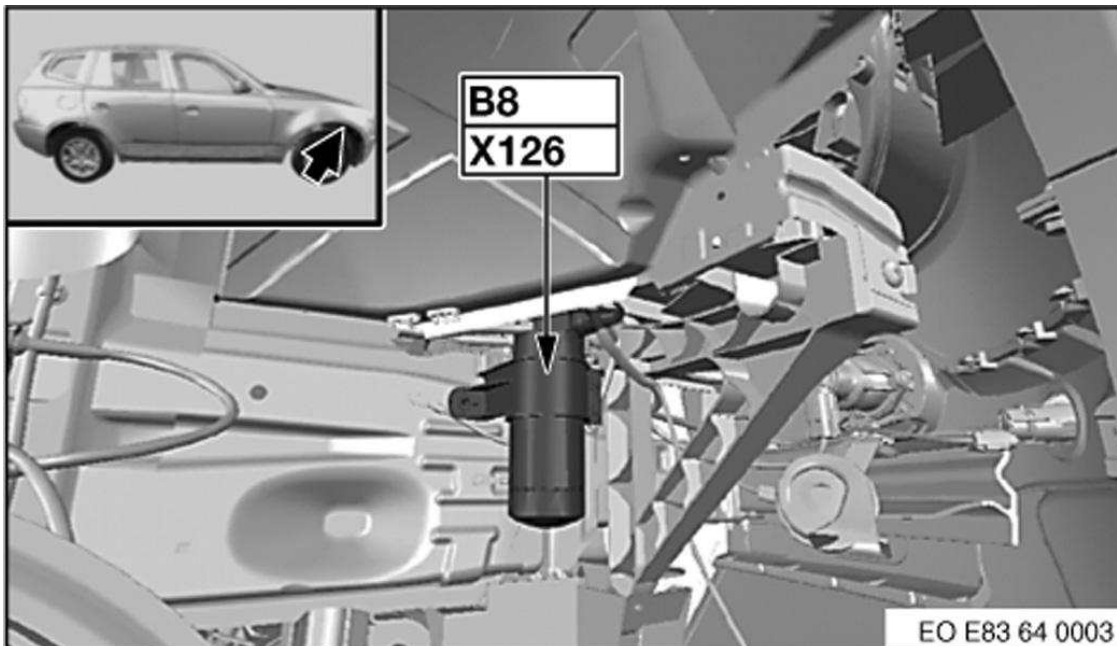
G00365176

**Fig. 25: Right Front Wheelwell**  
 Courtesy of BMW OF NORTH AMERICA, INC.

| <b>Component</b> | <b>Location</b> |
|---|---|
| Coolant Pressure Sensor (B8) | Right front wheelwell. See <b>Fig. 25.</b> |

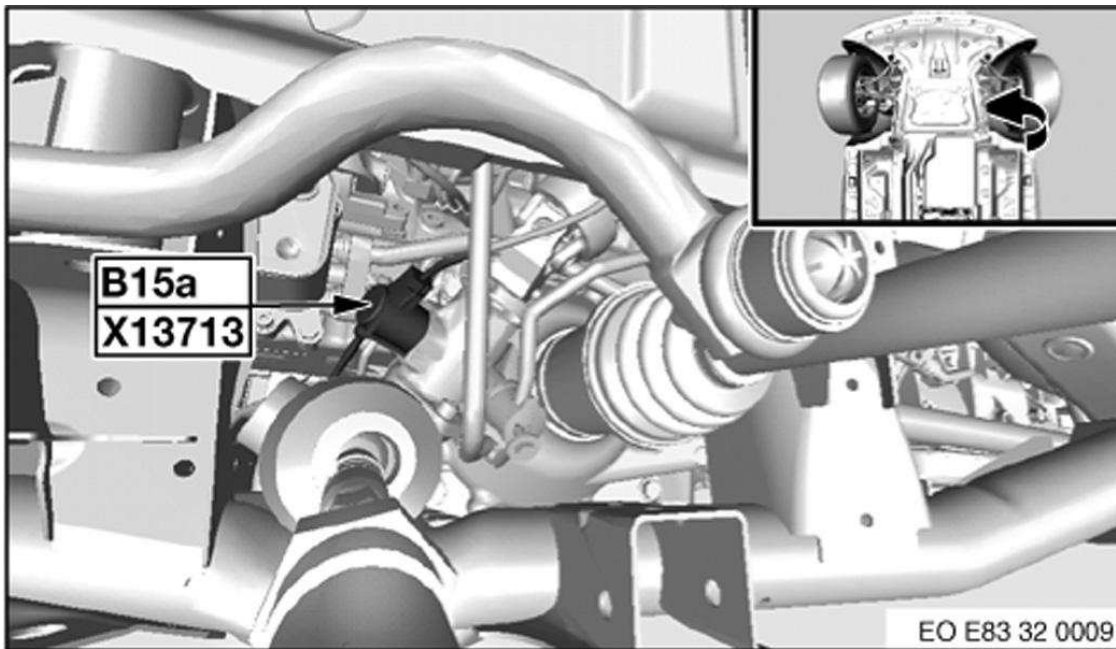
G00365177

**Fig. 26: Under Left Front Of Vehicle**  
 Courtesy of BMW OF NORTH AMERICA, INC.

| Component | Location |
|---|---|
| Servotronic Valve (B15a) | Under left front of vehicle. See <a href="#">Fig. 26.</a> |

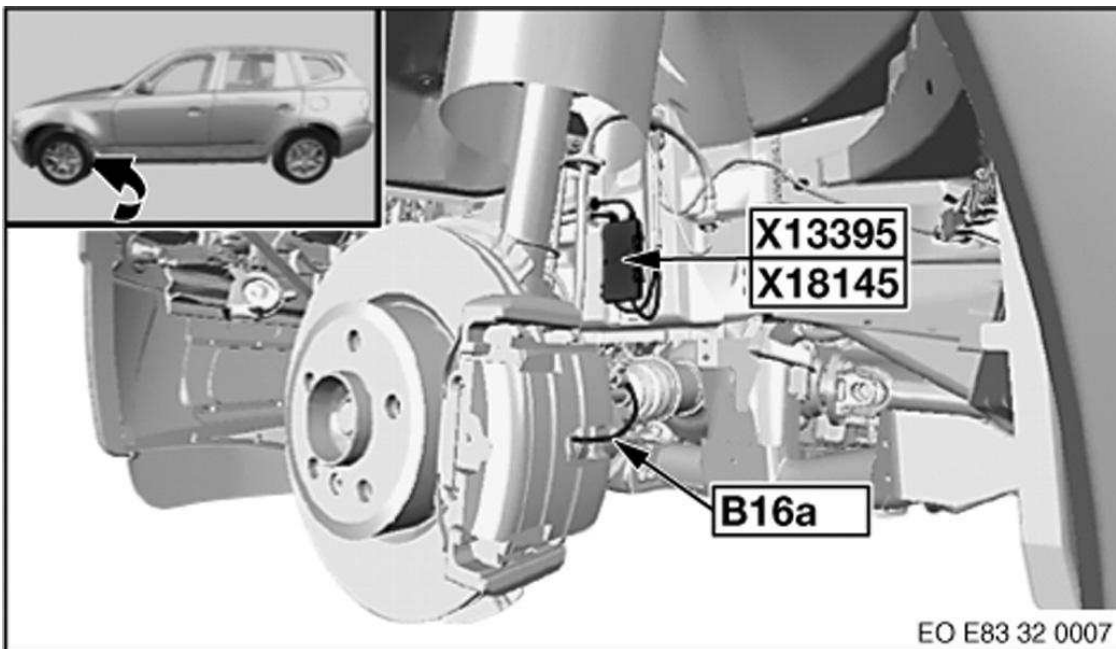
G00365178

**Fig. 27: Left Front Wheel**  
 Courtesy of BMW OF NORTH AMERICA, INC.

| <b>Component</b> | <b>Location</b> |
|---|---|
| Brake Pad Wear Sensor (Left Front) (B16a) | Left front wheel. See <b>Fig. 27.</b> |

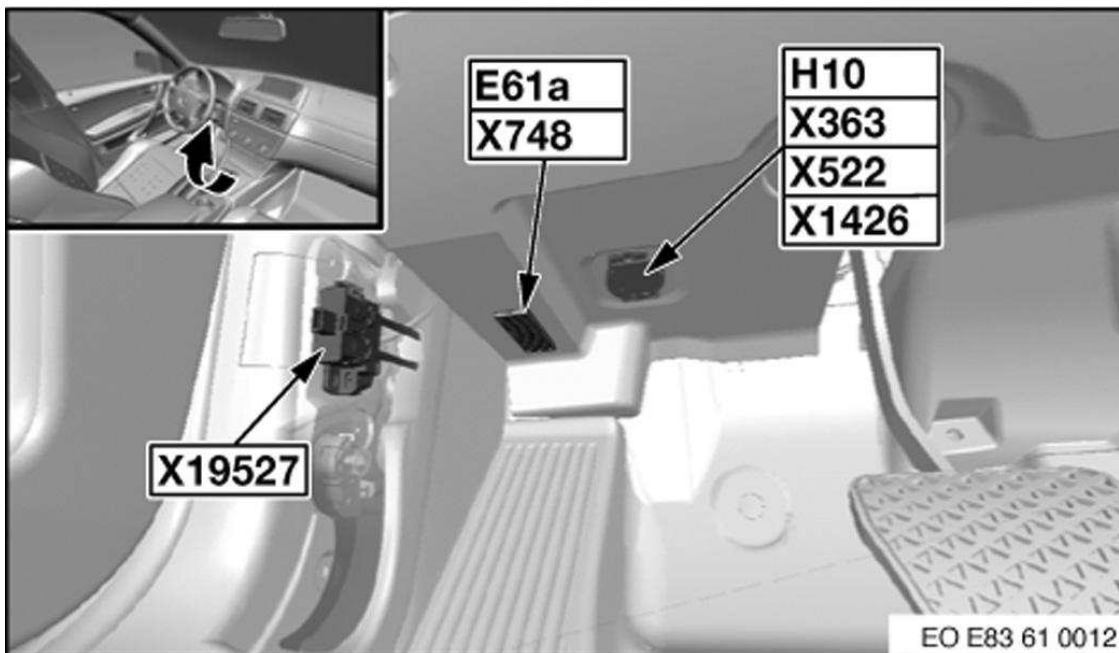
G00365183

**Fig. 30: Left Side Of Dash**

| Chime Module (H10) | Left side of dash. See <b>Fig. 30.</b> |
| OBDII (X19527) | Left side of left footwell. See <b>Fig. 30.</b> |

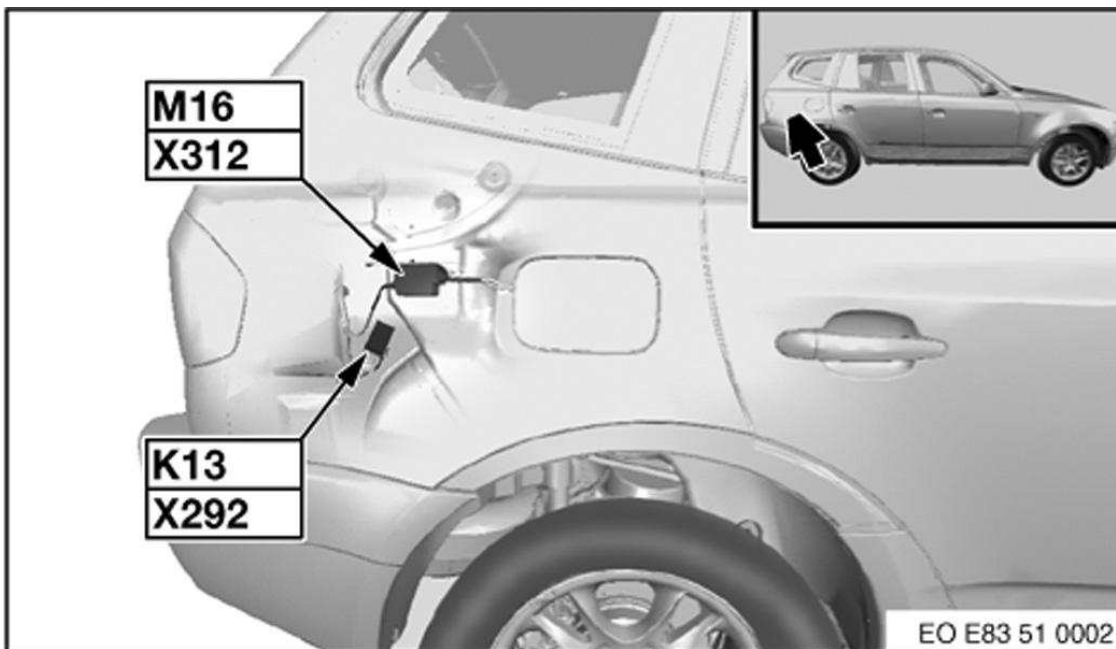
G00365186

**Fig. 32: Right Rear Quarterpanel**

| <b>Component</b> | <b>Location</b> |
|---|---|
| Rear Window Defroster Relay (K13) | Right rear quarterpanel. See <a href="#">Fig. 32.</a> |

| <b>Component</b> | <b>Location</b> |
|---|---|
| Fuel Filler Flap Central Locking Drive (M16) | Above right rear wheel. See <b>Fig. 32.</b> |

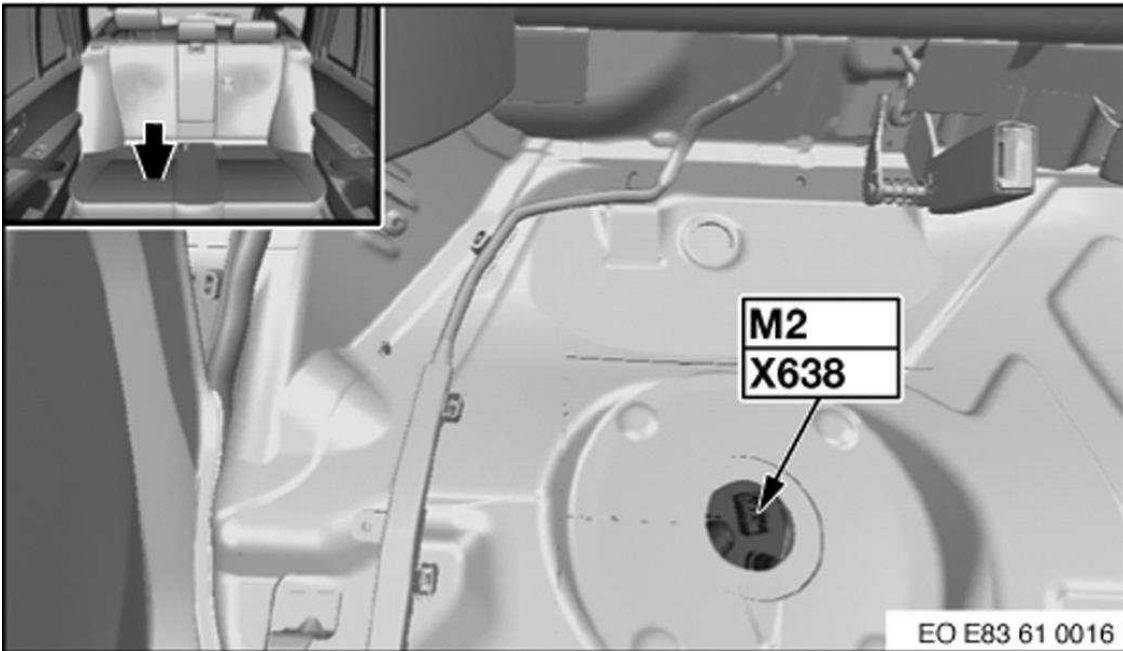
G00365188

**Fig. 34: Below Right Rear Seat**

| <b>Component</b> | <b>Location</b> |
|---|---|
| Electric Fuel Pump (M2) | Below right rear seat. See <b>Fig. 34.</b> |

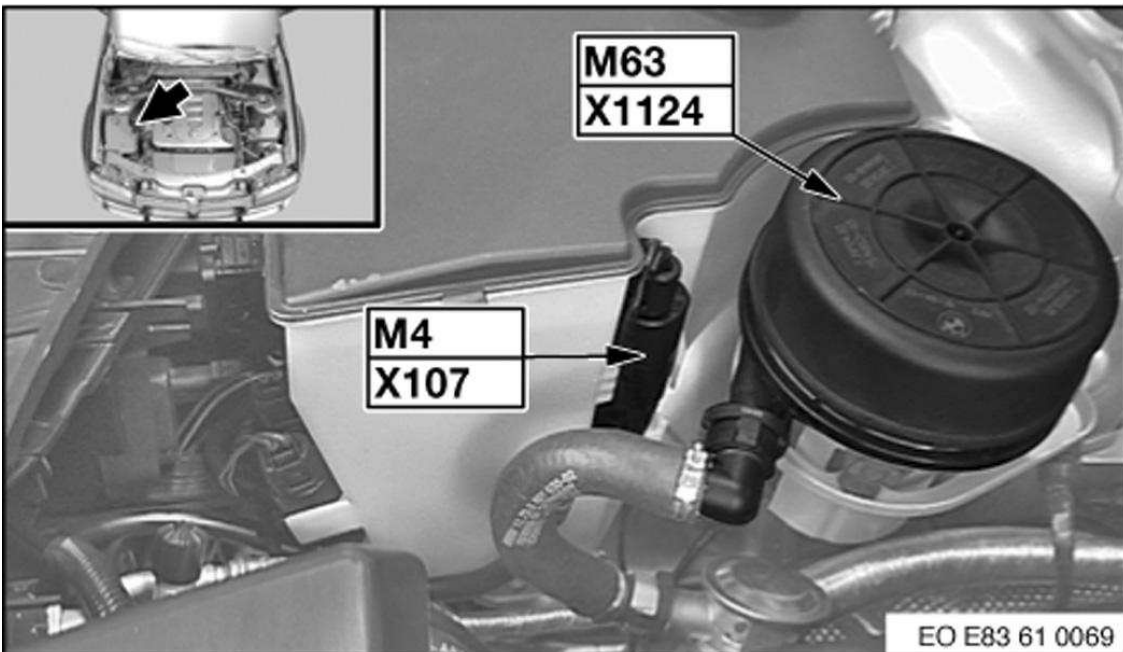
G00365189

**Fig. 35: Right Side Of Engine Compartment**

| Secondary Air Injection Pump (M63) | Right side of engine compartment. See <b>Fig. 35.</b> |
| Windshield Washer Pump (M4) | Right side of engine compartment. See <b>Fig. 35.</b> |

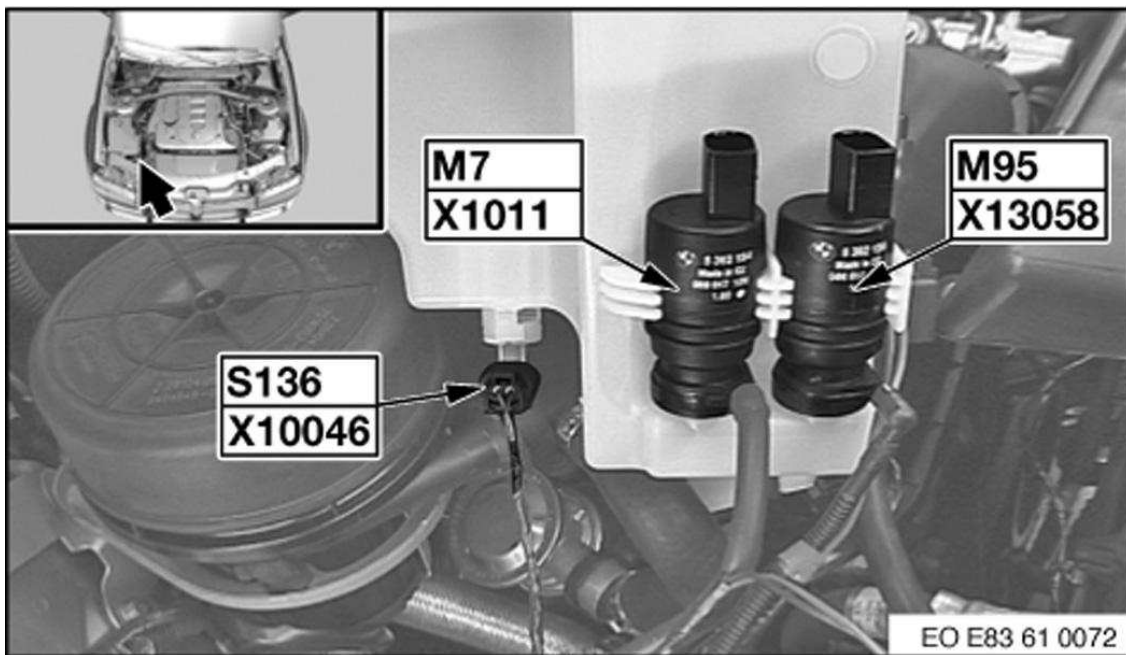
G00365190

**Fig. 36: Right Front Of Engine Compartment**  
 Courtesy of BMW OF NORTH AMERICA, INC.

| <b>Component</b> | <b>Location</b> |
|---|---|
| Headlight Washer Pump (M7) | Right front of engine compartment. See <b>Fig. 36.</b> |

| Rear Window Washer Pump (M95) | Right front engine compartment. See <b>Fig. 36.</b> |

| Component | Location |
|---|---|
| Wash Water Level Switch (S136) | Right front of engine compartment. See <a href="#">Fig. 36.</a> |

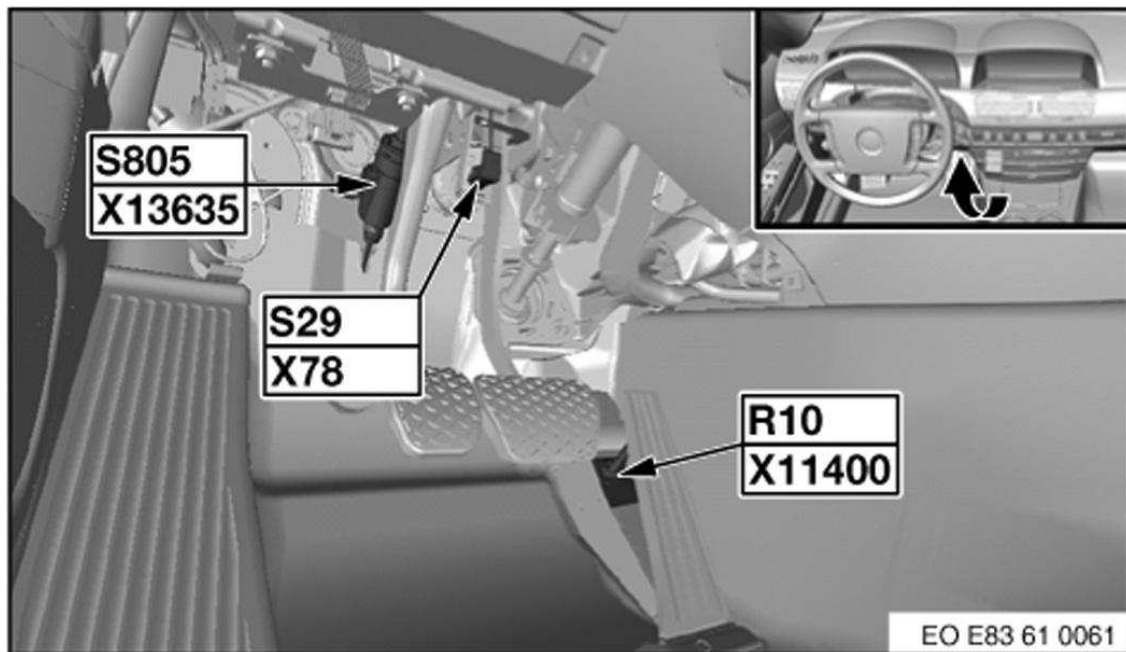
G00365191

**Fig. 37: Under Left Side Of Dash**  
 Courtesy of BMW OF NORTH AMERICA, INC.

| <b>Component</b> | <b>Location</b> |
|---|---|
| Pedal Position Sensor (R10) | Under left side of dash. See <b>Fig. 37.</b> |

| Component | Location |
|---|---|
| Brake Light Switch (S29) | Under left side of dash. See <a href="#">Fig. 37.</a> |
| Clutch Switch (S805) | Under left side of dash. See <a href="#">Fig. 37.</a> |
