**2007 BMW X3**

## GENERAL INFORMATION Diagnostic Connector (DLC) Locations

## COMPONENT LOCATION GRAPHICS

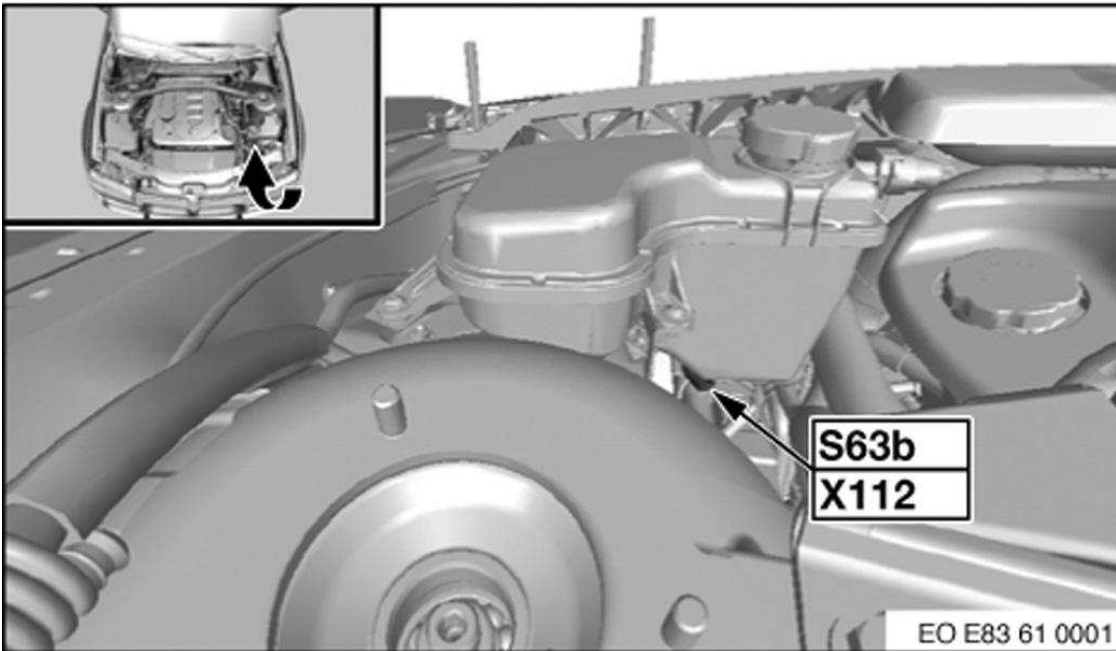
G00365193

**Fig. 38: Left Front Of Engine Compartment**  
Courtesy of BMW OF NORTH AMERICA, INC.

| Component | Location |
|---|---|
| Coolant Level Switch (S63b) | Left front engine compartment. See <a href="#">Fig. 38.</a> |

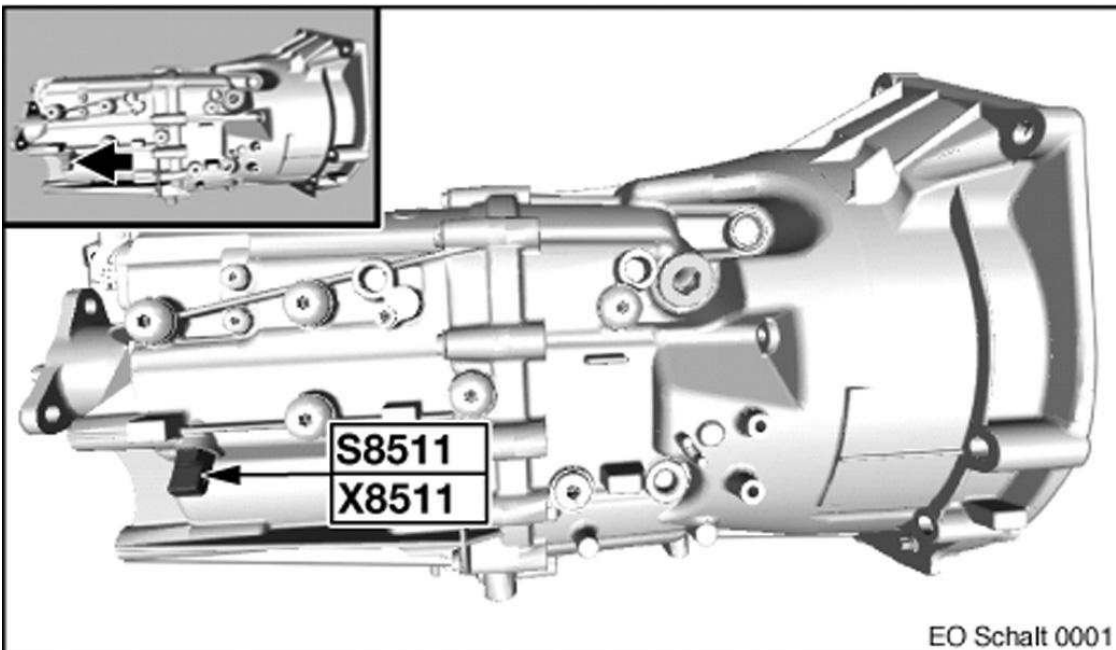
G00365195

**Fig. 39: Right Rear Side Of Transmission**  
Courtesy of BMW OF NORTH AMERICA, INC.

| Component | Location |
|---|---|
| Backup Light Switch (S8511) | Right rear side of transmission. See <a href="#">Fig. 39.</a> |

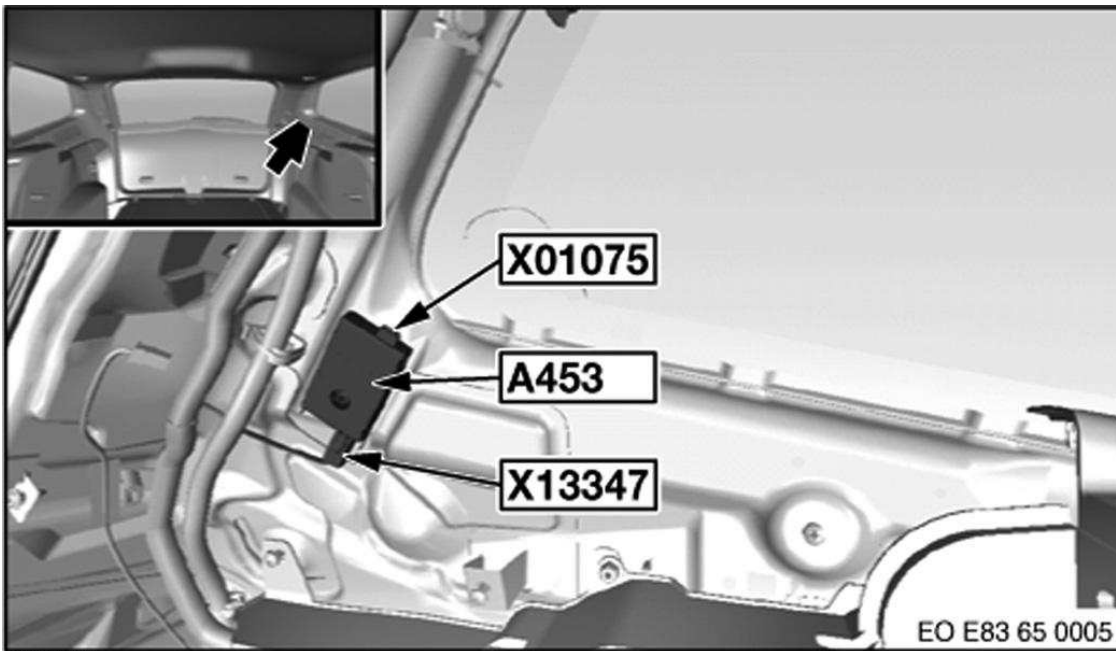
**Fig. 65: Rear Compartment Door**

| Component | Location |
|---|---|
| Antenna Diversity (A421) | Top center of rear compartment door. See <a href="#">Fig. 65.</a> |

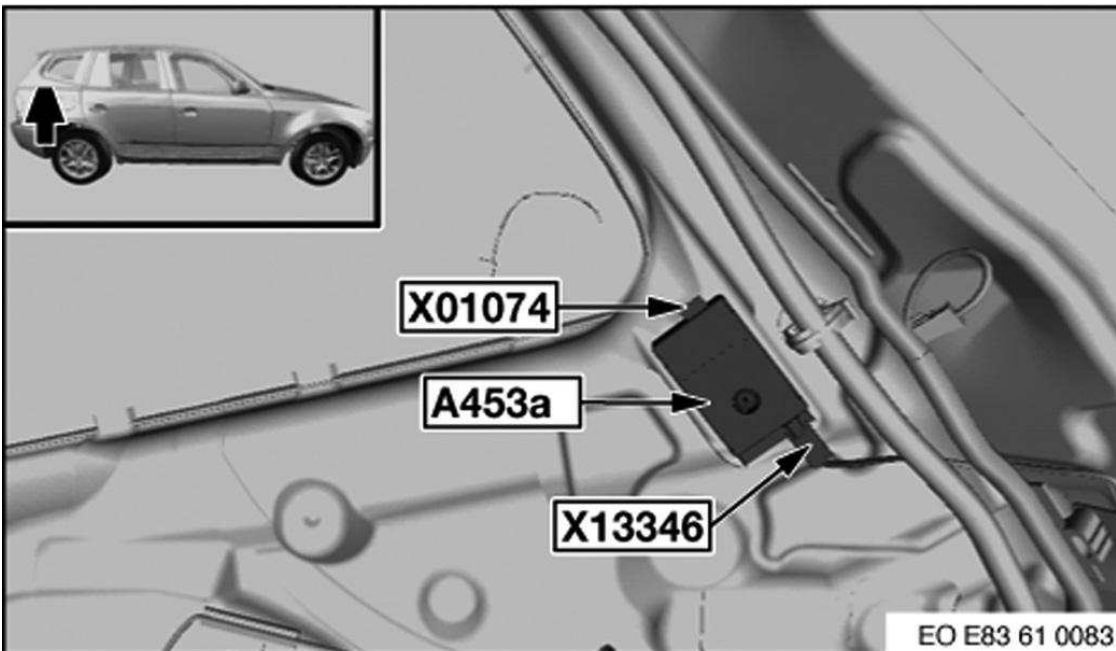
**Fig. 66: Bottom Of Left "C" Pillar**

| Left TV Amplifier (A453) | Left side of rear compartment. See <b>Fig. 66.</b> |

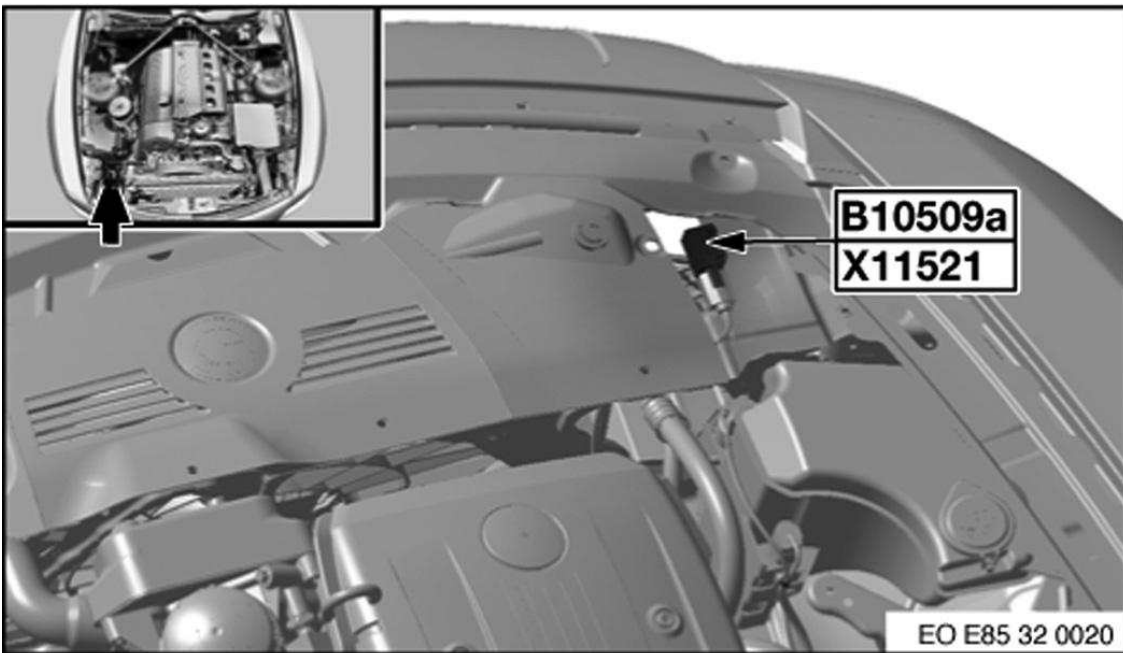
**Fig. 84: Left Front Of Engine Compartment**  
Courtesy of BMW OF NORTH AMERICA, INC.

| <b>Component</b> | <b>Location</b> |
|---|---|
| Driver's Side Front Airbag Sensor (B10508a) | Left front of engine compartment. See <b>Fig. 84.</b> |

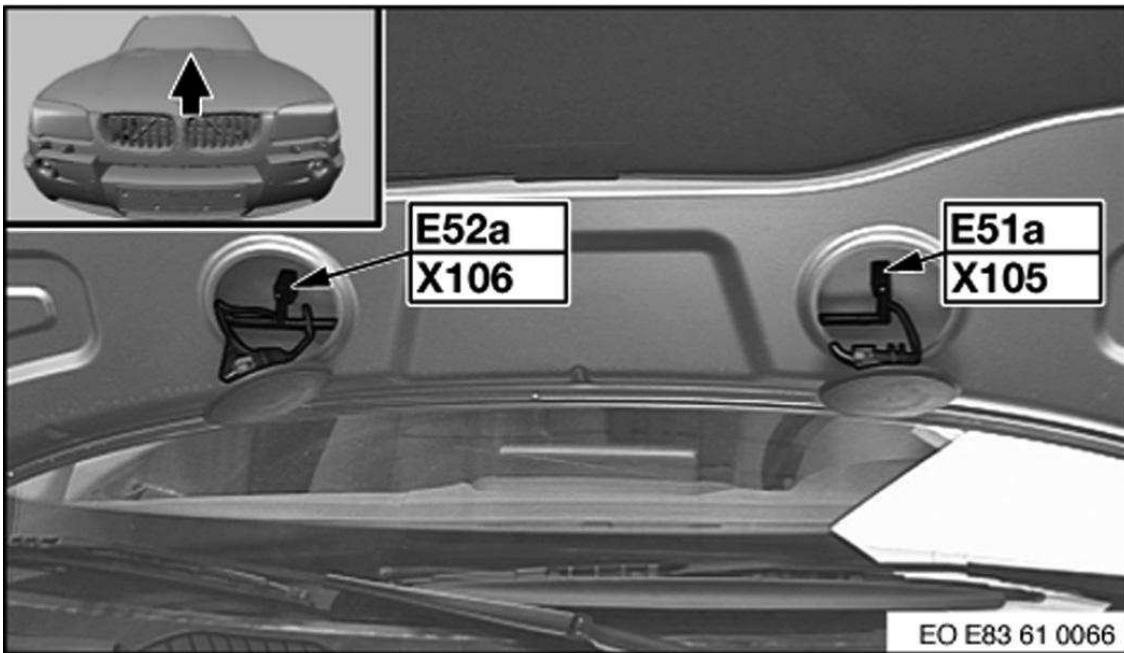
**Fig. 85: Right Front Of Engine Compartment**  
Courtesy of BMW OF NORTH AMERICA, INC.

| <b>Component</b> | <b>Location</b> |
|---|---|
| Passenger's Side Front Airbag Sensor (B10509a) | Right front of engine compartment. See <b>Fig. 85.</b> |

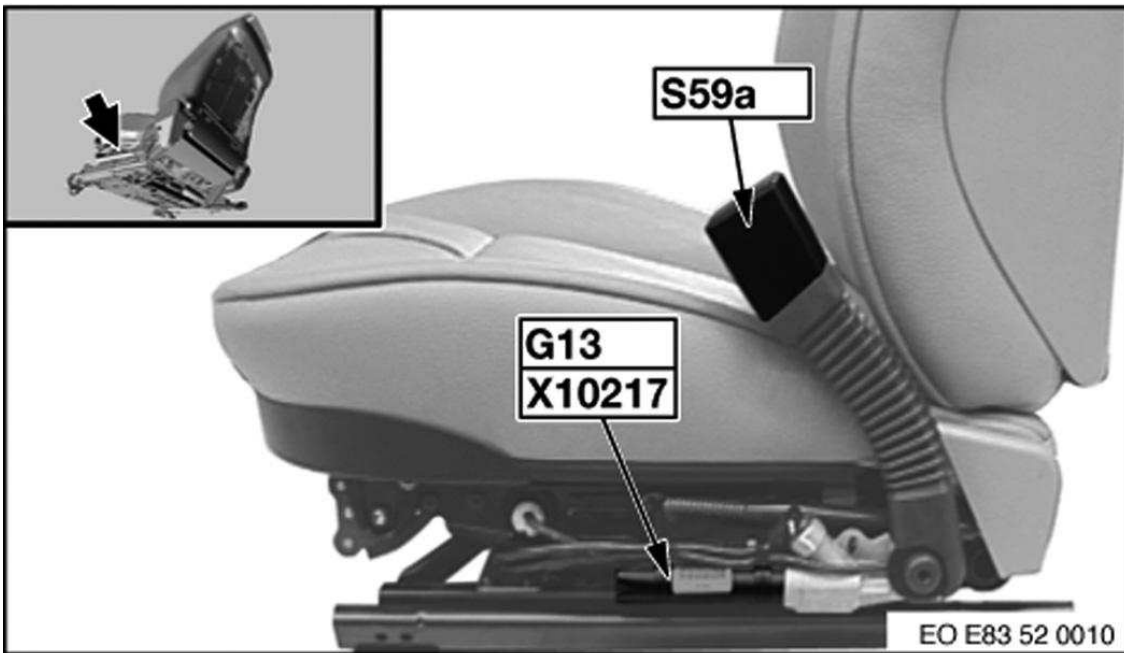
**Fig. 87: Part Of Seat Belt Buckle Assembly**

| Driver's Seat Belt Tensioner Generator (G12) | Part of seat belt buckle assembly. See <b>Fig. 87.</b> |

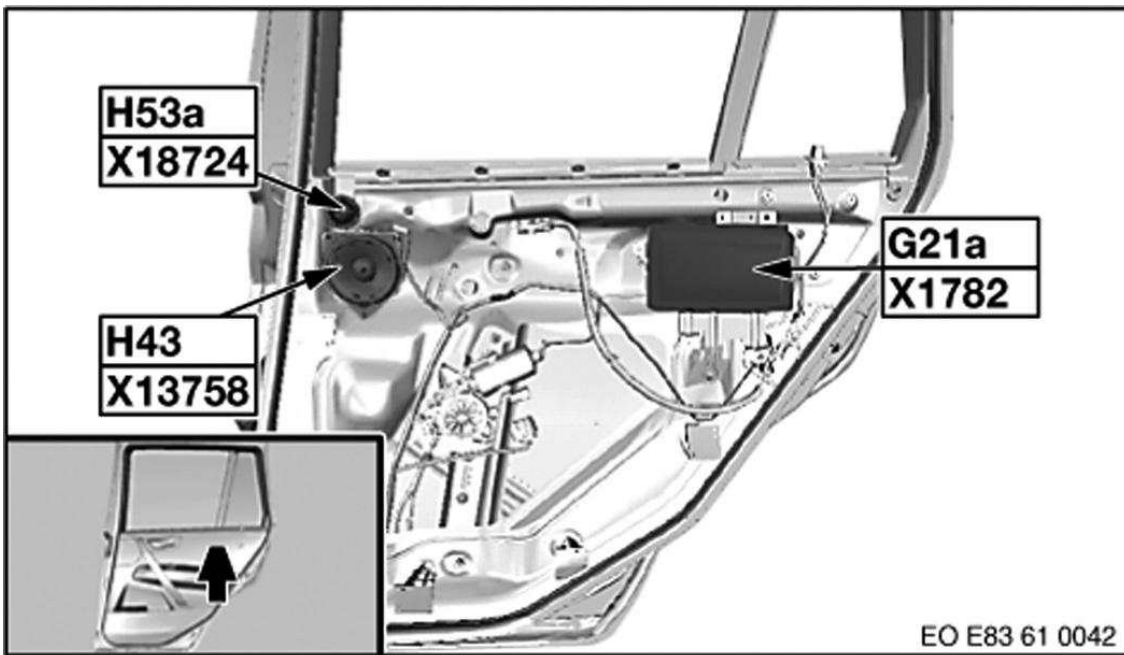
**Fig. 89: Left Rear Door**  
Courtesy of BMW OF NORTH AMERICA, INC.

| Left Rear Side Airbag Inflator Assembly (G20a) | In left rear door. See <b>Fig. 89.</b> |

| X834 | In left rear door. See <a href="#">Fig. 89.</a> |

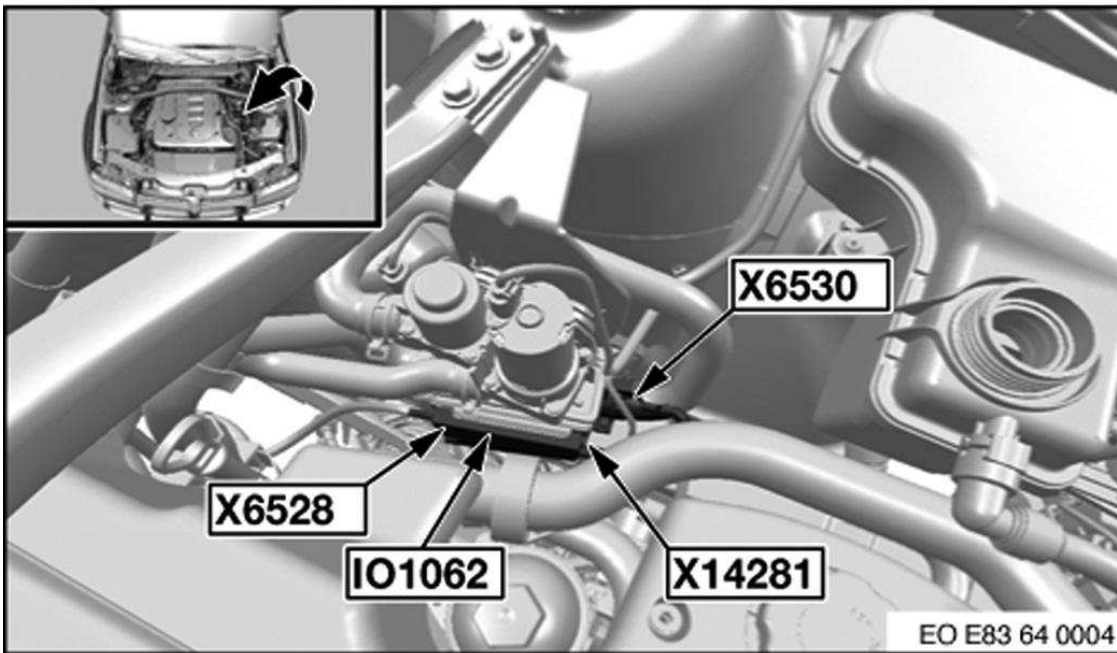
**Fig. 95: Right Side Of Engine Compartment**

| Right Headlight Beam Height Control Stepper Motor (M81) | Right front of engine compartment. See <b>Fig. 95.</b> |

| <b>Component</b> | <b>Location</b> |
|---|---|
| Right Front Airbag Sensor (S72) | Right front of engine compartment. See <b>Fig. 95.</b> |

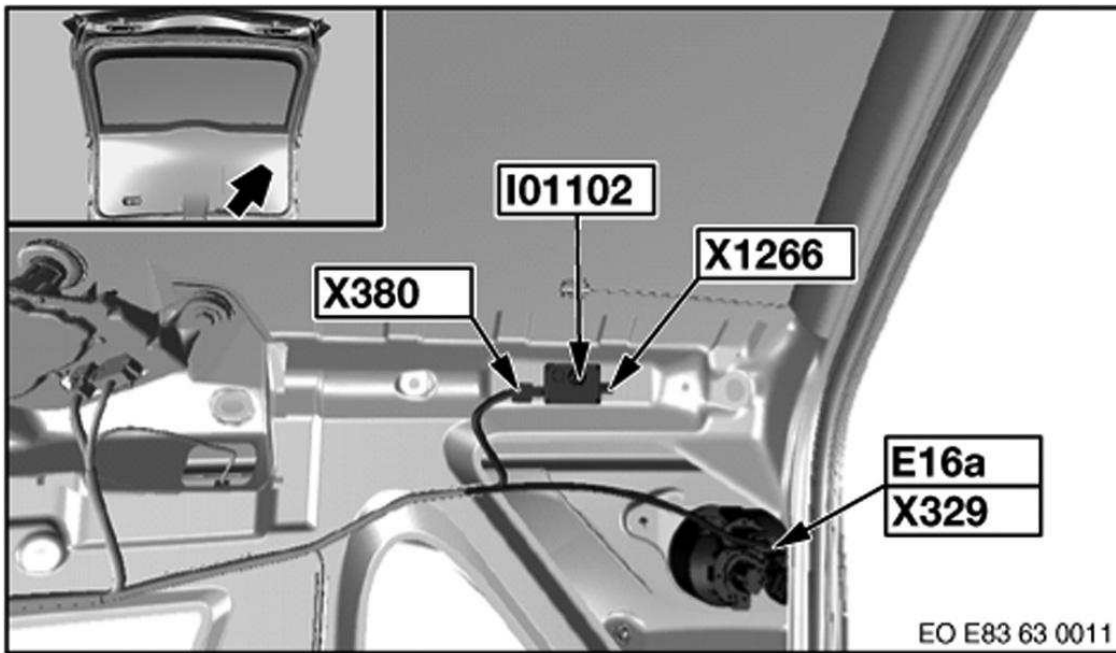
**Fig. 97: Rear Compartment Door**  
Courtesy of BMW OF NORTH AMERICA, INC.

| Wave Trap 1 (I01101) | Bottom right side of rear compartment door. See <b>Fig. 97.</b> |

| X461 | Bottom right of rear compartment door. See <a href="#">Fig. 97.</a> |

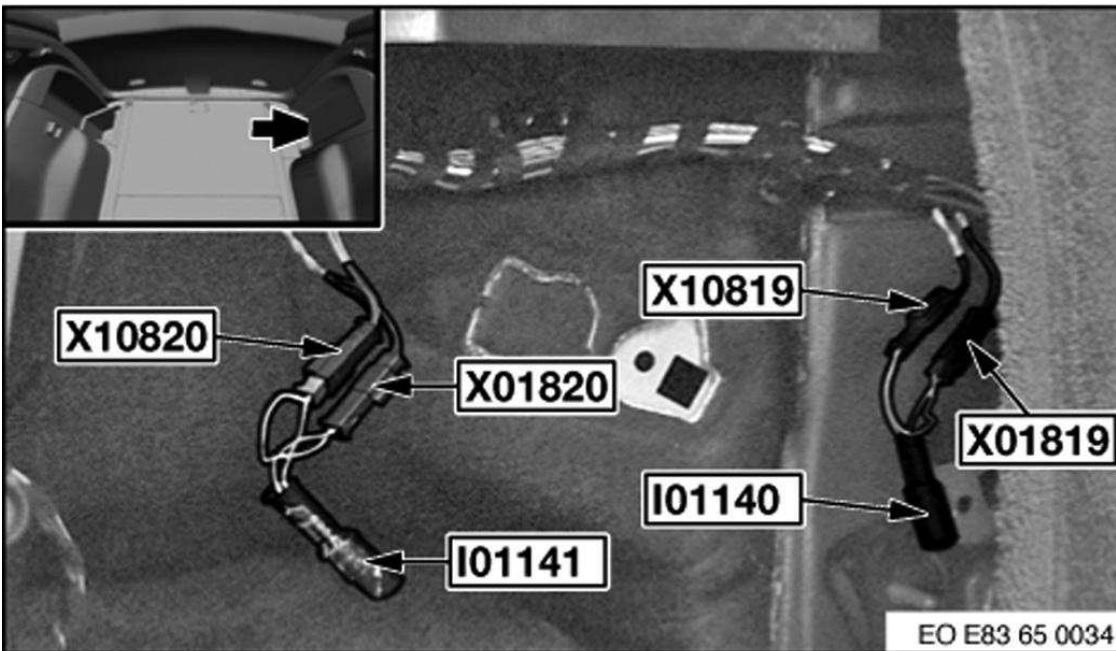
**Fig. 98: Rear Compartment Door**

Bottom left of rear compartment. See [Fig. 98](#).

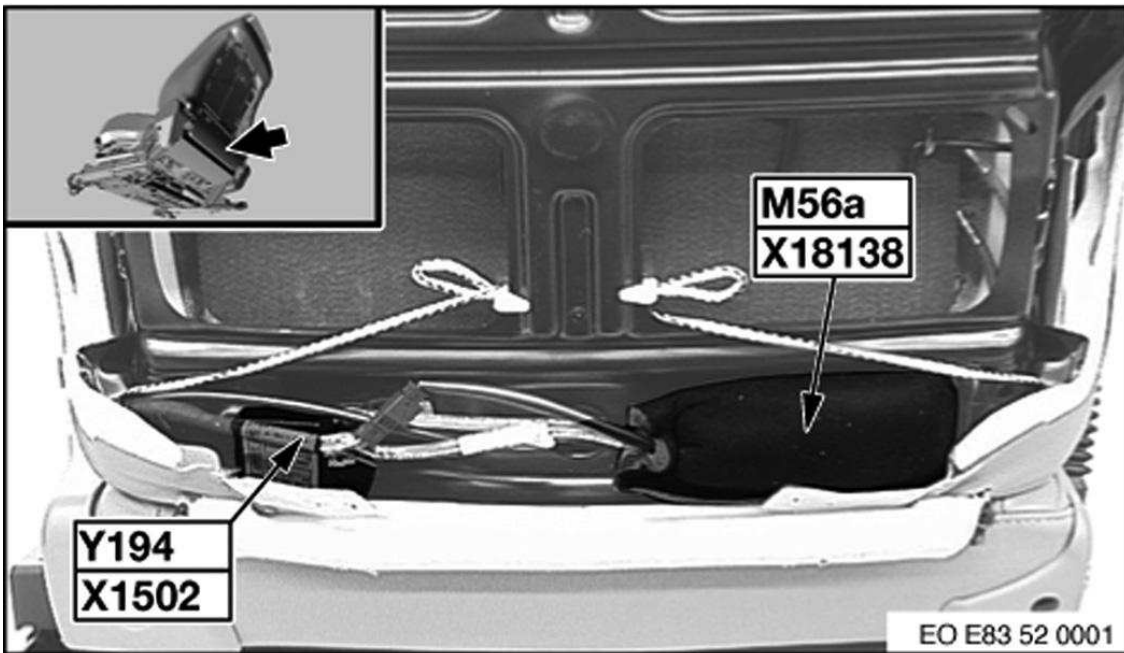
**Fig. 108: Under Driver's Seat**  
 Courtesy of BMW OF NORTH AMERICA, INC.

| Component | Location |
|---|---|
| Driver Lumbar Support Valve Block (Y193) | Under driver's seat. See <a href="#">Fig. 108.</a> |

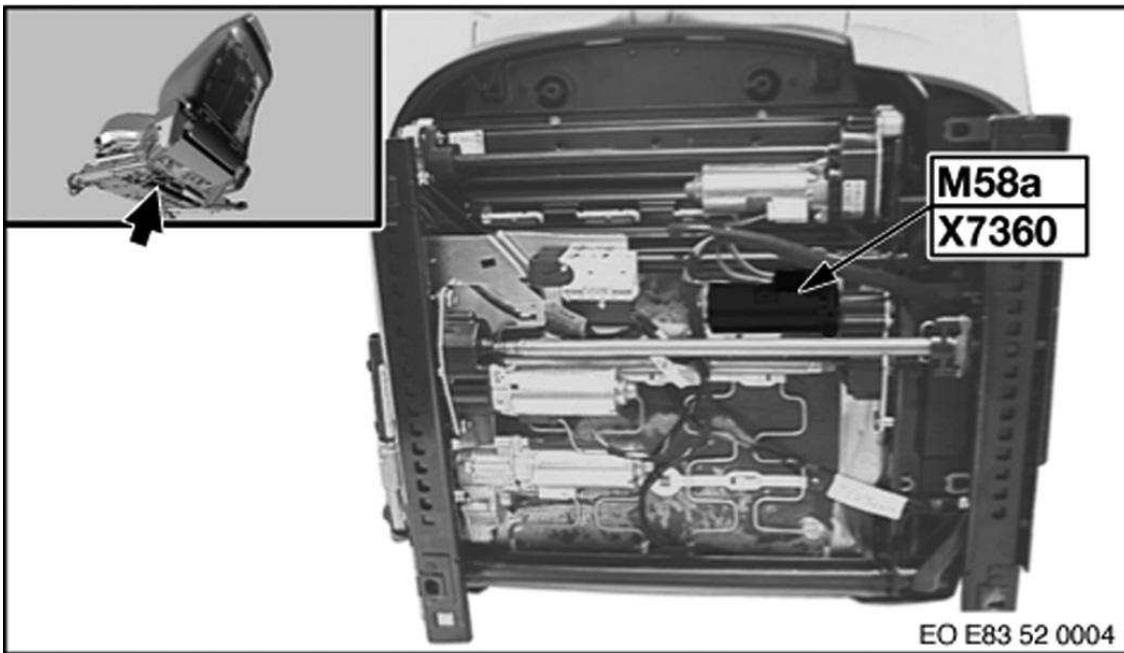
**Fig. 109: Under Front Passenger's Seat**  
 Courtesy of BMW OF NORTH AMERICA, INC.

| Passenger's Seat Lumbar Support Drive (M56a) | Under front passenger's seat. See <b>Fig. 109.</b> |

| Component | Location |
|---|---|
| Passenger's Lumbar Support Valve Block (Y194) | Under front passenger's seat. See <a href="#">Fig. 109.</a> |

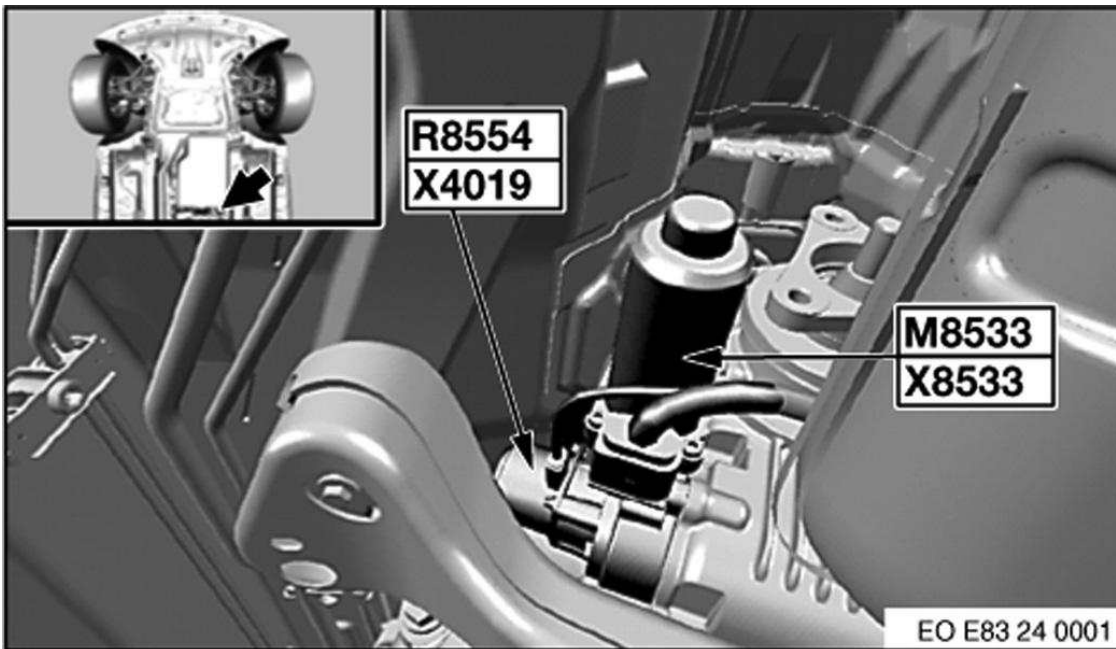
**Fig. 111: Under Front Passenger's Seat**  
Courtesy of BMW OF NORTH AMERICA, INC.

| <b>Component</b> | <b>Location</b> |
|---|---|
| Passenger's Seat Angle Adjustment Drive (M61a) | Under front passenger's seat. See <b>Fig. 111.</b> |
| Passenger's Seat Forward/Backward Adjustment Drive (M60a) | Under front passenger's seat. See <b>Fig. 111.</b> |

| Passenger's Seat Height Adjustment Drive (M59a) | Under front passenger's seat. See <b>Fig. 111.</b> |

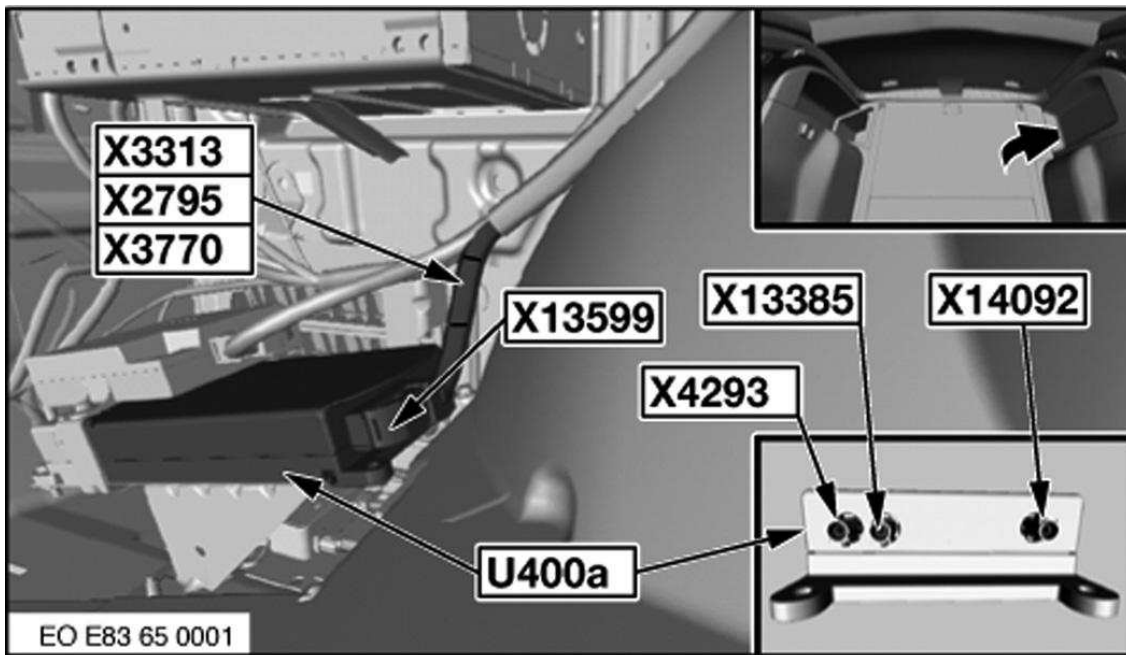
**Fig. 114: Left Side Of Rear Compartment**  
Courtesy of BMW OF NORTH AMERICA, INC.

| Compensator (N27a) | Left side of rear compartment. See <b>Fig. 114.</b> |
