INT

INTERIOR

CONTENTS

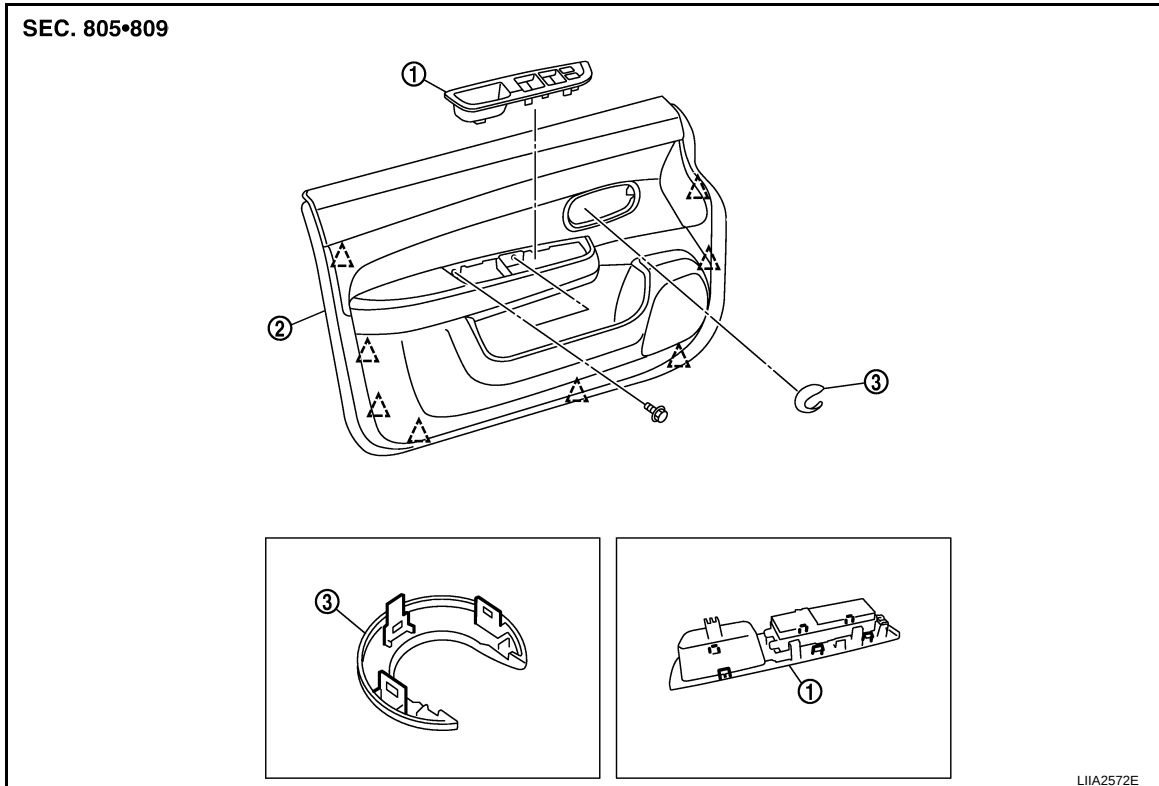
1. Power window and door lock/unlock switch finisher
2. Front door finisher
3. Inside handle escutcheon

Clip C101

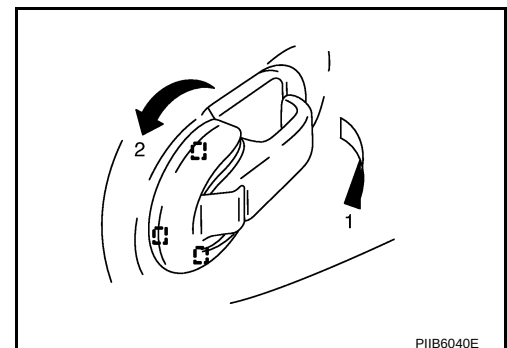
1. Open front door and front door window.
2. Disconnect the negative and positive battery cables.
3. Release the front door inside handle escutcheon pawls, then slide the escutcheon rearward to remove from front door finisher.

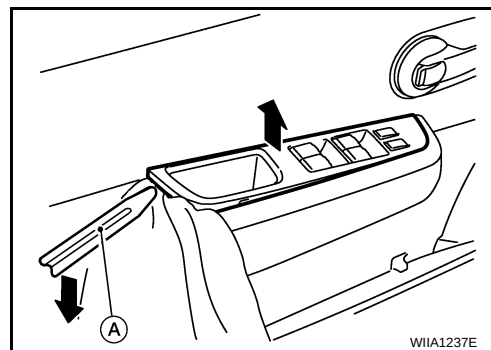
4. Insert a trim stick (A) or suitable tool into back edge of front door power window and door lock/unlock switch finisher. Lift upward to release the clips and remove.

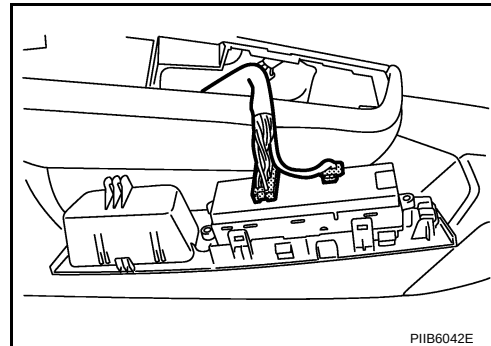
5. Disconnect front door power window and door lock/unlock switch harness connector.

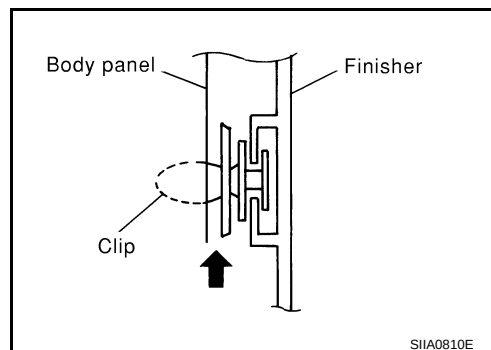
6. Remove the (2) front door finisher screws.
7. Release the clips, then lift front door finisher upward to remove it from door body panel.

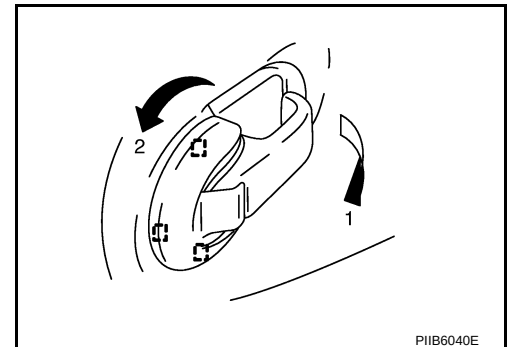
1. Open rear door and rear door window.
2. Disconnect the negative and positive battery cables.
3. Release the rear door inside handle escutcheon pawls, then slide the escutcheon rearward to remove from rear door finisher.

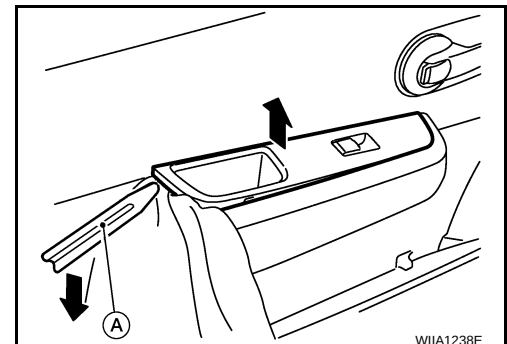
4. Insert a trim stick (A), or suitable tool into back edge of rear door power window switch finisher. Lift upward to release the clips and remove.

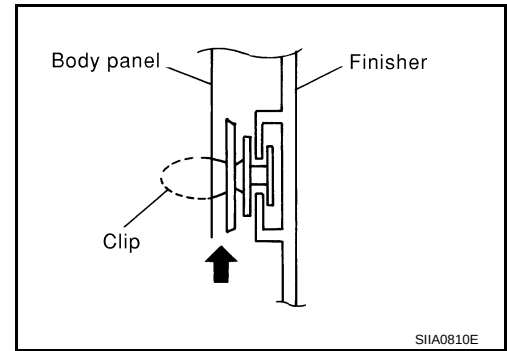
7. Release the clips, then lift rear door finisher upward to remove it from door body panel.

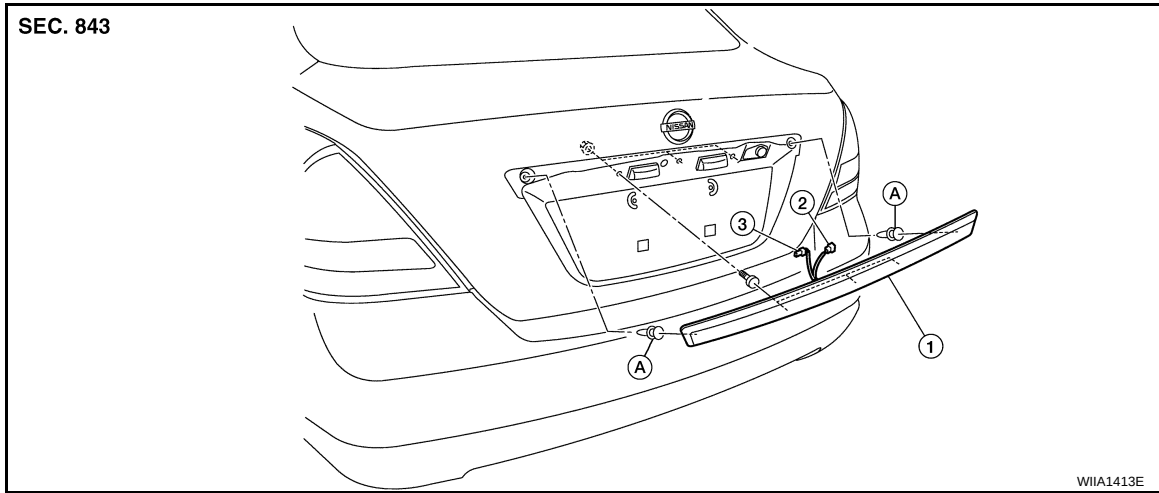
1. Trunk lid finisher outer      2. Trunk lid opener switch connector      3. Trunk opener request switch connector  
A. Clip C101

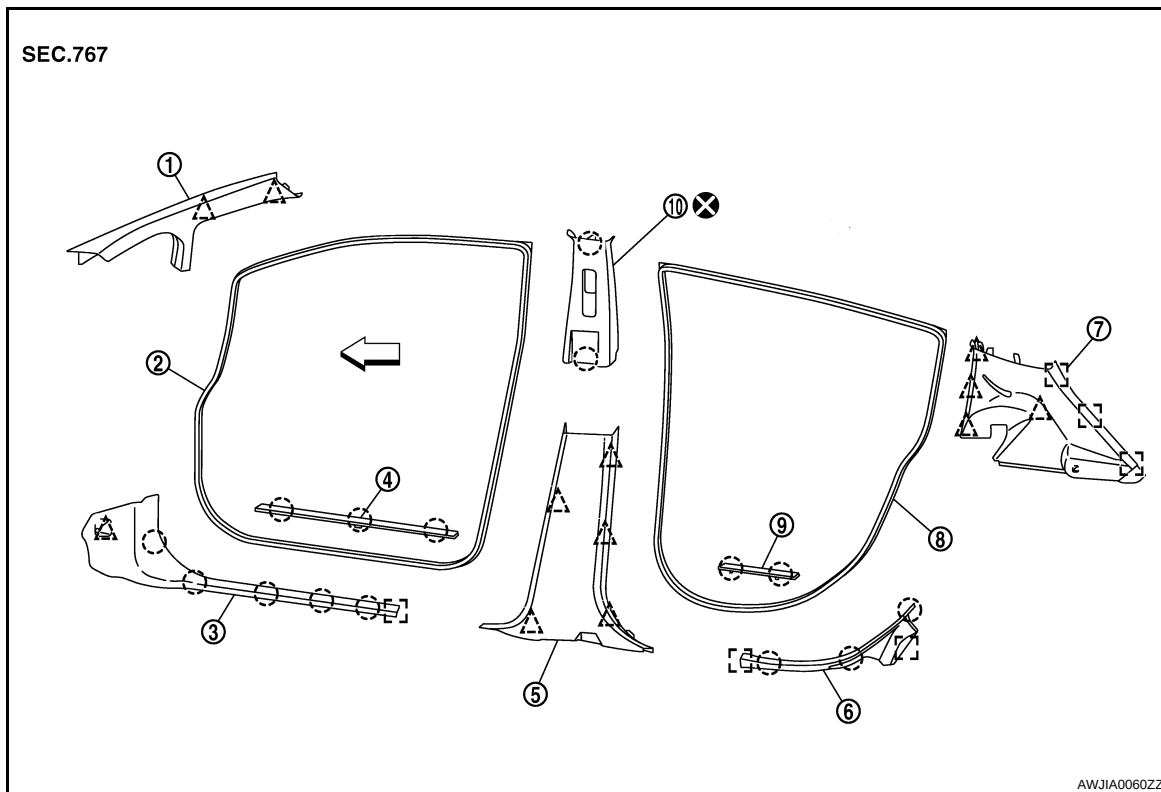
#### Hatchback Models

| 1. Front pillar garnish | 2. Front body side welt | 3. Front kicking plate inner |

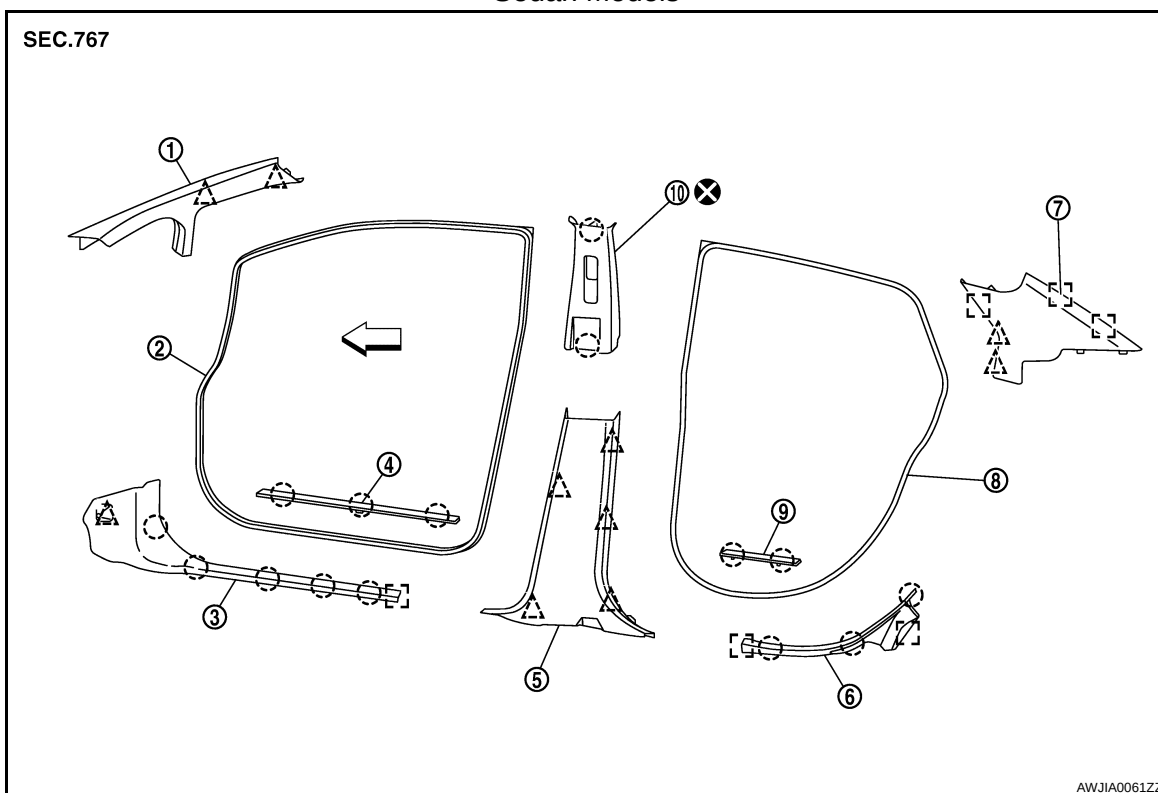
Sedan Models

| 1. Front pillar garnish | 2. Front body side welt | 3. Front kicking plate inner |

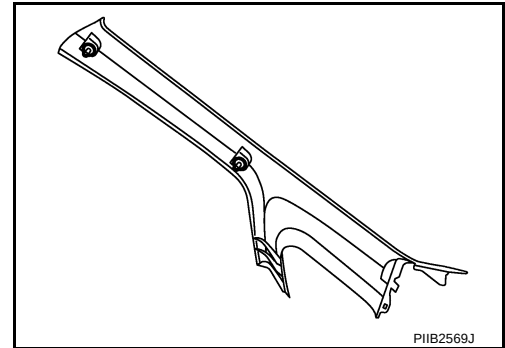
Release the clips, then remove front pillar garnish.

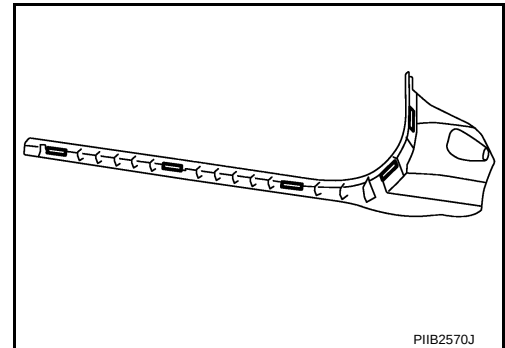
Release the clips, then remove front kicking plate inner.

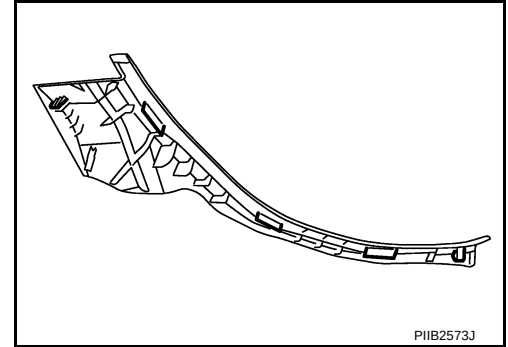
Release the clips, then remove rear kicking plate inner.

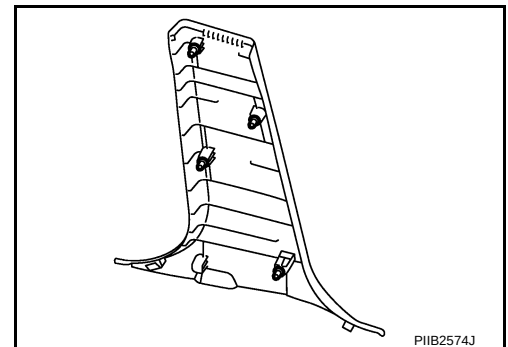
1. Remove front kicking plate inner. Refer to "FRONT KICKING PLATE INNER".
2. Remove rear kicking plate inner. Refer to "REAR KICKING PLATE INNER".
3. Remove front and rear body side welts.
4. Release the clips, then remove center pillar lower garnish.

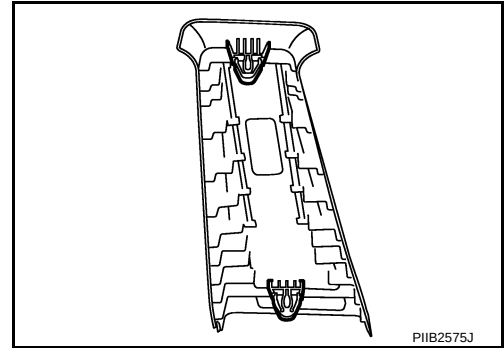
1. Remove center pillar lower garnish. Refer to "CENTER PILLAR LOWER GARNISH".
2. Remove front seat belt shoulder anchor. Refer to [SB-6, "Removal and Installation of Front Seat Belt"](#).
3. Remove front and rear body side welts.
4. Release the resin clips, then remove center pillar upper garnish.

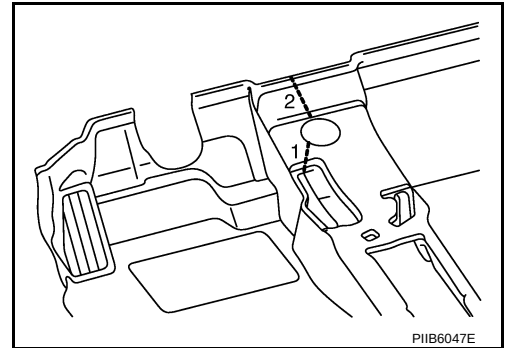
9. Remove floor carpet hook.
10. Cut floor trim using a blade knife first between openings (1), then at front edge (2) as shown.

LHD shown, RHD similar

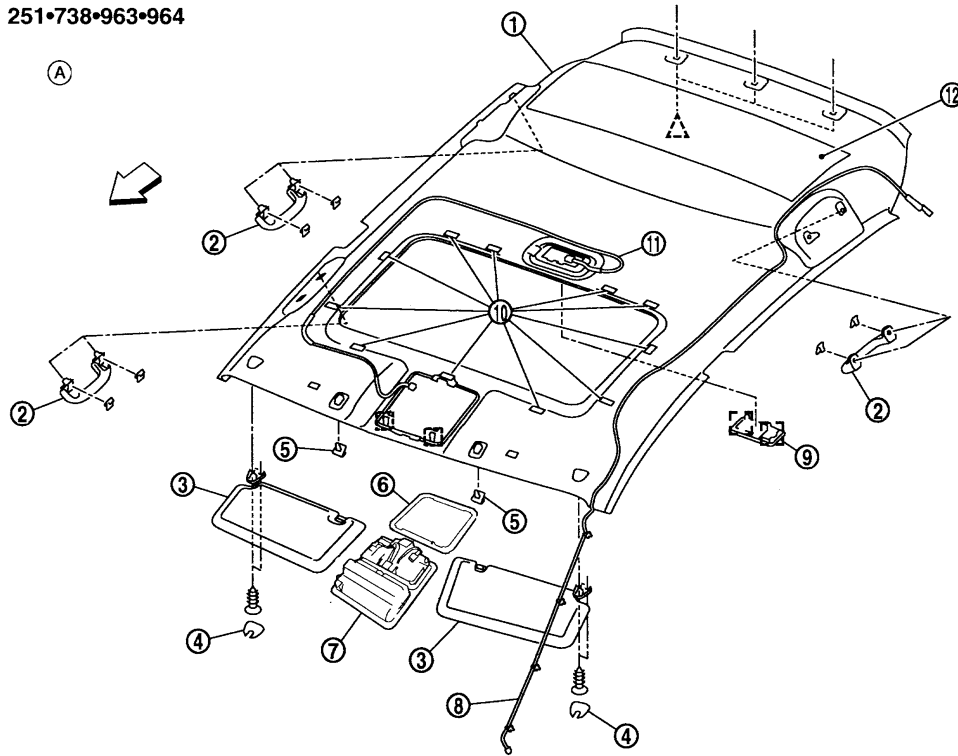
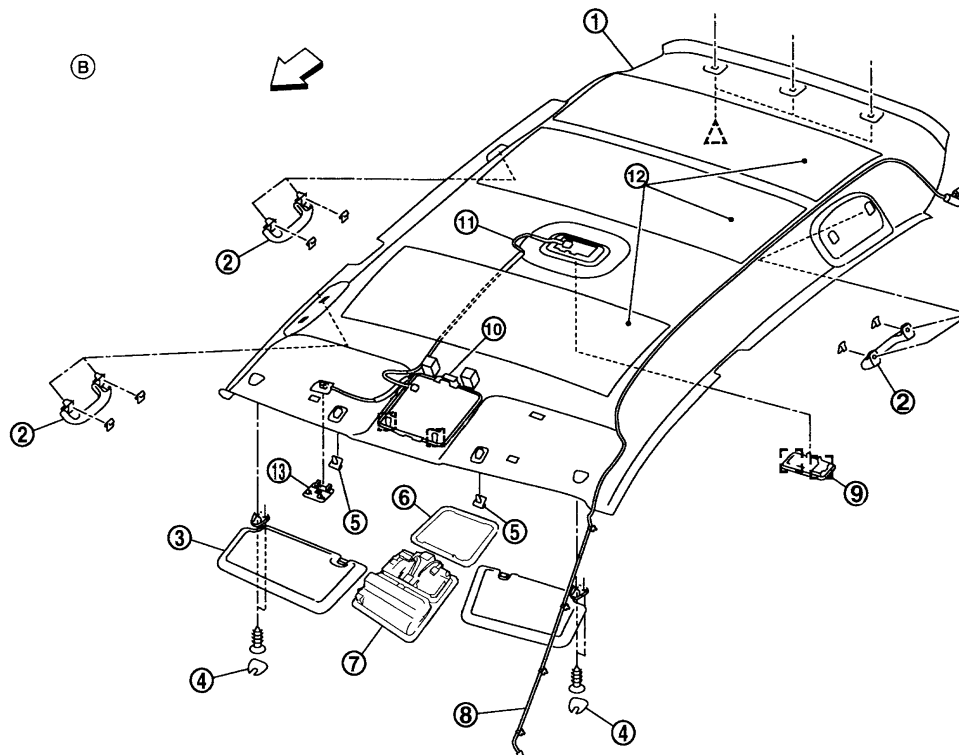
SEC. 251•738•963•964

| 1. Headlining | 2. Assist grip | 3. Sunvisor |

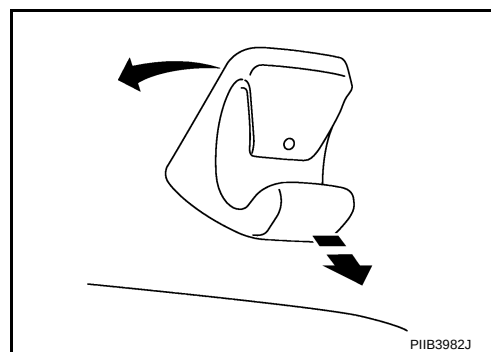
12. Remove sunvisor holders RH/LH by rotating 45 degrees, then pulling outward.

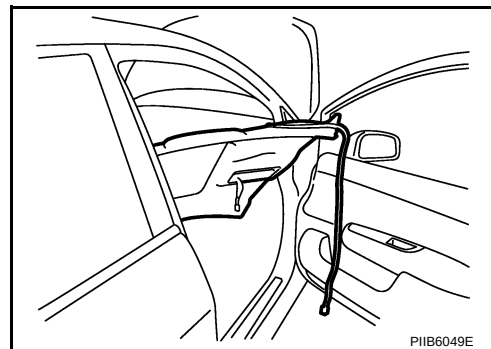
17. Position the headlining so the front edge goes through the opening of the right side front door.

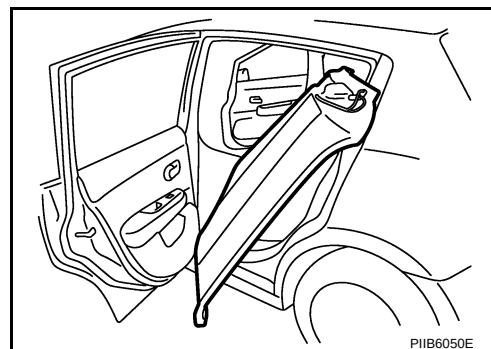
18. Position the headlining so the rear edge goes through the opening of the left rear door, then remove headlining.

- 2 technicians should be used to avoid damage when removing or replacing headlining.
- During headlining removal and installation, cover the center console finisher upper surface to prevent damage.
- Set A/T shift lever to the D position, and make a space to remove front end of headlining right side.
- Do not bend headlining when removing.

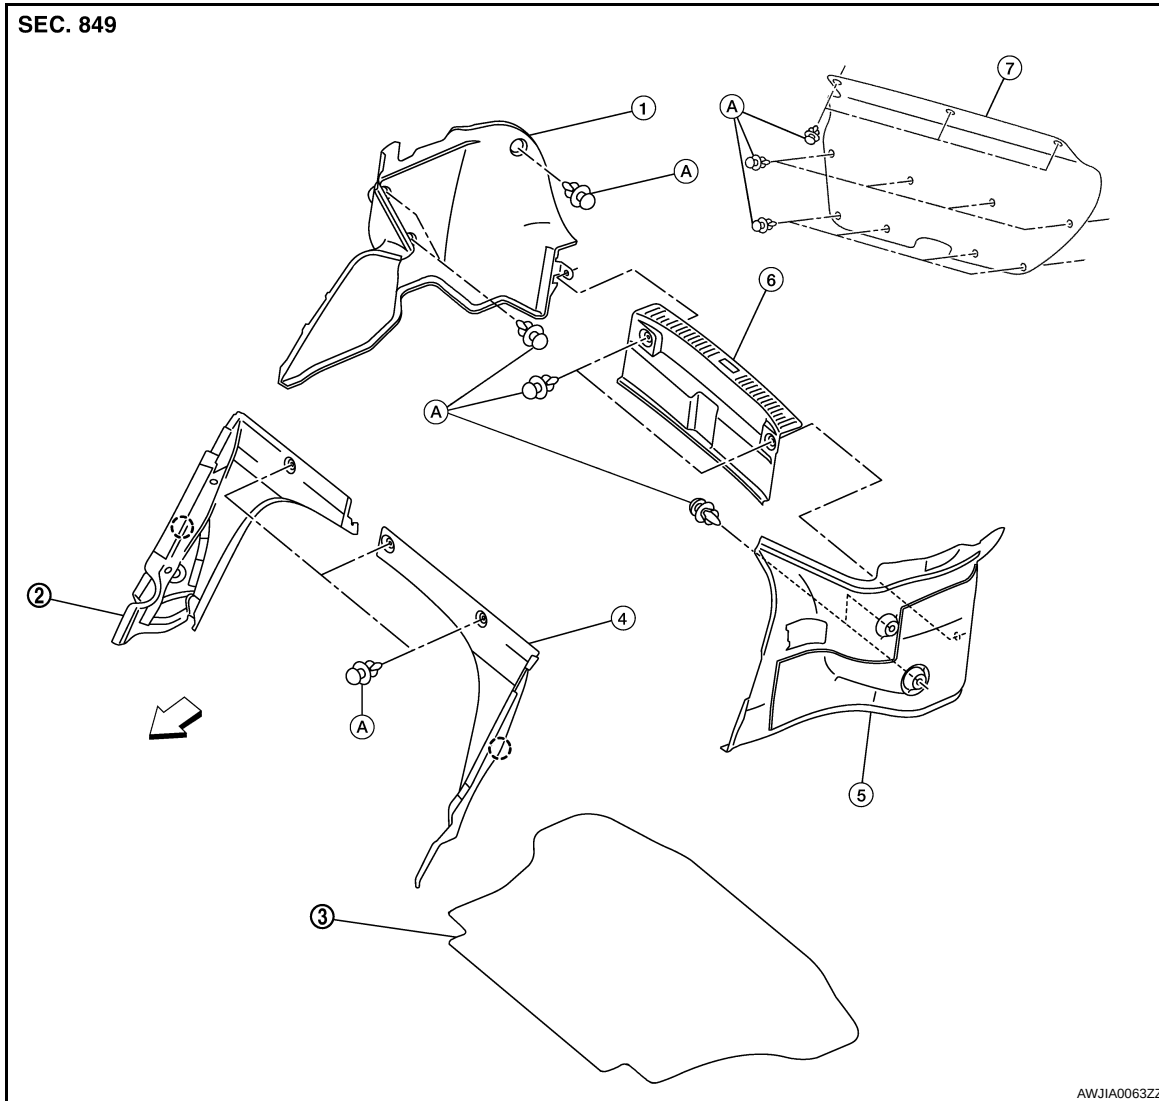
| 1. Trunk side finisher RH | 2. Seat back finisher RH (if equipped) | 3. Trunk floor carpet |
