# 260 Driveshaft

## GENERAL

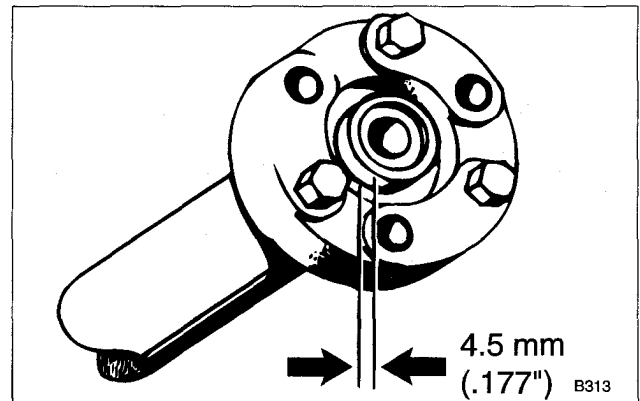
**Fig. 11.** When installing new driveshaft centering guide, drive guide in until its protrusion depth is as shown.

The sealing lip of the guide should face outward and it should be driven into the driveshaft to a specified depth. See Fig. 11.

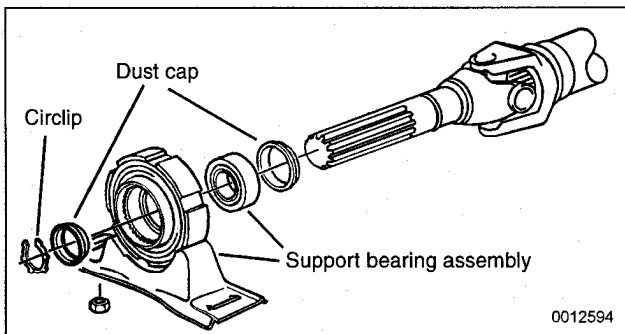
**Fig. 8.** Exploded view of driveshaft support bearing assembly.

To replace the center bearing assembly, the driveshaft must be removed from the car. The center bearing assembly consists of a grooved ball bearing in a rubber mount. The bearing assembly is pressed onto the front section of the driveshaft and secured by a circlip. See Fig. 8.

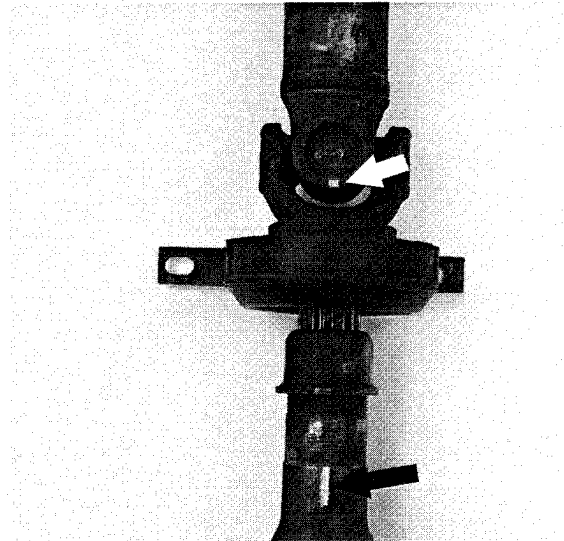
5333

**Fig. 9.** Before pulling apart driveshaft sections, make matching marks as shown.

1. Remove driveshaft. See **Driveshaft, removing**.
2. Make matching marks on front and rear driveshaft sections. See Fig. 9.
3. Loosen clamping sleeve fully and pull driveshaft sections apart. Remove rubber bushing, washer, and clamping sleeve from front section.

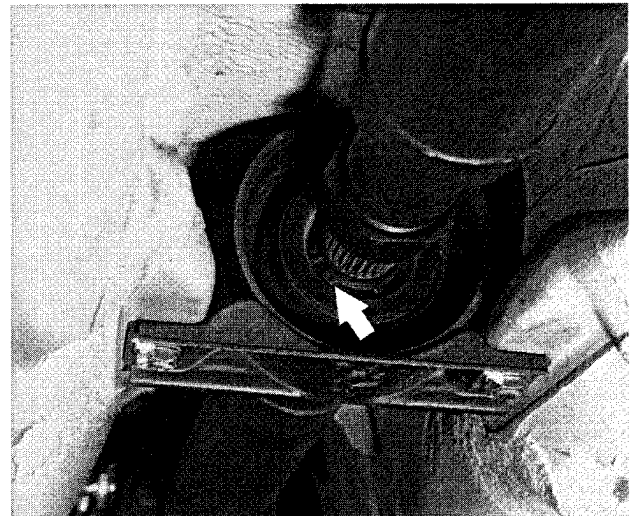
5334

**Fig. 10.** Center bearing circlip (arrow) to be removed. Driveshaft shown installed.

4. Inspect condition of rubber bushing for splined coupling. Replace worn or damaged parts.
5. Remove center bearing circlip and dust guard. See Fig. 10. Remove bearing from driveshaft using puller.

*Install puller so that it pulls on inner hub of bearing. Pulling on outer ring of mount may tear rubber, and entire bearing assembly will need to be replaced.*

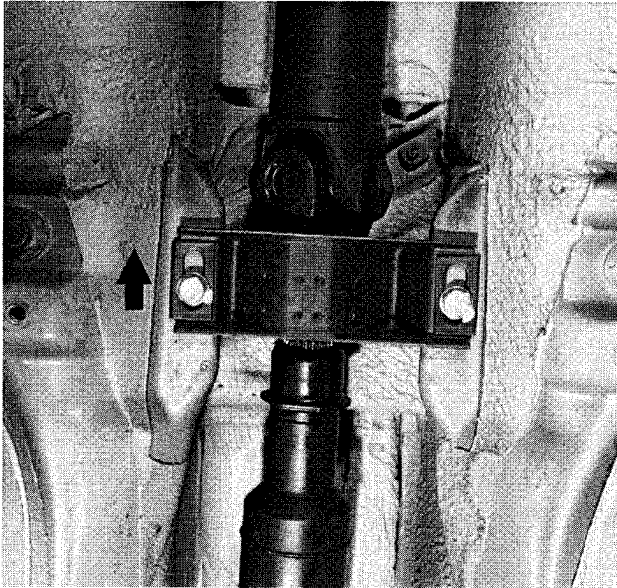
5331

**Fig. 6.** Preload center bearing toward front 4-6 mm (arrow).

1. Align driveshaft matchmarks at final drive and then at transmission flange. Start attaching nuts. Use new self-locking nuts.
2. Position center support bearing and start attaching nuts. Use new self-locking nuts.
3. Tighten flange nuts while preventing bolts from twisting in coupling. Tighten final drive flange first, then tighten coupling at transmission.
4. Preload center support bearing by pushing bearing forward 4-6 mm (0.16-0.24 in.) from center. See Fig. 6. Tighten attaching bolts.

| Symptom | Probable cause | Corrective action |
|---|---|---|
| 1. Vibration when starting off (forward or reverse). | a. Incorrect preload of center bearing. | a. Check preload of center bearing. Readjust preload. See Fig. 6. |

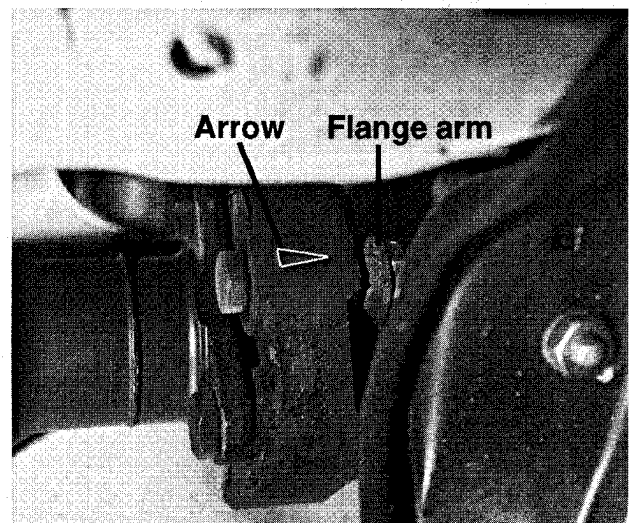
5332

**Fig. 7.** When attaching flex-disc, molded arrows must point toward flange arms.

3. Install new flex-disc using new self-locking nuts. Molded arrows on coupling should face flange arms. See Fig. 7.

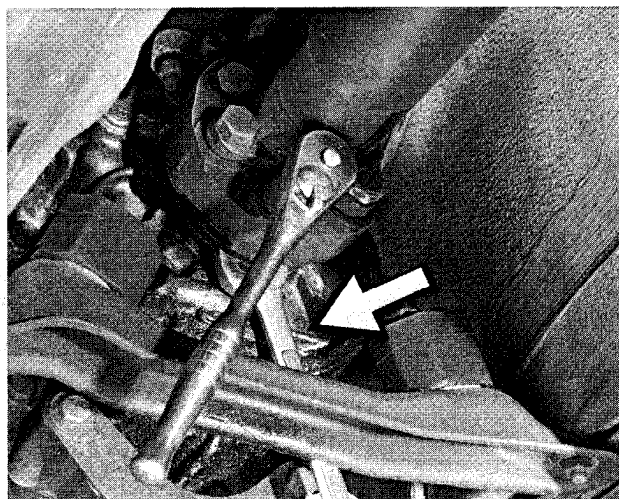
**Fig. 3.** Front driveshaft to transmission mounting bolt being removed. Note open-end wrench (arrow) being used to counterhold bolt.

1. Disconnect oxygen sensor electrical connectors and remove complete exhaust system. See **180 Exhaust System**.
2. Remove exhaust heat shield and heat shield cross-member.
3. Matchmark front and rear driveshaft connections at transmission and final drive.
4. Remove driveshaft mounting bolts. See Fig. 3. Discard old nuts.

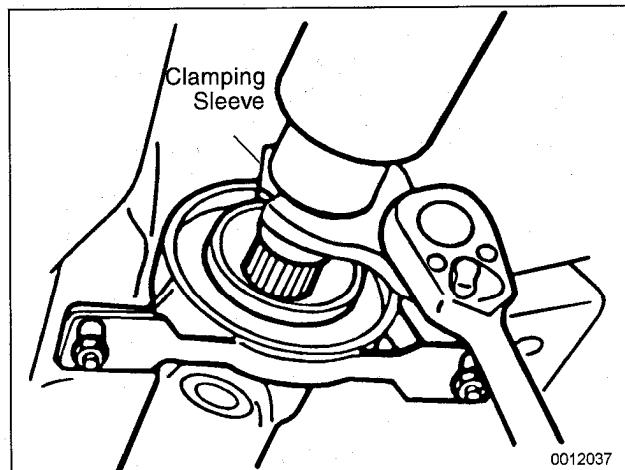
**Fig. 4.** Threaded clamping sleeve nut being loosened.

5. Loosen threaded clamping sleeve on driveshaft a few turns. See Fig. 4.

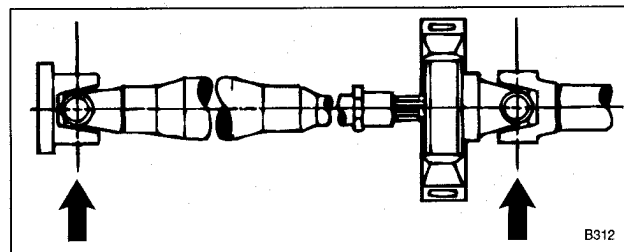
**Fig. 5.** Driveshaft alignment. Centerlines of universal joints (arrows) must be parallel or at 90° to each other.

If driveshaft halves were separate and not match-marked, assemble driveshaft as shown in drawing. If a vibration occurs, disassemble driveshaft and rotate one section 180°. See Fig. 5.

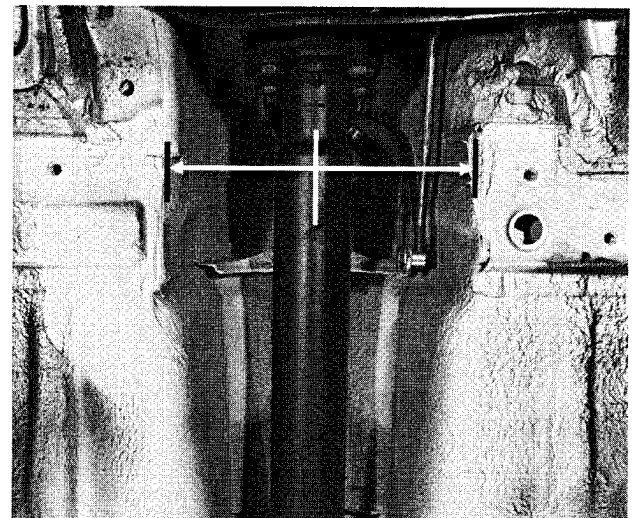
**Fig. 2.** Driveshaft side-to-side alignment. Driveshaft should be centered in driveshaft tunnel.

There are two important driveshaft alignment checks. The first is to make sure that the driveshaft runs straight from the transmission to the final drive, without any variation from side-to-side caused by misalignment of the engine/transmission in its mounts. Make a basic check by sighting along the driveshaft from back to front. Any misalignment should be apparent from the center bearing forward. To adjust the side-to-side alignment, loosen the transmission or engine mounts to reposition them, then retighten the mounts. The driveshaft should be exactly centered in the driveshaft tunnel. See Fig. 2.

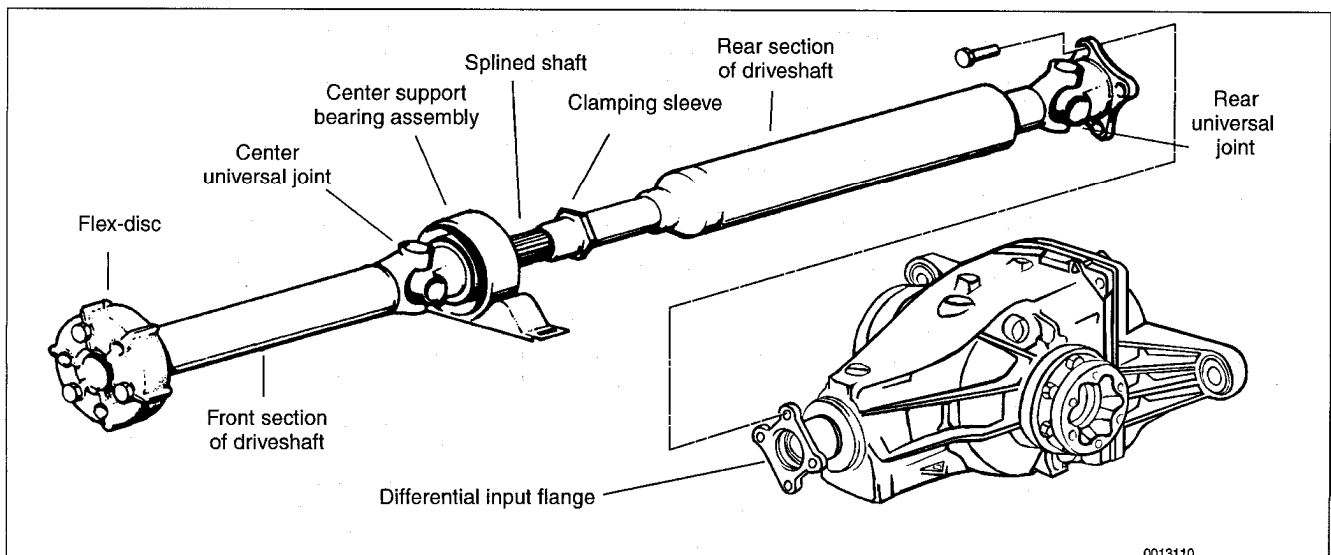
Fig. 1. Driveshaft and final drive assembly.

The two-piece driveshaft is joined in the center by a sliding splined coupling. This coupling compensates for fore and aft movement of the drive line. The driveshaft is connected to the transmission by a rubber flex-disc and to the final drive by a universal joint. It is supported in the middle by a center support bearing. The bearing is mounted in rubber to isolate vibration. See Fig. 1.
