# HORN SYSTEM

## PARTS LOCATION

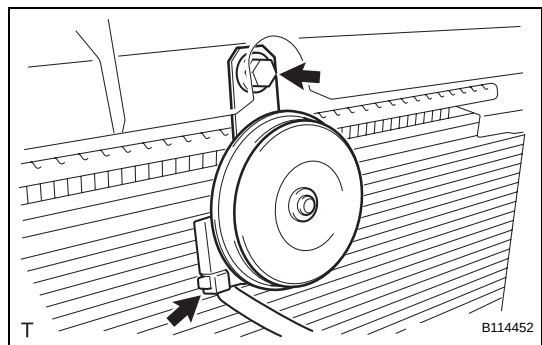
- 1. INSTALL LOW PITCHED HORN ASSEMBLY
  - (a) Install the low pitched horn with the bolt.  
Torque: 19.5 N\*m (200 kgf\*cm, 14 ft.\*lbf)
  - (b) Connect the low pitched horn connector.
- 2. INSTALL FRONT BUMPER COVER (See page ET-73)
- 3. CONNECT CABLE TO NEGATIVE BATTERY TERMINAL  
Torque: 5.4 N\*m (55 kgf\*cm, 48 in.\*lbf)
